## Introduction

# TV

## MANUFACTURERS' RECEIVER TROUBLE CURES

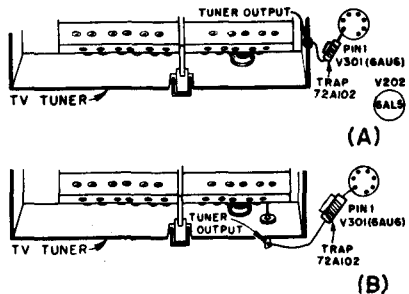
Fig. 2 — Admiral

The picture may have a herringbone interference pattern produced

by the adjacent lower channel sound carrier. Close examination will often reveal the fine lines of herringbone pattern varying in accordance with the speech or music on the adjacent lower channel. Since f-m interference from other sources also produces a herringbone pattern, the presence of a station on the adjacent lower channel should be definitely determined.

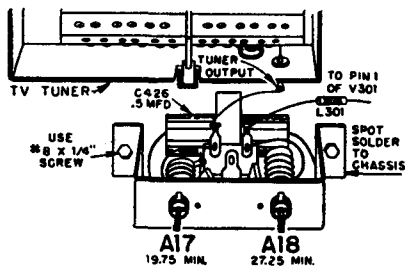
Fig. 6 — Admiral

**ADMIRAL**Chassis 24D1  
through 24H1**Eliminating adjacent-channel  
interference (see Fig. 6).**

Two adjacent-channel traps *L309* (27.25 mc) and *L310* (19.75 mc) may be added between the output of the tv tuner and the input of the first video i-f amplifier *V301* (6AU6). This is done to eliminate the possibility of interference from the video carrier of the adjacent channel above, and the sound carrier of the adjacent channel below, the desired channel.

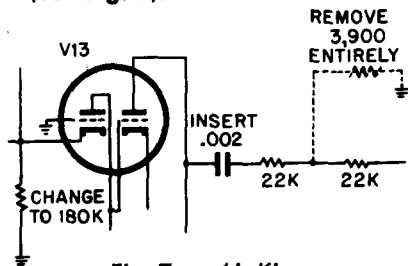
Fig. 7 — Air King

**AIR KING** 700-series Chassis  
**Increasing vertical sync stability**  
(see Fig. 7).

To increase vertical sync stability a .002- $\mu$ f capacitor should be inserted between the 22,000-ohm resistor and plate (pin 1) of the sync amplifier and phase splitting tube (V-13) as shown in the drawing. In conjunction with this change the 3,900-ohm resistor from the junction of the 22,000-ohm resistor to ground should be removed.

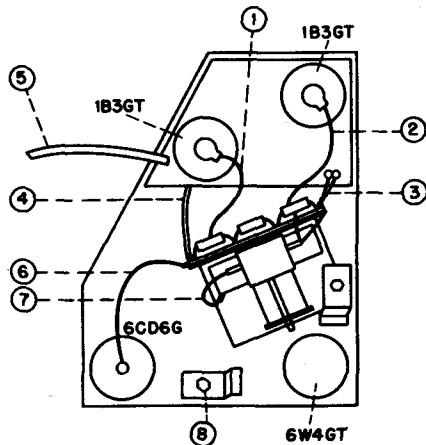
Fig. 8 — Andrea

**ANDREA** Chassis VL-16  
**Preventing arcing and burning**  
(see Fig. 8).

Whenever any work must be done in the high-voltage compartment or if a tube is replaced in this section, proper lead dress must be maintained. Extreme care must be used to prevent connecting wires to the tube caps from touching any portion of the metal compartment or other components. Failure to observe this precaution may cause arcing and burning.

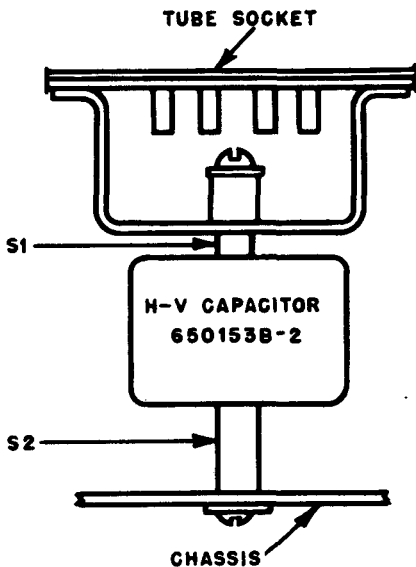
Fig. 20 — Capehart-Farnsworth

#### *Internal arcing in h-v capacitor (see Fig. 20).*

This is the 500- $\mu\mu\text{f}$ , 200,000-volt high-voltage filter capacitor, part No. 650153B-2.

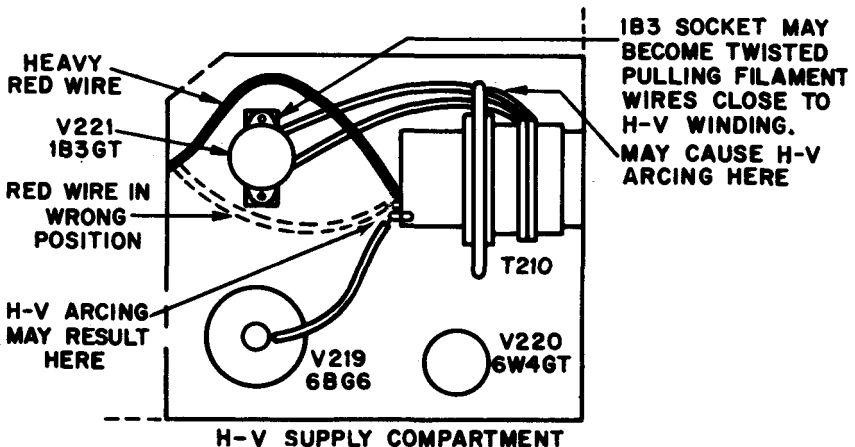
Fig. 21 — Capehart-Farnsworth

If necessary to replace the 1B3 rectifier tube in h-v section of the receiver, it is possible, if care is not exercised, to disarrange the wiring. This might cause high-voltage arcing or a short to develop resulting in a burned-out transformer. Note carefully in the sketch the proper position of the 1B3 socket, so as to avoid drawing the filament-supply leads against the transformer coil. Also note correct position of the heavy red wire between the horizontal-output transformer and the deflection yoke.

It must be between the 1B3 tube and power-supply shield — not between the 1B3 and 6BG6 tubes.

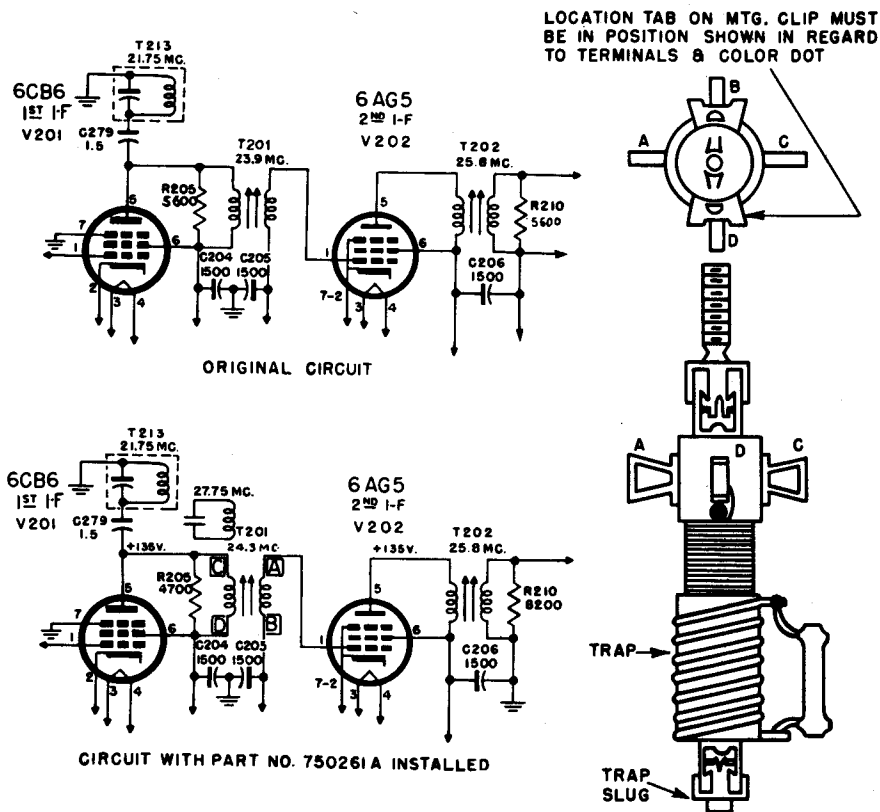
Fig. 23 — Capehart-Farnsworth

For the few areas where severe adjacent-channel interference is encountered, a special trap is available. This trap, part No. 750261A, is a combined first i-f transformer and

trap and replaces the original first i-f transformer.

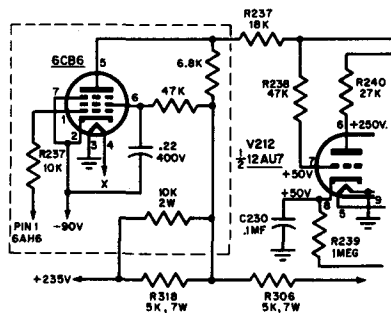
Fig. 24 — Capehart-Farnsworth

It is possible, under particularly severe conditions, that greater range of the contrast control may be required without loss of sync. If so, a

6CB6 sync-amplifier tube may be easily installed on the chassis between the 6AL5 (*V204*) and 12AU7 (*V212*). Using a socket punch, cut a 5/8-inch hole in the chassis. Install socket and wire as shown in the figure.

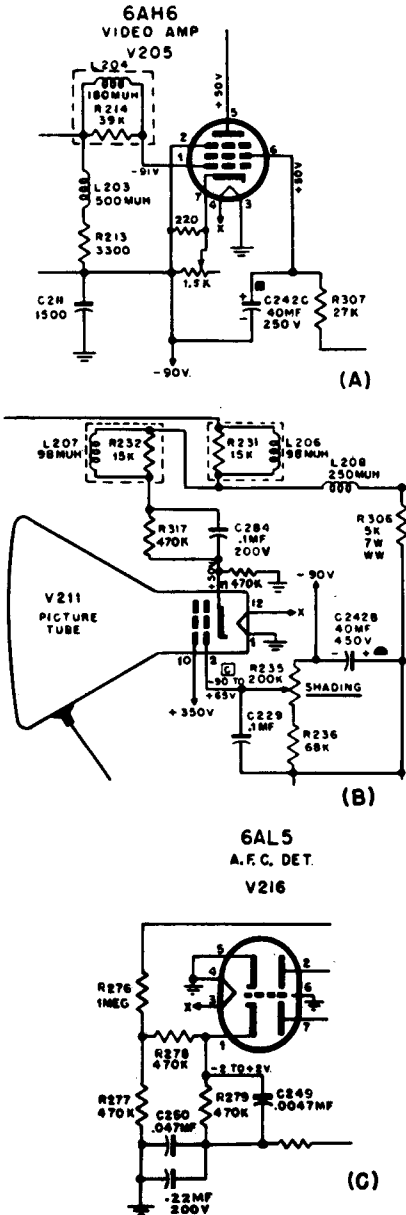
Fig. 26 — Capehart-Farnsworth

A condition of vertical linearity instability evidenced by a cyclic, or

repetitive, expansion and contraction in the vertical direction of a portion of the picture can be corrected by the following circuit change. Remove the center arm of the *Height Control* (R273) from +310 volts and connect to the junction of R266 and C243A. Remove R266 from +310 volts and connect to +295 volts. All connections are in a convenient position and it should take only a few seconds to change the two wires involved.

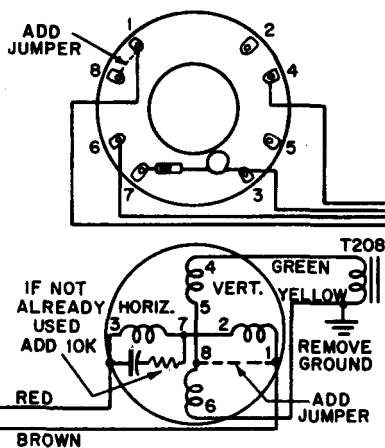
Fig. 27 — Capehart-Farnsworth

Some high-voltage breakdowns between yoke windings have been reported in yokes 750192A and B which are furnished with models 335 and 337 (with the above chassis). To reduce the potential difference between windings, the following change procedure should be followed:

1. Remove the chassis.

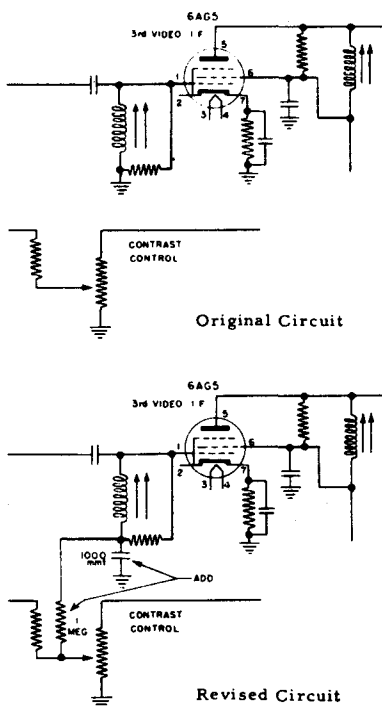
**Fig. 29 — Crosley**

In some cases where these sets are operated in areas where the signals from one or more stations is exceptionally strong it may cause the contrast control to operate very critically. This condition can be corrected without losing sensitivity in the re-

ceiver by adding a variable bias to the third picture i-f stage. This can be accomplished by making the following wiring changes:

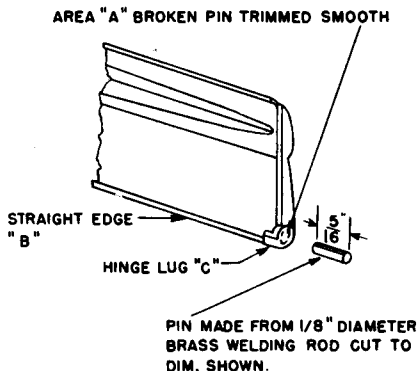
Fig. 30 — Crosley

### Repair of broken hinge (see Fig. 30).

When a broken hinge pin is encountered on the doors, repairs can easily be made in the following manner:

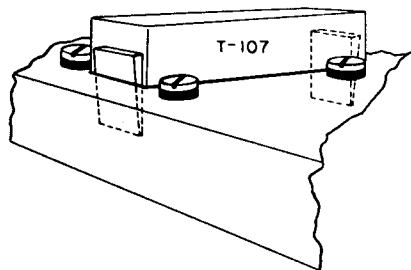
Fig. 32 — Crosley

Horizontal-sweep sing can be caused by vibration of the mounting bracket on the horizontal-output transformer, *T107*. This mounting

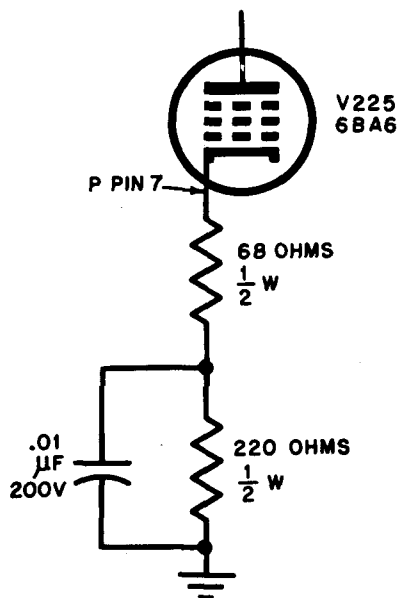
Fig. 41 — DuMont

**Correcting vertical jitter**  
(see Fig. 41).

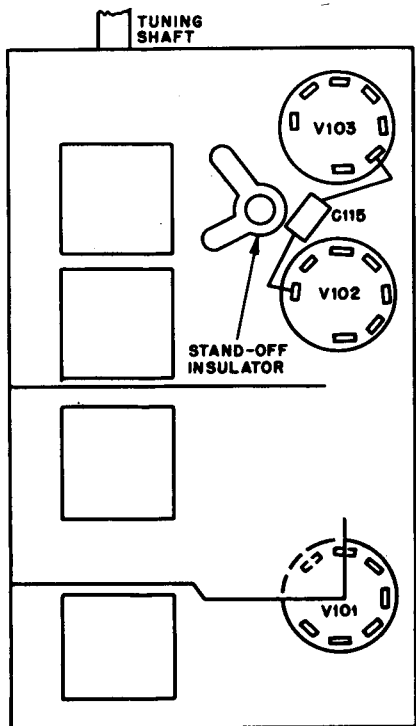
Fig. 44 — DuMont

A few field complaints have been received indicating that the high-channel sensitivity of the receiver is low in certain areas, as a result of low oscillator-injection voltage. If this condition should be encountered it is suggested that the following procedure be followed to improve the sensitivity:

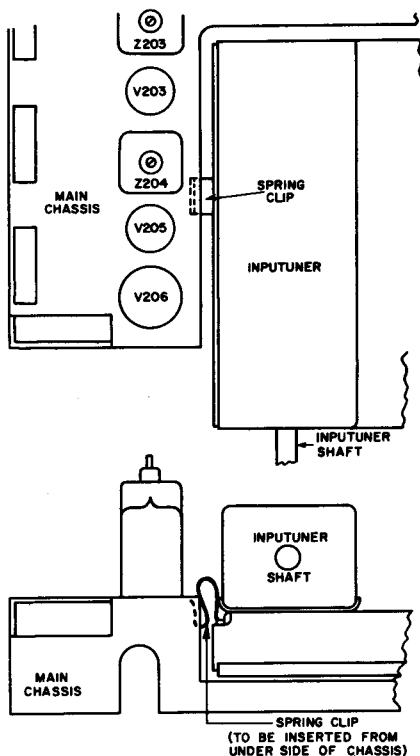
Fig. 45 — DuMont

**DUMONT Model RA-109A**  
**Elimination of channel 7 beat**  
(see Fig. 45).

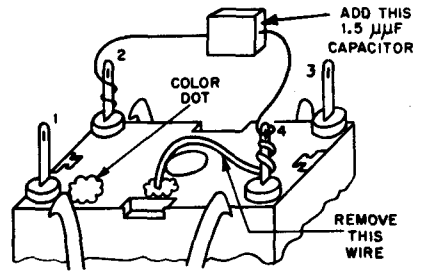
Fig. 51 — DuMont

Some complaints of breakdown of the ceramic coupling capacitor in the video i-f transformers have been received. The condition encountered
