MANUFACTURERS' RECEIVER TROUBLE CURES

VOLUME 2

Copyright 1953 by

JOHN F. RIDER PUBLISHER, INC.

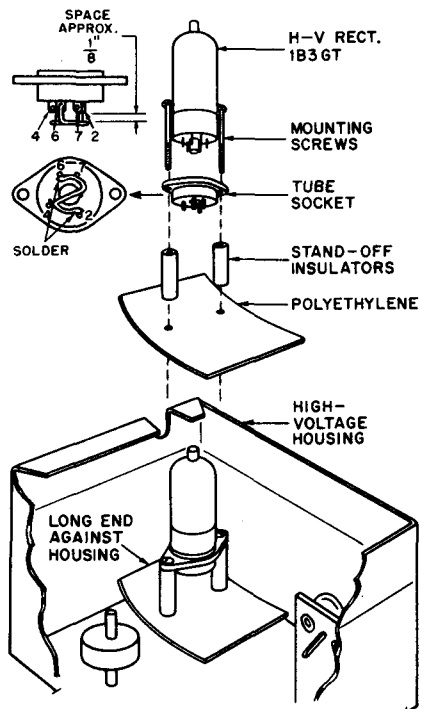
Fig. 16 - Fada

Place the plastic insulator strip on the chassis with the long end toward the h-v cage as shown on the sketch. When the socket assembly is remounted, care should be taken that the filament link and leads are kept as far away as possible from the main coil of the horizontal-output transformer, since otherwise corona may result between these two points.

In areas of high humidity an additional change may be necessary if corona still exists under the 1B3 socket. The one megohm resistor mounted on the socket should be replaced with an S-shaped corona ring, constructed of heavy solid wire. The corona ring should be mounted so that all the lugs of the socket are in line with the corona ring, as shown on the attached sketch. In most cases the corona ring will not be necessary; it should be used only when required.

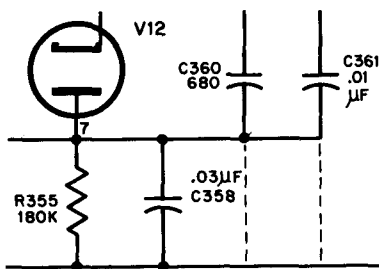
Fig. 20 — General Electric

Curl at top of picture (see Fig. 20).

A few receivers have shown a slight displacement (to the right) of the first few horizontal scan lines which shows up as a slight curl at the top of the picture. This trouble is caused by a delay in recovery of the horizontal afc circuit after the occurrence of each vertical sync pulse, and is compensated for by feeding a correction voltage of proper magnitude and phase into the afc circuit. The circuit revision is shown in the sketch; the procedure follows:

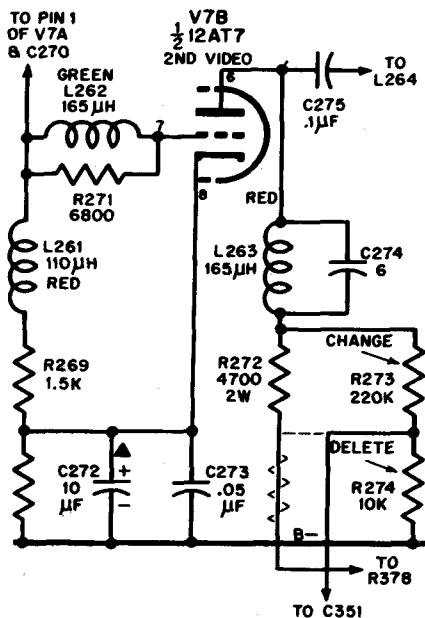
Fig. 22 — General Electric

Correcting bending at top of picture (see Fig. 22).

In early production receivers R-273, R-274 and the sync voltage take-off capacitor C-351 were connected as shown in the figure. To correct bending at the top of the picture R-274 is deleted. R-273 is changed to 220 ohms and is reconnected in series with R-272. C-351, the sync-coupling capacitor, is now connected at the junction of R-272 and R-273 as shown in the dashed lines.

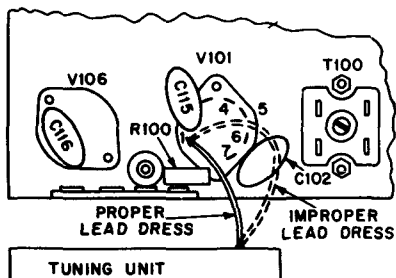
Fig. 37 — Hoffman

Channel-11 picture interference
(see Fig. 37).

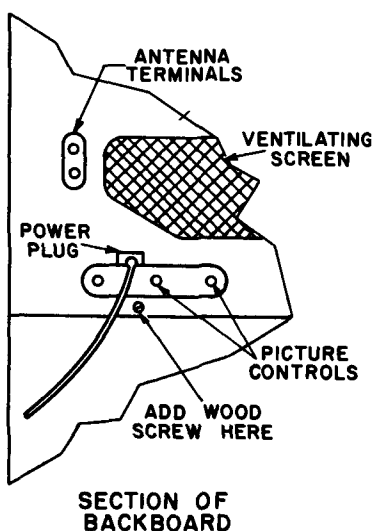
Fig. 43 — Hoffman

HOFFMAN Chassis 146
Power-cord interlock looseness (see Fig. 43).

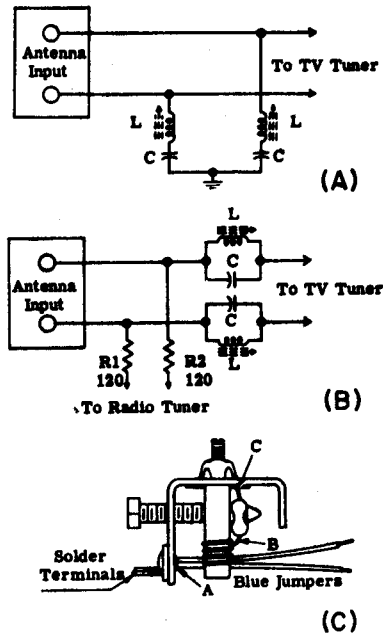
Fig. 45 — Hoffman

Interference trap for channel 2 (see
Fig. 45).

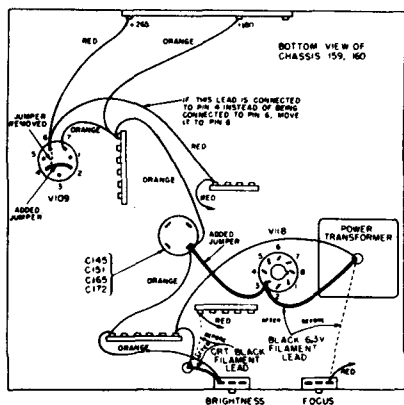
Fig. 48 — Hoffman

Forestalling heater-cathode breakdown in picture tube (see Fig. 48).

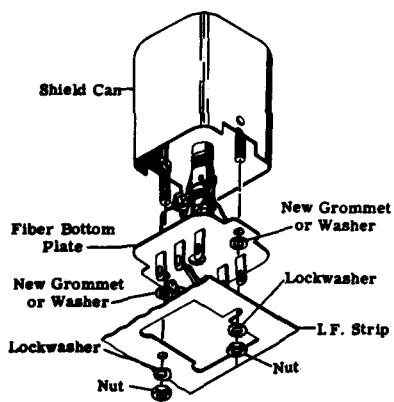
Fig. 50 — Hoffman

**Mounting modification of 3rd i-f
transformer shield (see Fig. 50).**

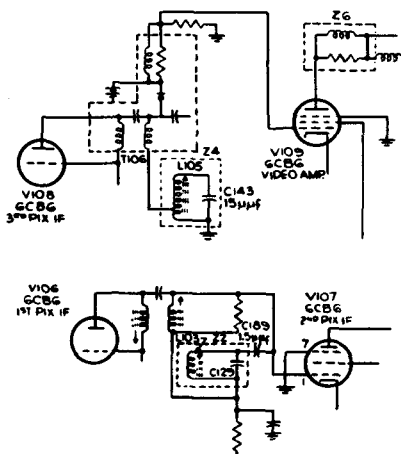
Fig. 51 — Hoffman

Removing 4.5-mc beat interference (see Fig. 51).

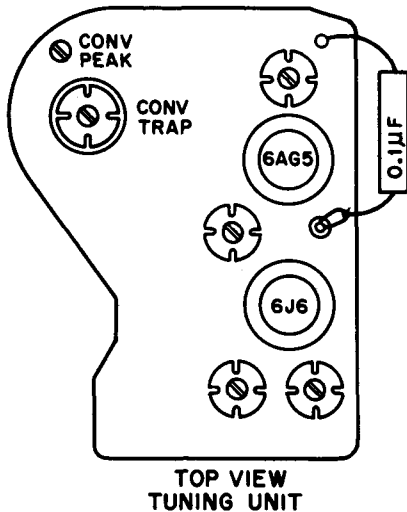
Fig. 58 — Hoffman

HOFFMAN Chassis with turret tuners RF-3 through RF-6
Tunable modulation hum (see Fig. 58).

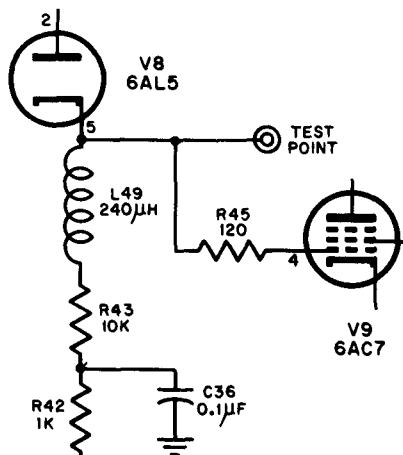
Fig. 61 — Industrial

Removing intercarrier hum (see Fig. 61).

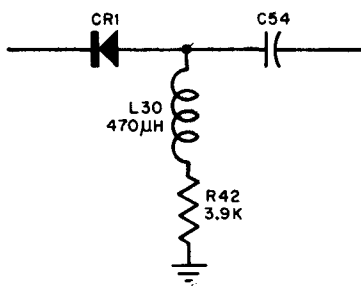
Fig. 63 — Industrial

INDUSTRIAL Chassis IT-35R
Improvement in video response
 (see Fig. 63).
