TV

MANUFACTURERS' RECEIVER TROUBLE CURES

VOLUME 3

A RIDER Publication

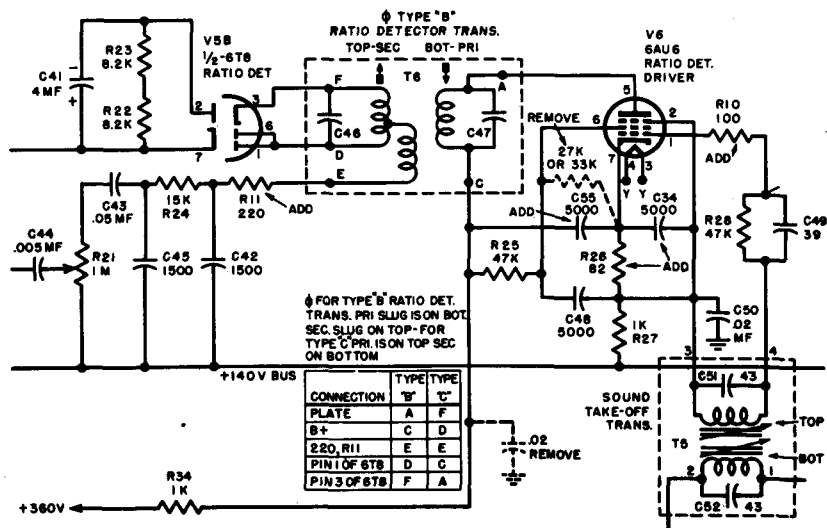
Fig. 2 — Majestic

Because of unstandardized FCC regulations, some tv stations are transmitting signals whose white level is near zero carrier. This condition may cause an objectionable buzz on receivers using the intercarrier sound system. To minimize this buzz on 94, 97, or 98 series receivers, the following circuit revision is recommended. Note: This revision has been made on production receivers which are identified by a rubber-stamped letter "B" on the rear panel of the chassis.

1. Remove the .02- μ f, 400-volt paper capacitor (6AU6 plate decoupling at junction of 1-k (*R34*) and 47-k (*R25*) resistors, located at a

terminal of the ratio-detector transformer).

Note: If, after the above procedure is followed, it is found that the buzz persists, particularly on a single station in a fringe area, align T5 and T6 by ear while listening for maximum audio signal with corresponding minimum buzz. An audio-output meter across the speaker voice coil may be helpful.

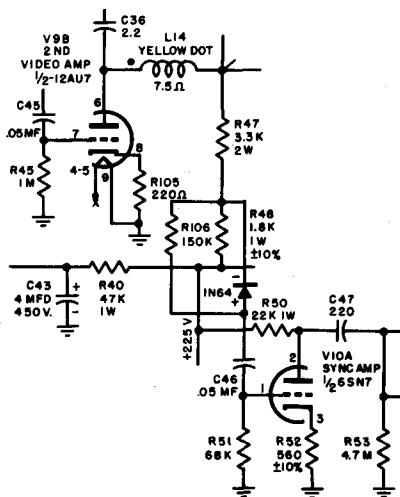
Fig. 3 — Majestic

MAJESTIC Chassis 99 through 103, 105
Improved sync clipping and better horizontal hold
(see Fig. 3).

A crystal diode 1N64, is connected in series with the sync take-off lead to provide additional clipping action. The value of *R51* (grid resistor of sync amplifier) is changed from 1 meg to 68,000 ohms.

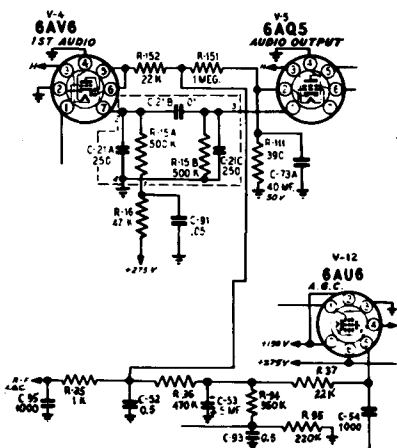
Fig. 9 — Montgomery Ward

Near the end of production a change was made in the agc circuit to improve the signal-to-noise ratio for fringe-area operation. This

Remove the Following Components
in the Plate Voltage-Divider Circuit
of the Agc Tube

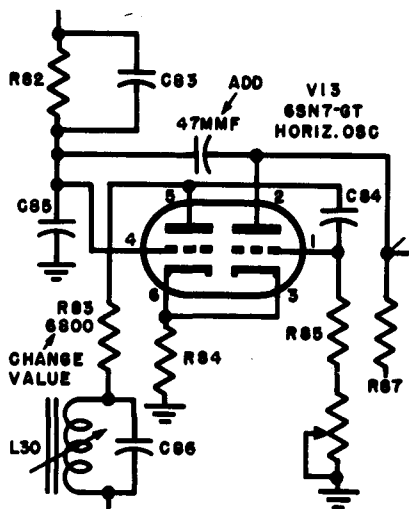
Fig. 11 — Montgomery Ward

Models 84HA-3010 A, B, C
Improved horizontal sync
(see Fig. 11).

To improve the horizontal sync, proceed as follows:

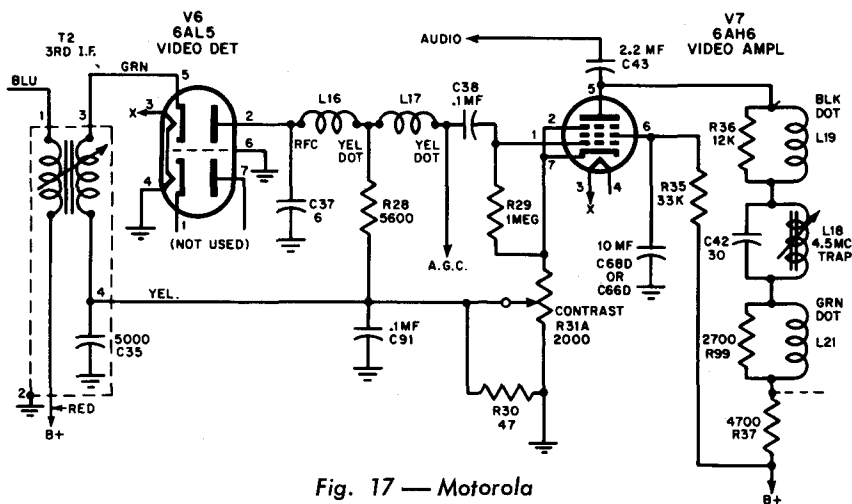
Fig. 17 — Motorola

MOTOROLA Chassis TS-89, TS-95
Improved compensation
(see Fig. 17).

An improvement in picture quality is achieved with a change in compensating coils. *L17* (in video-detector circuit) is changed from a red-dot coil to a yellow-dot coil; *L19* (in plate circuit of video amplifier) is changed from a red-dot coil to a black-dot coil; and *L21* (in plate circuit of video amplifier) is changed from a green-black dot coil to a green-dot coil. With this change in compensation, the R-C network on the tapped contrast control, *R31A*, is eliminated. Later production runs already include this modification.

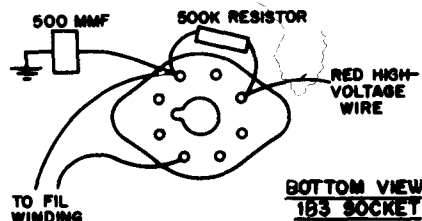
Fig. 29 — Muntz

MUNTZ Chassis M169
Frying sound at low picture-control settings (see Fig. 29).

A frying sound from the rear of the cabinet that occurs at low settings of the picture control may be caused by a slight corona condition from the high-voltage leads to ground beneath the 1B3 tube socket. To remedy, wire the 1B3 tube socket as shown in the figure.

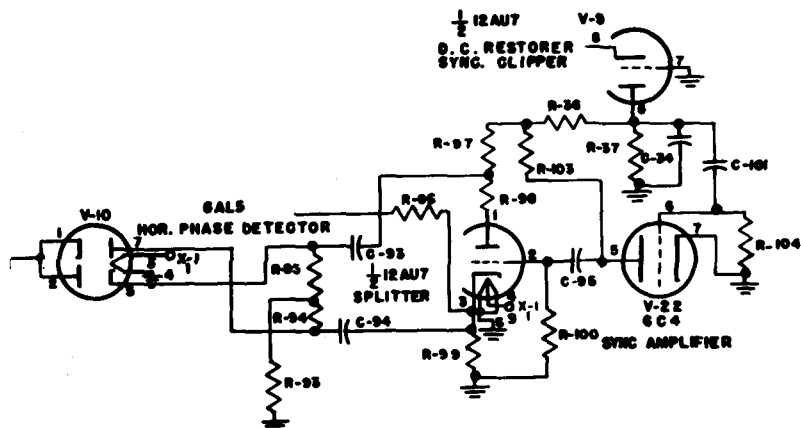
Fig. 32 — National

The affected portion of the schematic diagram is shown in the figure. Note the phase reversal at the horizontal phase detector tube *V10*.

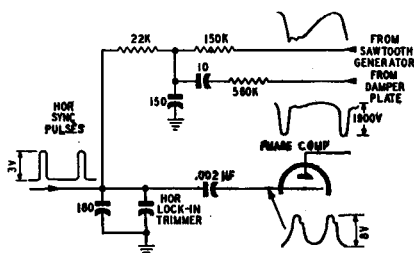
Fig. 42 — Philco

PHILCO Models 50-1403, 50-1630
Horizontal foldover
(see Fig. 42).

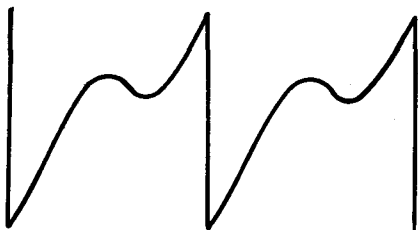
Fig. 46 — Philco

PHILCO Model 50-T1400
Horizontal-oscillator squeal
(see Fig. 46).

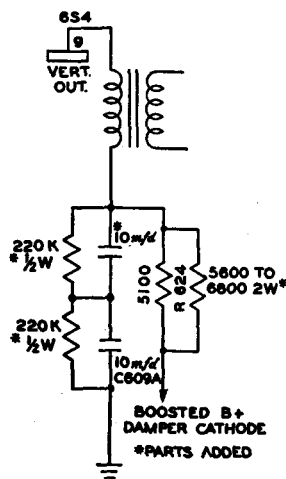
Fig. 55 — Philco

If vertical foldover is encountered at the bottom of the screen, in most cases it is due to the 6S4 be-

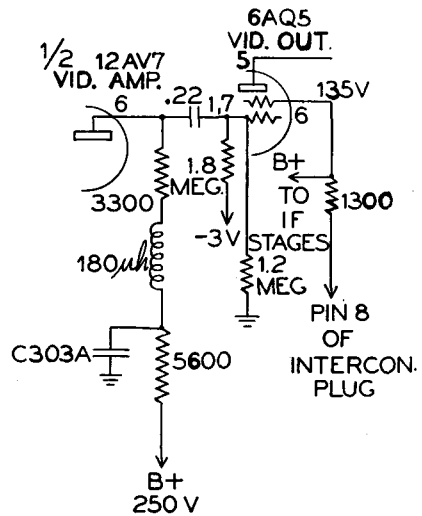
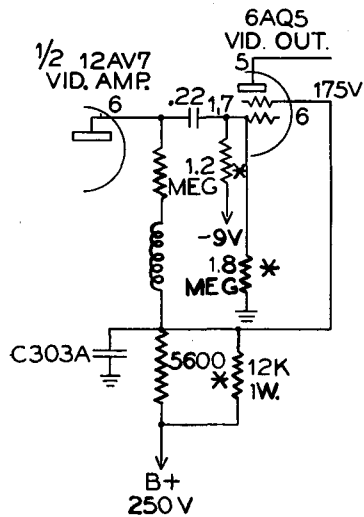
To correct "wash out" the supply point for the B+ to the screen of the 6AQ5 video-output tube should be changed. This change will permit the tube to handle a large signal. The new supply point provides a higher screen voltage and a voltage which does not vary as much with variations in agc voltage. Previously the screen grid was connected to the same B+ line as the i-f strip. Since
