MANUFACTURERS' RECEIVER TROUBLE CURES

VOLUME 4

(CAT. NO 143-4)

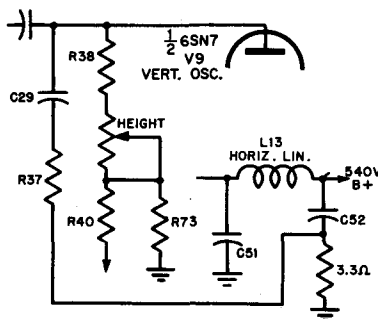
Fig. 1 — Philharmonic

1. Place a 3.3-ohm resistor in series with C52 (.05 μ f) to ground. This capacitor, shown in the figure,

is connected to one side of the linearity coil.

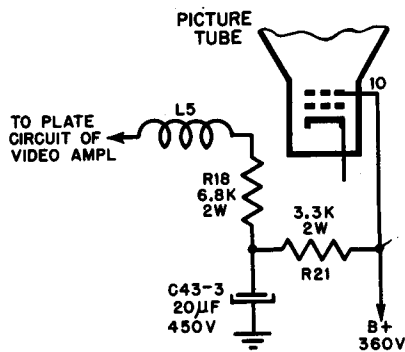
Fig. 2 — Philharmonic

If the set is going to be operated under conditions of low line voltages (less than 105 volts), make the following changes:

1. Remove C58, .02- μ f, 1,000-volt capacitor connected between pin 10 of the picture tube and ground.

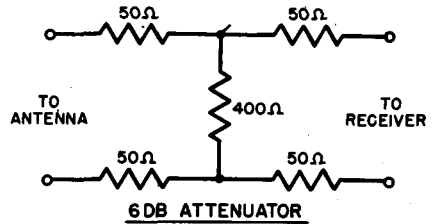
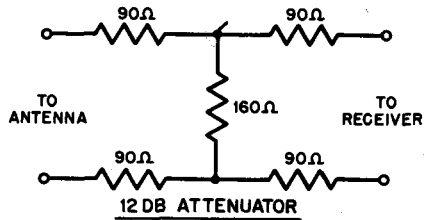
Fig. 3 - Pilot

In strong-signal areas, excessive input at the antenna terminals will produce picture smear and picture jitter. This is due to cross-modulation effects in the r-f amplifier which

may operate as a detector on the nonlinear portion of its curve near cut-off. An attenuation network at the antenna terminals will remedy this condition. A 6-db and a 12-db attenuator network are shown in the figure.

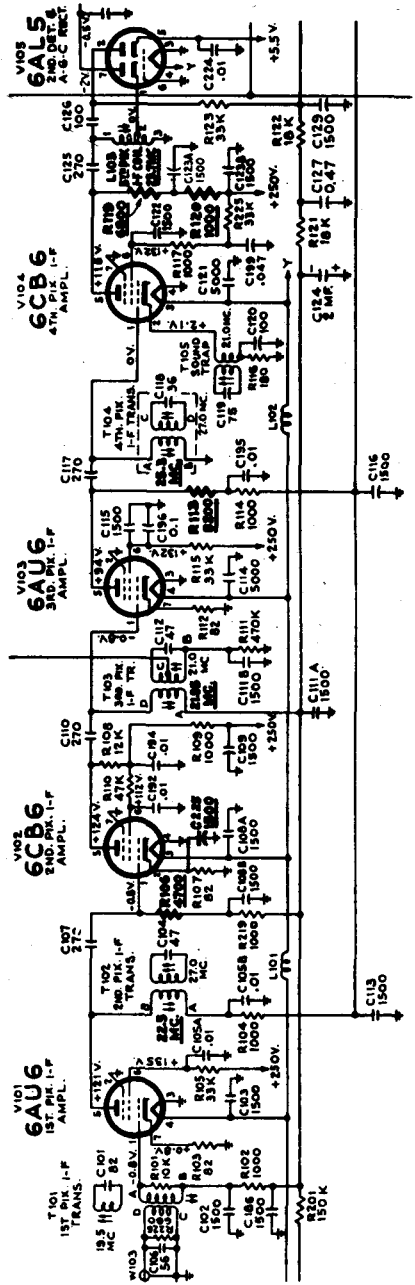
Fig. 5 - RCA Victor

In those fringe areas where additional sound gain is desirable, the

following suggestion will effect up to a 4 to 1 increase in sound gain. See the figure for a partial schematic diagram showing the changes for model 7T103.

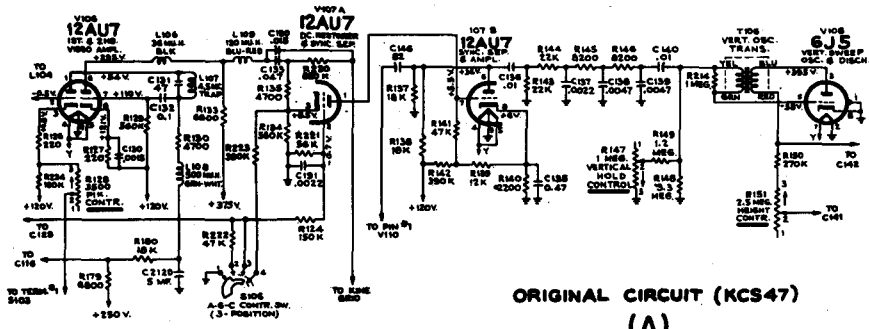
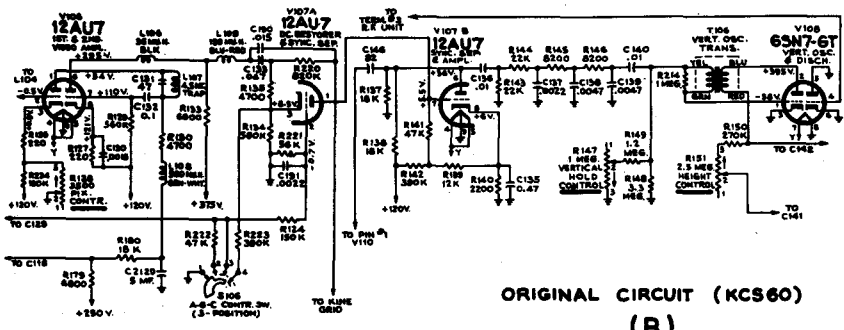
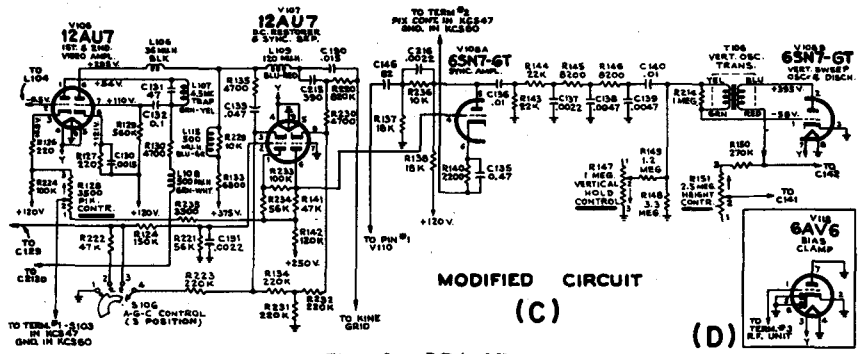
Comparing part (A) with part (C), it will be noted that V107, which was originally used as a d-c restorer, sync separator and amplifier, is reconnected with the first half of the tube as d-c restorer and horizontal-sync separator, and with the second half connected as a vertical-sync separator. V108, which was a 6J5 type used as a vertical-sweep oscillator and discharge tube, is replaced by a 6SN7 type, half of which is used as the vertical-sweep oscillator and discharge tube, while the

tion of the 6SN7 tube V108 which was formerly used as a bias-clamp is reconnected as a sync amplifier, and it is necessary to install a separate bias-clamp tube. The connections for the additional bias-clamp are shown in part (D) of the figure. Although type 6AV6 is recommend-

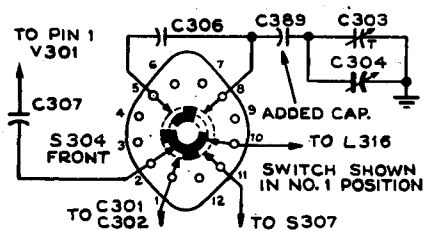
Fig. 7 — RCA Victor

RCA VICTOR Model 9TW390
Preventing heater-choke burnout (see Fig. 7).

When the radio-function switch is in the TV position, the filament voltage is present on the high side of the tuning capacitor (C303/C304) due to the function switch design. Any shorting of the tuning capacitors to ground causes L314 (filament choke) to burn out. The insertion of the capacitor removes filament voltage from the tuning capacitor without affecting its operation.

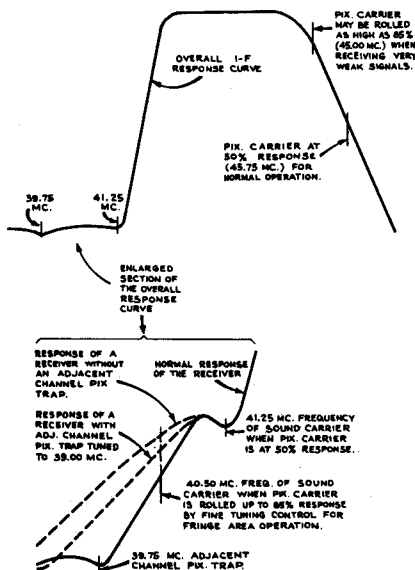
Fig. 8 — RCA Victor

It is possible to overcome the above described difficulty in many cases by a simple adjustment which can be made in the field without the aid of test equipment. When the picture carrier is rolled up the slope by .75 mc, the adjacent channel picture carrier is lowered in frequency to 39.00 mc and no longer falls into the adjacent channel picture trap. If the trap is returned to 39.00 mc, it will permit the response at 40.50 mc to rise somewhat, produce stronger sound, and will produce greater adjacent channel picture rejection un-

der the actual operating condition. If a strong signal is available on another channel and the fine tuning is adjusted to roll the picture carrier down the slope to the normal 50-percent point, the adjacent channel picture trap will appear mistuned. However, it is not likely that adjacent channel picture interference will be experienced on strong signals.

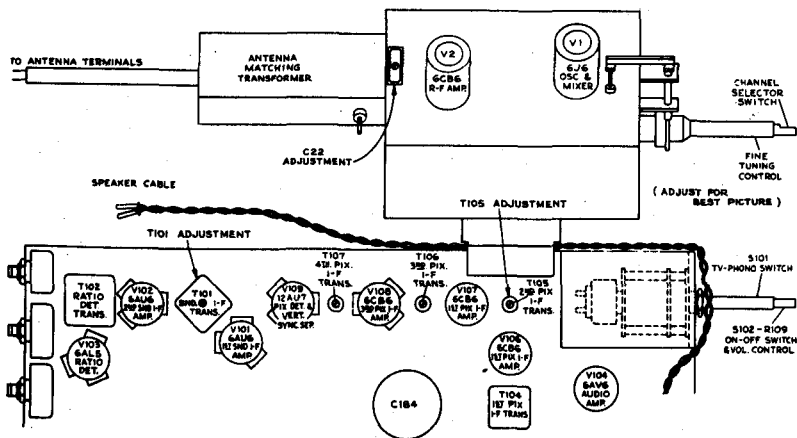
Fig. 13 — RCA Victor

In setting the agc control on these receivers, care must be taken that the receiver is generating the maximum agc voltage which will be required for that particular location of the receiver. If the agc control is adjusted on a weak signal, the receiver may overload, bend on sync, etc., when a stronger signal is received.

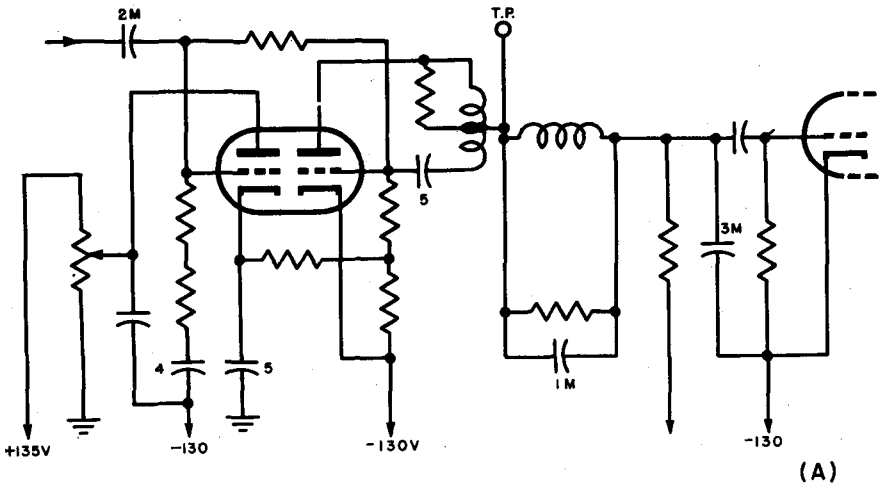
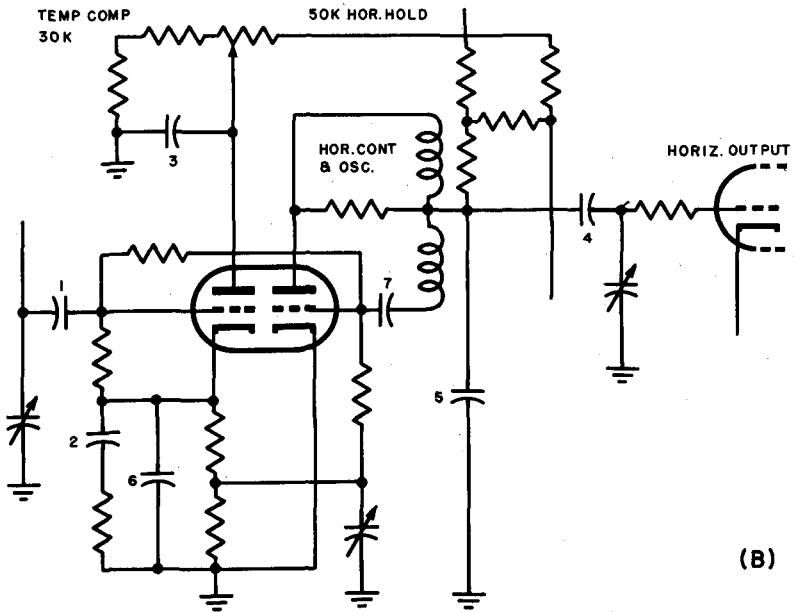
Fig. 37 - Sears Roebuck

For drift in this circuit, check the 30-k temperature-compensating resistor. It should be placed parallel to and 3/8 to 1/2 inch away from the power transformer. Check the numbered capacitors in the order indicated for leakage and replace only with molded capacitors. The .002-μf input capacitor to sync-guide grid is especially critical. Leakage of 1 to 5 megohms in any of the above capacitors can cause horizontal drift.

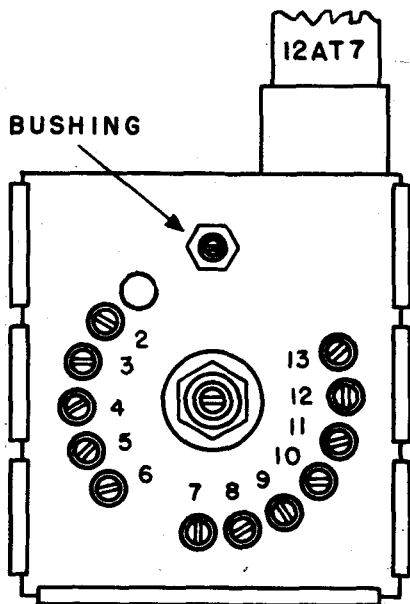
Fig. 43 — Sentinel

Tearing when set is jarred
(see Fig. 43).

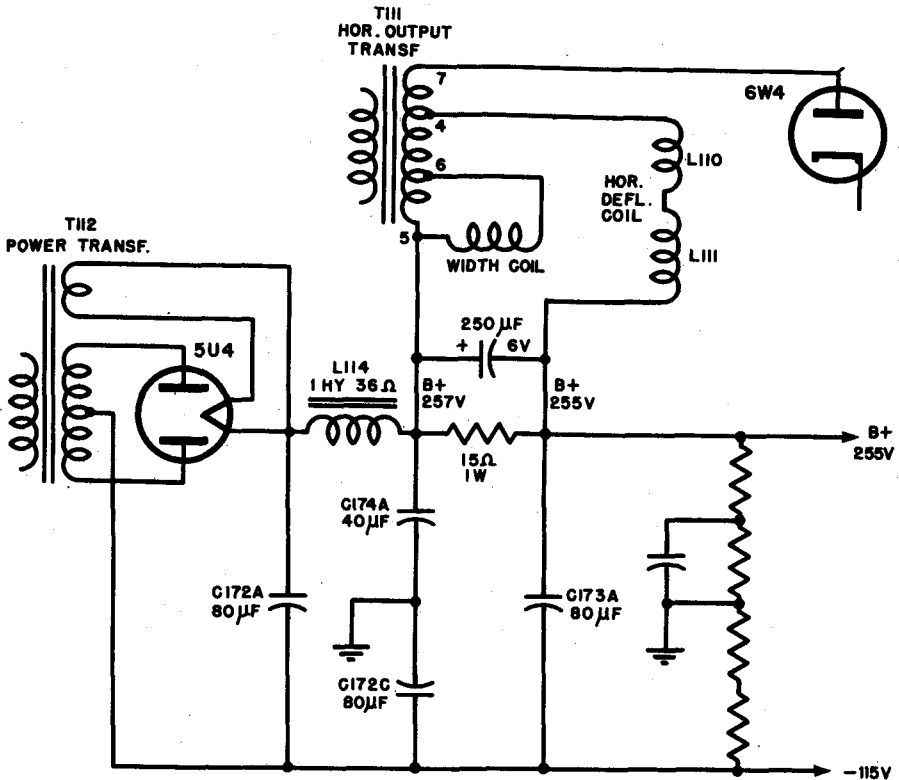
Fig. 57 — Shaw TV

SHAW TV Chassis 224
Improved horizontal centering
 (see Fig. 57).
