## MANUFACTURERS' RECEIVER TROUBLE CURES

### **VOLUME 5**

**MANUFACTURERS'  
RECEIVER  
TROUBLE CURES**

*Edited by*  
Milton S. Snitzer

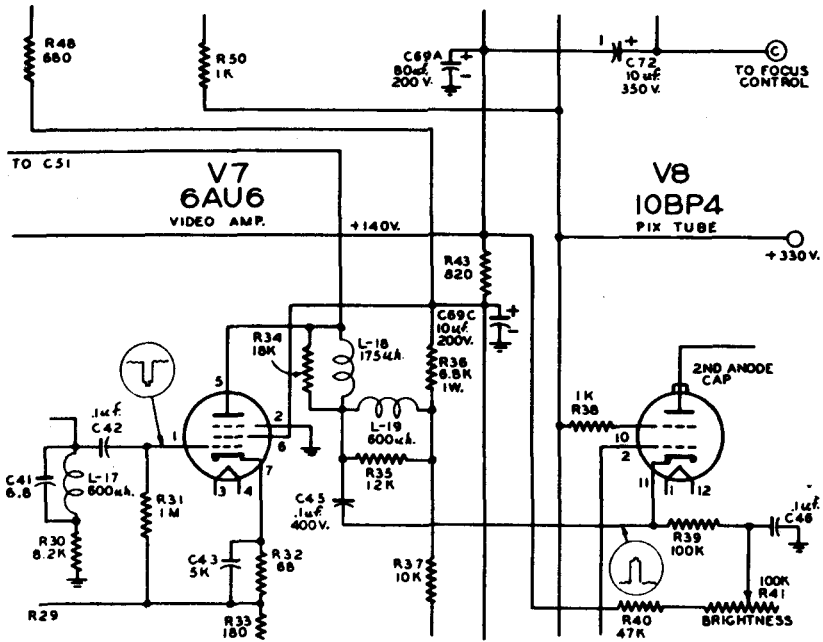
Fig. 1 — Sparton

### Reducing hum in final audio stage (see Fig. 1).

To reduce objectionable hum introduced in the final audio stage through common coupling with the video amplifier, sync separator, and sync amplifier, a decoupling network has been devised in the +140 volt line feeding these points. A sectional schematic diagram of the video i-f circuit, showing *V7*, 6AU6 video amplifier, and its associated

R48. When this change is made, the 4-point terminal strip on the receiver chassis should be replaced with a 5-point strip to provide the additional tie point needed. C69C, the 10- $\mu$ f, 200-v capacitor, is an additional section in the original C69A and C69B filter.

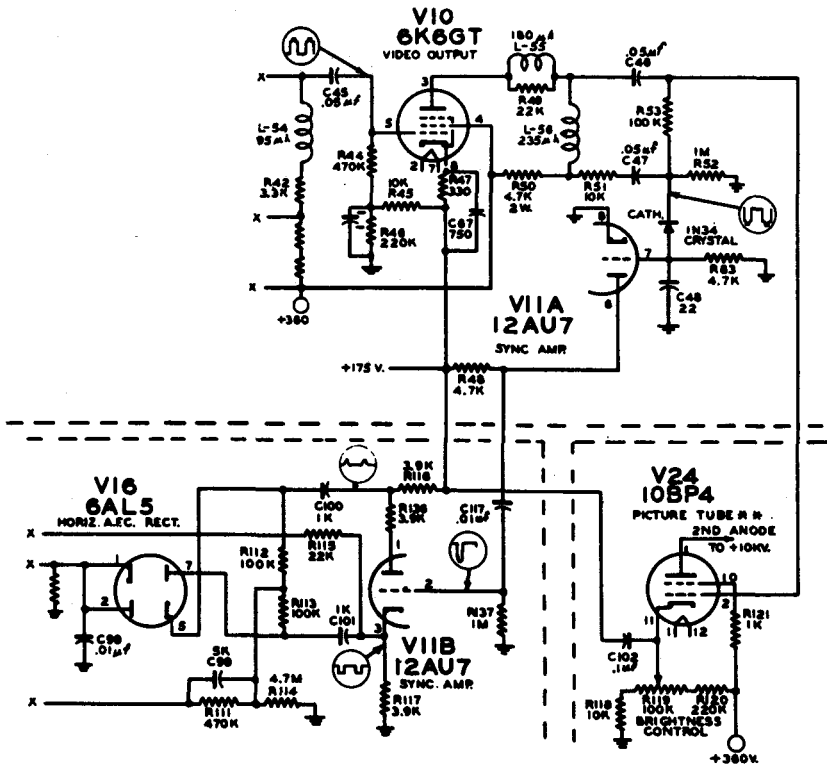
Fig. 3 - Spartan

If the picture i-f strip is badly out of alignment, it may become unstable and fall into oscillation. When this condition occurs, a comparatively large voltage is developed across the picture detector load resistor. This voltage is independent of i-f signal input at the converter grid.

8. Replace  $R48$  (1 meg) from pin 6 to +135 volt line with new  $R48$  (4.7 k).

New parts required:

1. 1N34 germanium crystal diode (part No. PA4206).
2. 4.7-k, 1/2-watt resistor (part No. BR12S-472).

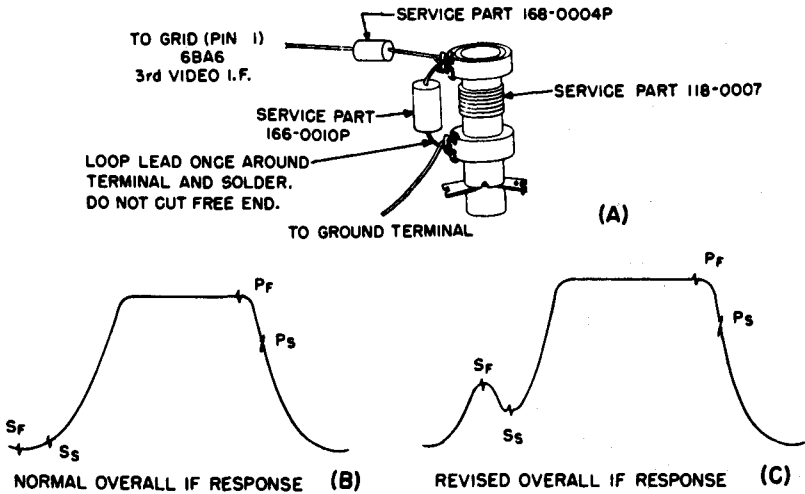
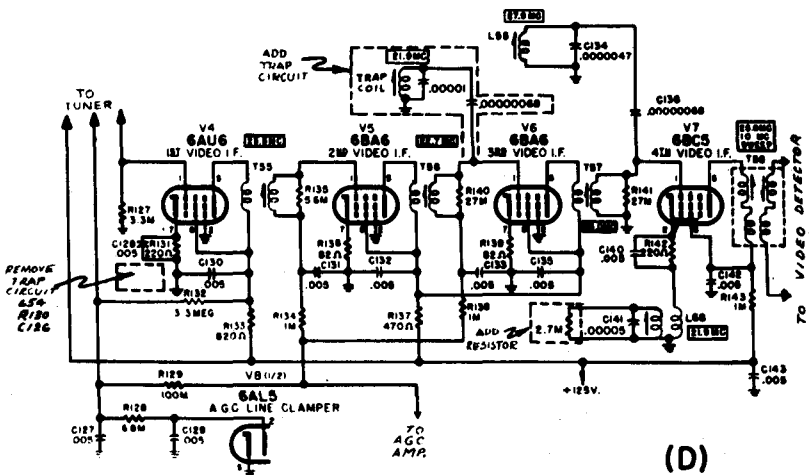
Fig. 15 — Sylvania

If it is desired to modify any of the above chassis to improve sound

reception in fringe areas, the following procedure is recommended:

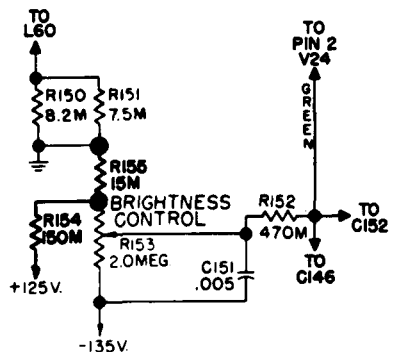
Fig. 20 — Sylvania

**SYLVANIA** Chassis 1-387-1, -437-3, -502-3  
**Improving operation of brightness control**  
*(see Fig. 20).*

To improve operation of the brightness control, two new resistors are added in later production. These are identified as *R154* and *R155* with values of 150,000 and 15,000 ohms respectively. See figure for connection. In some chassis, these resistors are identified as *R155* and *R156* or as *R156* and *R157*.

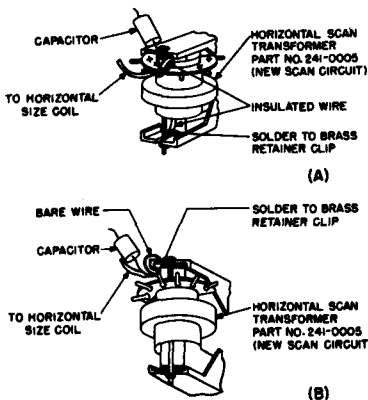
Fig. 26 — Sylvania

**SYLVANIA** All chassis with h-v transformer 241-0005  
**Arcing and corona in h-v transformer retaining clip**  
**(see Fig. 26).**

Arcing and corona in h-v transformer retaining clip may be corrected by connecting an insulated wire from the clip to the center transformer terminal as shown in sketch (A).

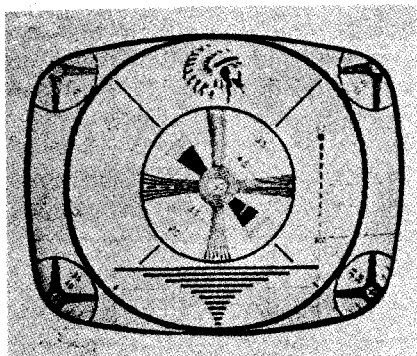
Fig. 39 — Westinghouse

**WESTINGHOUSE** Models with 6AU5 horizontal output tube  
**Ragged picture tube pattern**  
 (see Fig. 39).
