# TV

## MANUFACTURERS' RECEIVER TROUBLE CURES

**VOLUME 6**

This is the sixth in a series of volumes which deal with specific tv receiver troubles and their cures. These trouble cures are the tv manufacturers' own answers to some of the problems that may arise in their particular receivers.

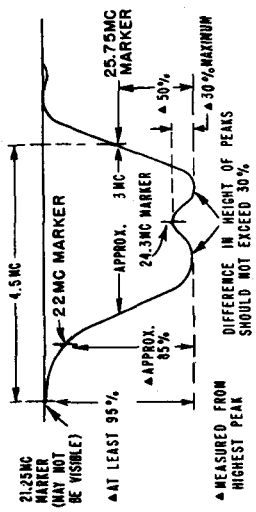
**IDEAL IF RESPONSE CURVE**

If the curve cannot be made to resemble the response curve shown, repeat all steps under "I-F Amplifier and Trap Alignment" making sure that generator frequencies are accurate and adjustments are carefully made. If a satisfactory curve cannot be obtained after repeating these steps, it may be necessary to change i-f amplifier tubes or check for a defective circuit component to

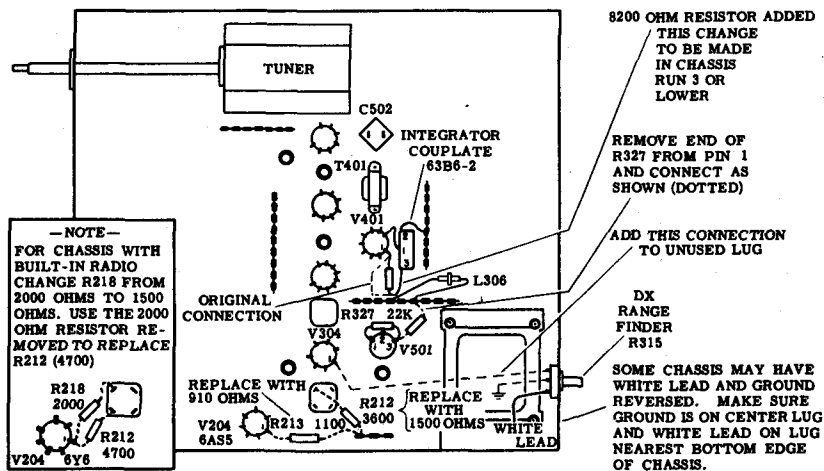
Fig. 2 — Admiral

The horizontal stability of the 19-series chassis is improved with the use of a new vertical sync integrator Couplate, 63B6-11. The circuit of this Couplate is the same as the 63B6-2 Couplate used in chassis stamped Run 6 or lower, except that resistor *R407* (22,000 ohms) is not contained in this new Couplate. In-

stead, resistor *R407* is connected externally from terminal 3 of the Couplate to pin 1 of *V401B*. This change in integrator Couplates improves the horizontal sync stability by increasing the amplitude and “squaring up” the horizontal sync pulses.

To replace the old Couplate, 63B6-2, with the new improved Couplate, 63B6-11, omit *R443*, the 8,200-ohm resistor added at Run 4. Chassis stamped Run 3 or lower will not have this resistor. Connect *R407*, a 22,000-ohm, 1/2-watt resistor, 60B8-223, between terminal 3 of the new Couplate and pin 1 of *V401B*.

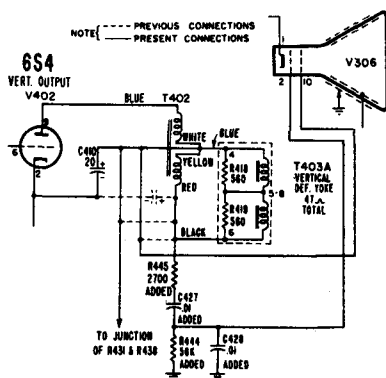
Fig. 3 — Admiral

All 19-series chassis stamped Run 5 and higher have a vertical

retrace blanking circuit incorporated for eliminating retrace lines. A schematic of the retrace blanking circuit and detailed instructions for adding this change to an early production receiver, is given in the paragraphs below. The following parts are required:

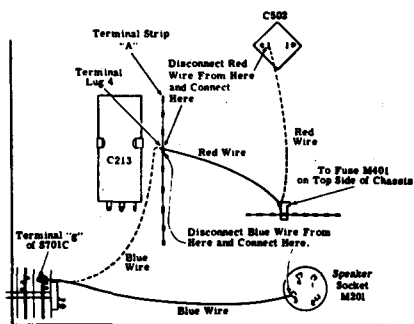
Fig. 4 — Admiral

### ADMIRAL Chassis 19E1, 19G1, 19N1 Preventing fuse failure (see Fig. 4).

In some of the above chassis, the  $\frac{3}{8}$ -amp fuse *M401* may blow when the function switch is rotated from the Radio to the TV position. This occurs because in some 77B43

Function Switches, the rotor contact of the switch section *S701C* is wide and, during rotation of the switch, there is one position where all contacts on this section may short, resulting in a surge of current that blows the fuse.

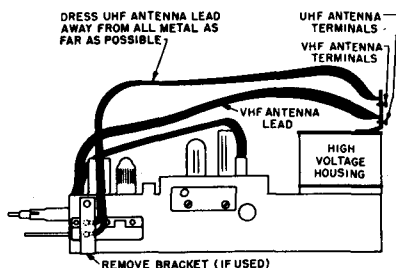
Fig. 10 — Admiral

Poor performance of all-channel receivers on uhf may be caused

by the uhf antenna lead from the uhf antenna terminals to the uhf tuner being close to or touching the metal brackets of the rear picture tube mount. This lead is purposely long and acts as a quarter-wave trap at the mean frequency of the higher vhf channels.

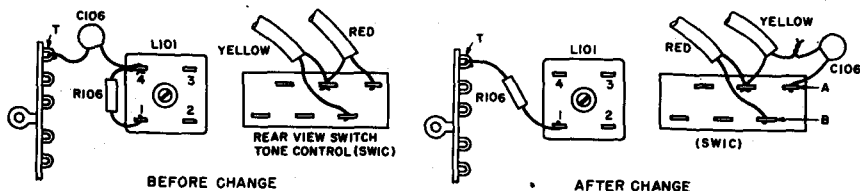
Fig. 15 - Arvin

The purpose of this change was to improve the stability of the sound detector circuit by broadening the tuning of quadrature coil *L101*. The specific defect being corrected was the tendency of *L101* to drift off re-

sonance after warm-up, causing distorted sound.

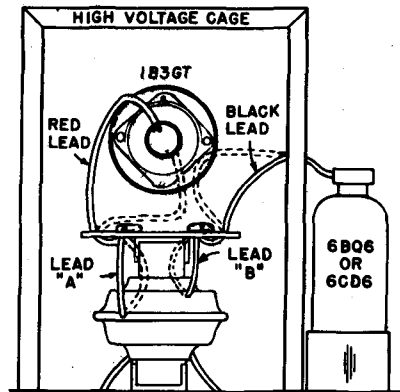
Fig. 19 — Capehart

It is important that the dress of the leads in the h-v cage be checked carefully after replacement of any tubes or components in this section. In the drawing, proper dress of high potential leads within the h-v cage is illustrated by the leads which are drawn with solid lines. This is the position in which they are placed in manufacturing. Leads represented by dotted lines indicated examples of improper dress. Note that lead A and lead B must be separated from each other and looped away from the transformer winding (toward rear of chassis). The red and black leads must be dressed away from each other. The red lead can be properly dressed by rotating the 1B3 tube cap in a clockwise direction. The black lead can be properly dressed by rotating the 6BQ6 tube cap in a counterclockwise direction on a 70-

degree chassis or on a 90-degree chassis, and by rotating the 6CD6 tube cap in a clockwise direction.

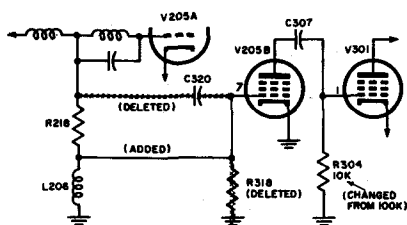
Fig. 20 — Capehart

This change is incorporated in later production to eliminate the

sometimes apparent objectionable frying or hissing in the sound under extremely weak signal conditions. To make this change on early production chassis:
