MANUFACTURERS' RECEIVER TROUBLE CURES

VOLUME 7

(CAT. NO. 143-7)

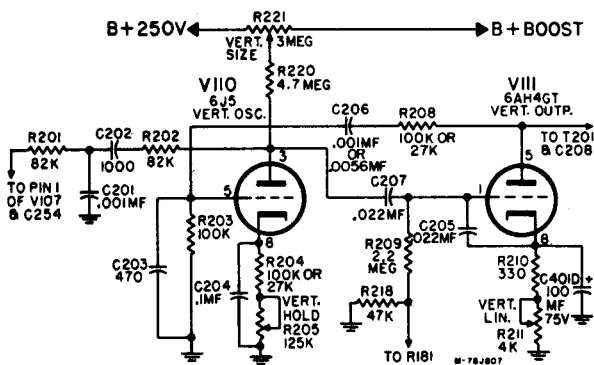
Fig. 1 — General Electric

Improved interlace and vertical control range (see Fig. 1)

Vertical Size Circuit (Mid & Late Production)

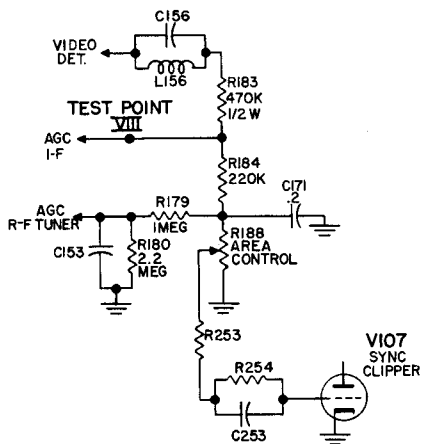
Fig. 2 — General Electric

Increasing range of area control (see Fig. 2)

AGC CIRCUIT DIAGRAM

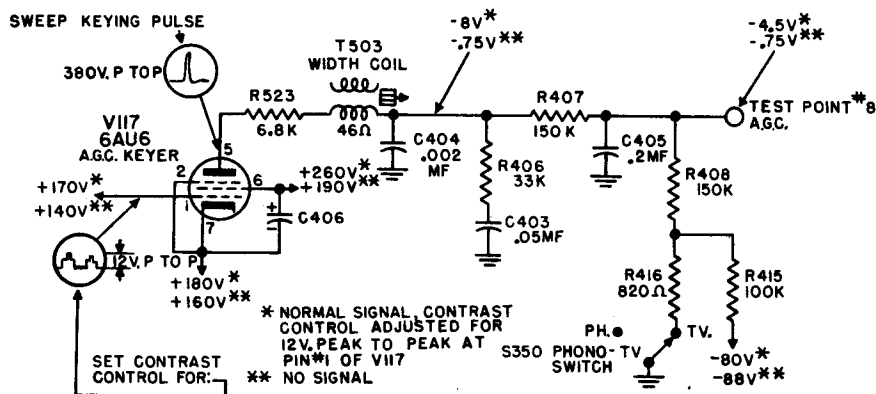
Fig. 3 — General Electric

The agc action may be seriously impaired or fail completely if the

2. With a vtvm, the voltage at the agc test point No. 8 should read at least -28 volts and in some receivers as high as -40 volts.

3. A further check of the voltages throughout the agc keyer circuit may be made by checking the voltages shown in the accompanying diagram. First adjust the receiver for normal picture. Then, with an oscilloscope, adjust the contrast control for a 12-volt peak-to-peak signal as shown at pin 1, *V117*. The keying pulse on the

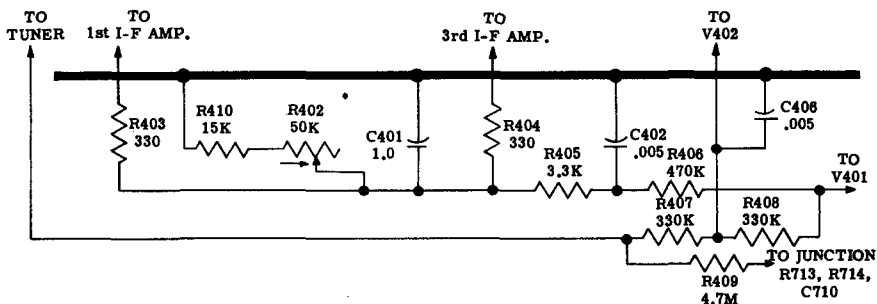
Fig. 5 — Hoffmann

above series receivers. The new control is located on the chassis rear apron next to the Horizontal Frequency knob. The figure shows the new agc circuit. A comparison of this circuit with the original schematic diagram will disclose that R402, the 47k-ohm resistor that forms a portion of the agc voltage divider, has been replaced by a 50k-ohm potentiometer connected as a rheostat and a 15k-ohm fixed resistor. This circuit arrangement places the position of the tap on the i-f agc voltage divider at the discretion of the serviceman. In order to maintain the crossover point of the r-f and i-f agc voltage where it was prior to the above change, it is necessary to increase R407, the 180k-ohm resistor, to 330k ohms in the delayed agc network.

When the agc control is turned fully clockwise, the greatest bias appears on the i-f agc bus and the lowest

bias appears on the r-f agc bus for a given signal. When the control is turned fully counterclockwise, the situation is reversed; the i-f agc bias voltage is minimum and the r-f agc bias is maximum for a given signal. This source of high r-f bias is very useful when strong signals cause the video stages to overload, clipping the sync pulses.

In very strong signal areas, turn the agc control counterclockwise until loss of sync is eliminated. Do not turn more than necessary, though, because increased bias on the r-f amplifier with simultaneous decrease in i-f bias will lead to excessive noise in the picture after a certain point is reached. Conversely, in weaker signal areas, the control should be turned clockwise so that the r-f bias is reduced and the i-f bias is increased. This condition will improve the signal-to-noise ratio, minimizing snow in the picture. Again, take care not to turn the control too far or the i-f stages may be overdriven, resulting in sync clipping. The optimum point of adjustment of the agc control is

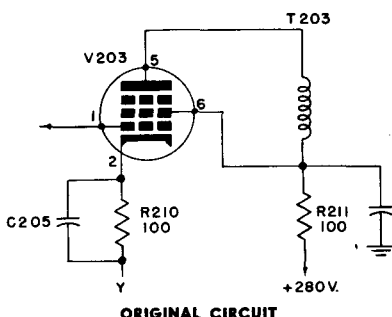
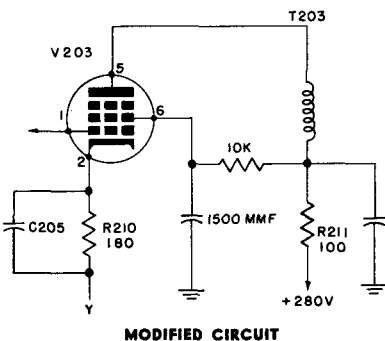
Fig. 13 — Magnavox

MAGNAVOX Chassis 105-series
Signal blocking in strong signal areas (see Fig. 13).

If signal blocks when tuning from weak to strong signals, proceed as follows:

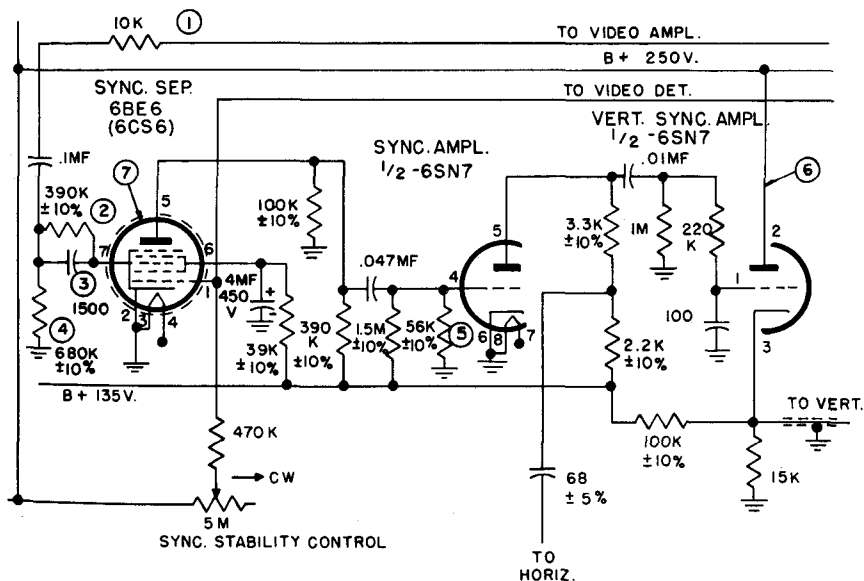
Fig. 16 — Majestic

The schematic diagram shows the revised sync amplifier circuits, with the circled numbers corresponding with the numbered steps above.

6. Remove 33k-ohm plate resistor of vertical sync amplifier and connect plate (pin 2) to 250-volt B+ instead of 135-volt B+.

7. A 6CS6 tube may be used in place of the 6BE6 tube. Tubes are directly interchangeable.

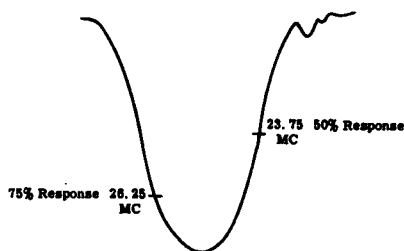
Fig. 17 — Mars

MARS TV Model 630-K3B
Extreme fringe area alignment
(see Fig. 17).

For extremely difficult fringe area coverage where signal-to-noise ratio is a problem, it is possible to narrow the 4-mc i-f bandwidth to 2 1/2 mc to obtain extra gain and a better signal-to-noise ratio. It has been found that in the nominal 100 to 150 mile sector where video reception is possible but not comfortably viewable, the 2 1/2-mc bandwidth will in most cases bring in the picture to a suitable viewable point, minimizing snow.

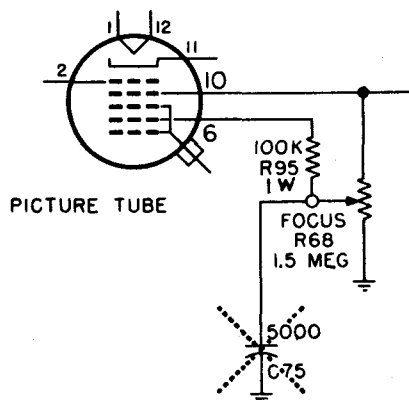
Fig. 19 — Motorola

To add protection to the focus control potentiometer, the following changes, already made in later production are included:

1. C75, 5,000- μ mf capacitor is removed.
2. R95, a 100k-ohm, 1-watt resistor, is added between the focus control arm and the blue lead to the picture tube focus anode. (Note: The

pin 2 plate of 1st sync clipper) is changed to 1 meg.

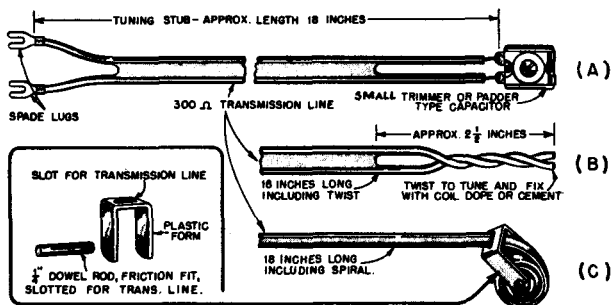
Fig. 22 — Motorola

Since the cut-and-try method of obtaining the correct length of the stub is not too effective in actual practice, a means of tuning the open-end quarter-wave stub is the logical answer to the problem. The sketches il-

illustrate these methods of accurately tuning the stubs for optimum performance.

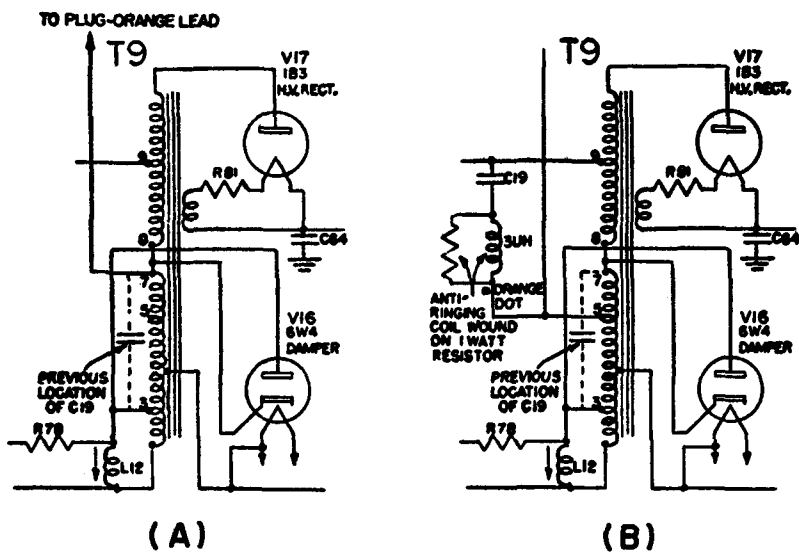
Fig. 25 — Pacific Mercury

An anti-ringing coil (part No. PMA-52062) has been designed to effectively minimize ringing for those sets produced before the new yoke assembly change. The coil will seldom be required since, in most instances,

ringing is not of objectionable intensity and its use should be restricted only to those cases where a customer's complaint actually exists.

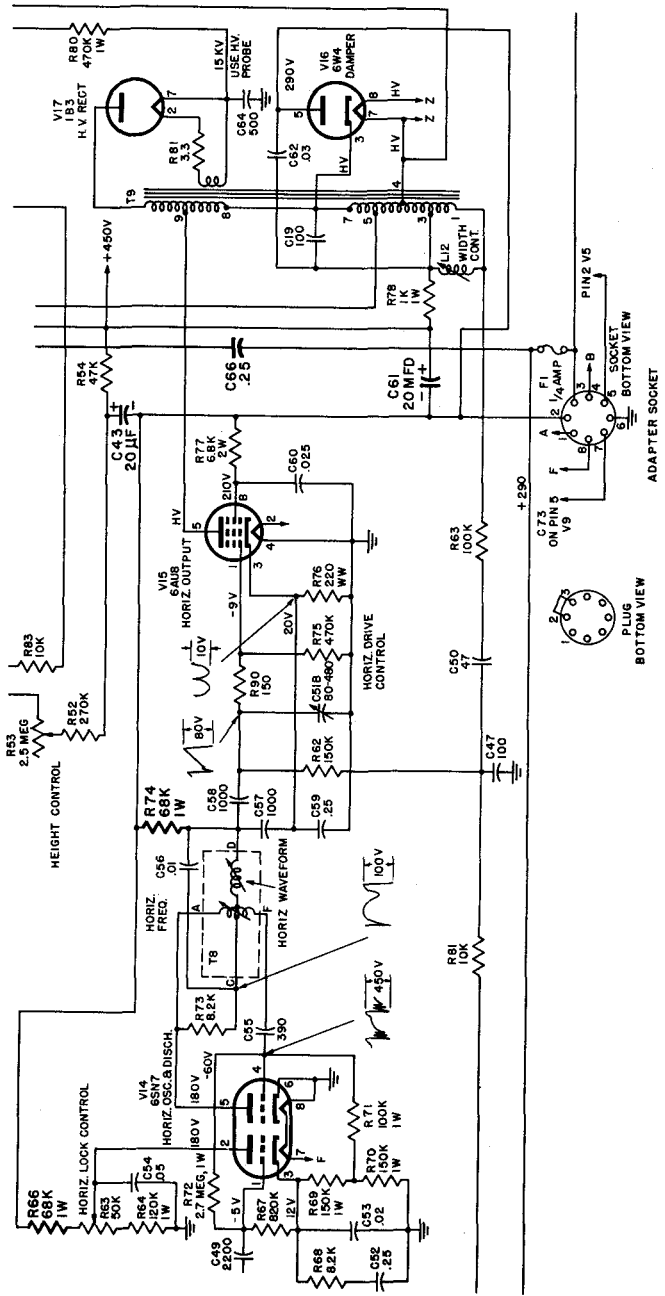
Fig. 27 — Pacific Mercury

The resistor (part No. PMA-45019-30) is already added in later

production with the unit having the serial No. 158, 573.

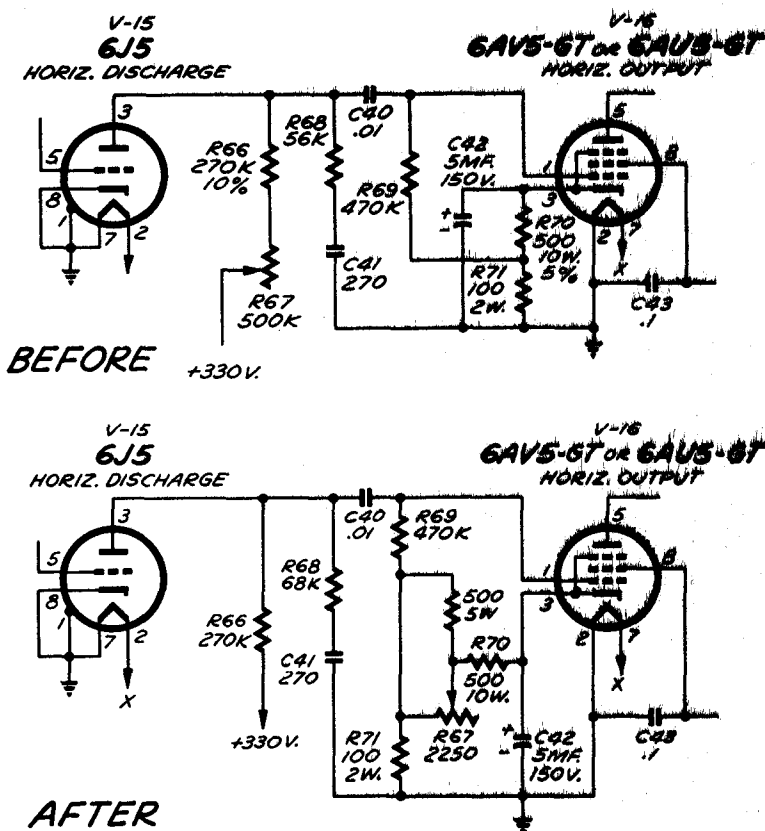
Fig. 28 — Pacific Mercury

This form of cathode limiting, controls the amount of current that can be drawn by the anode of the picture tube without affecting the high voltage regulation.

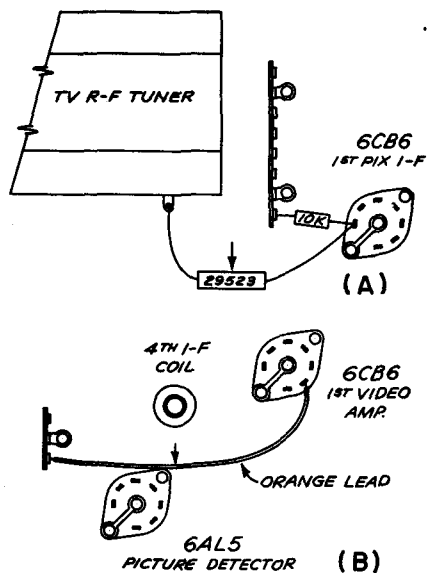
Fig. 29 — Packard-Bell

Unless the following precautions are taken in fringe areas, some re-

generation may occur which will contribute to noise in the picture.

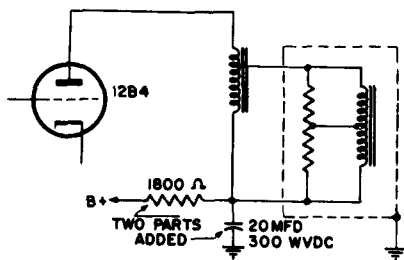
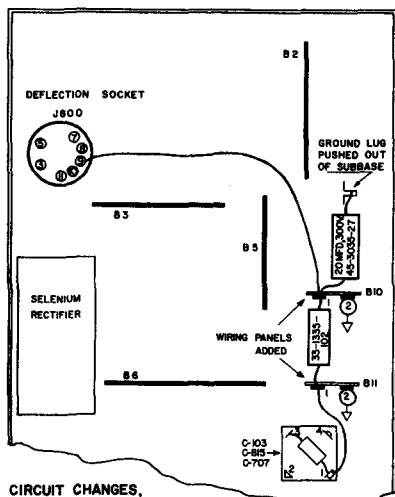
DIAGRAM OF 12B4 VERTICAL OUTPUT CIRCUIT SHOWING ADDED COMPONENTS

CIRCUIT CHANGES, D-201 CHASSIS, FOR INCREASED LIFE OF 12B4 TUBE

1. Mount two 2-lug wiring panels in the locations shown on the accompanying layout drawing. These panels will be referred to as *B10* and *B11*.

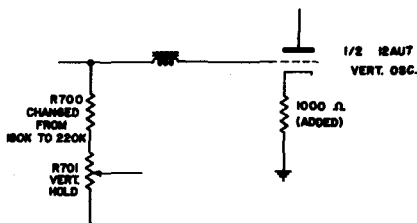
Fig. 35 — Philco

Note: These changes are already made in later production run 4 for

chassis J-2 and in later production run 3 for Chassis J-5.

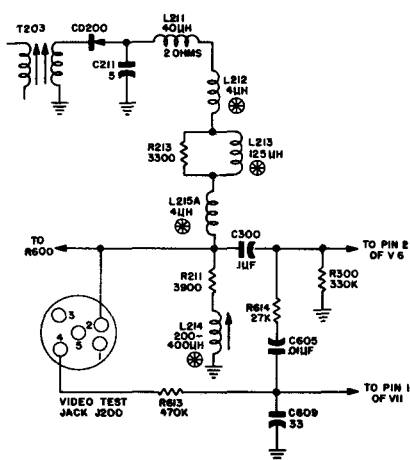
Fig. 37 — Philco

To reduce channel 5 picture beat, an additional 4- μ h series peak-

ing coil (*L215A*, part No. 324112-50) is added to the video detector load circuit. To install this coil, terminal board *B9* adjacent to the video test jack is changed from a 2-lug to a 3-lug type. The revised wiring of the video detector circuit, already done in later production run 18, is shown in the figure.

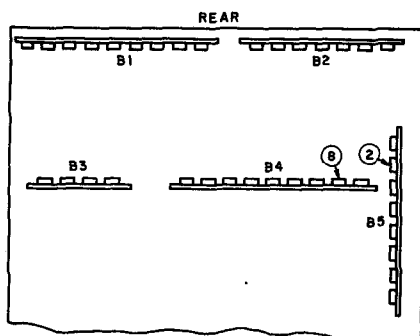
Fig. 38 — Philco

To improve video transient response, all wiring is interchanged between lug 8 of terminal board *B4* and lug 2 of terminal board *B5*. A bottom view of the chassis showing these

boards is shown in the figure. This change is already made in later production run 3.

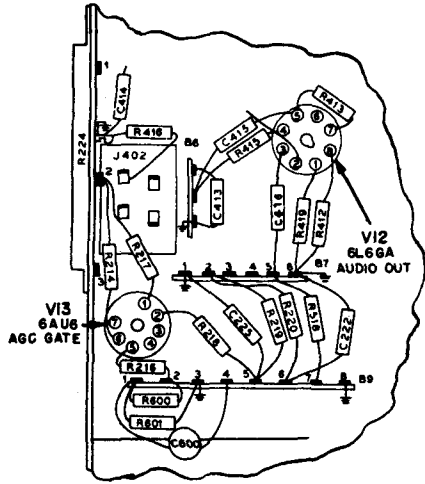
Fig. 41 — Philco

To permit use of the uhf tuner with the above chassis, the following changes, already included in later production are made:

1. Lead of resistor *R518*, 15k ohms, is moved from lug 5 to lug 4 of terminal board *B7*.

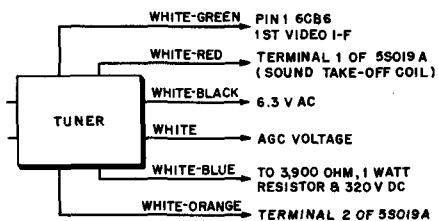
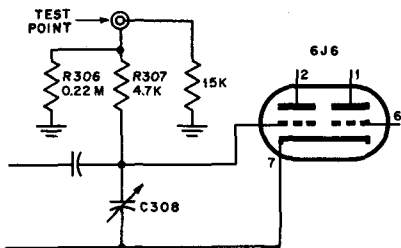
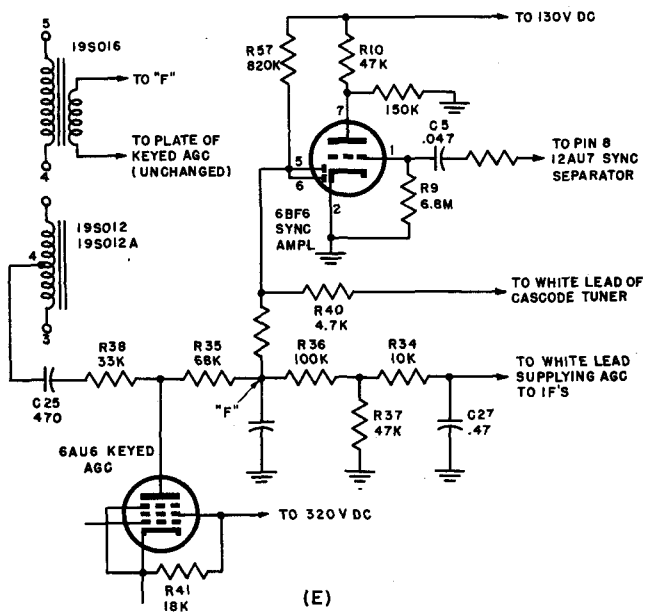
Fig. 42 — Radio Craftsmen

A delayed and graded automatic gain control must be added in order to obtain optimum performance. The new circuit correctly proportions the gains of the r-f and i-f amplifier stages for minimum snow in fringe areas and prevents overload effects in strong signal areas. The new cir-
