## Introduction

# TV

## MANUFACTURERS' RECEIVER TROUBLE CURES

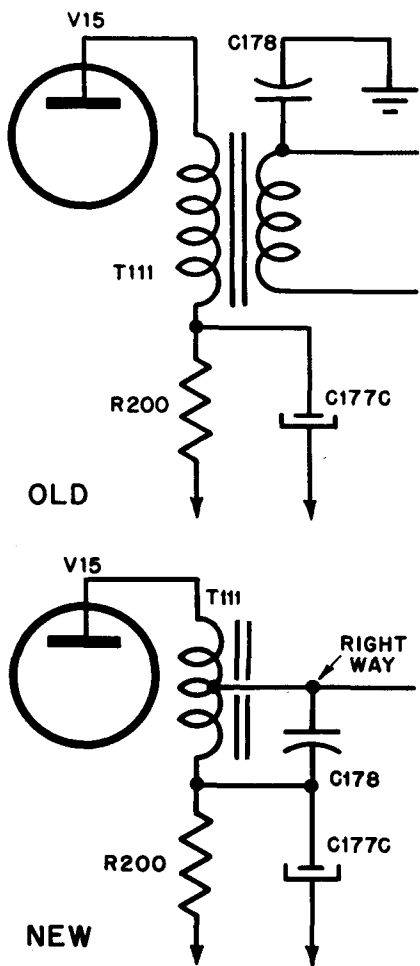
Fig. 9 — Arvin

### Audio buzz at minimum volume setting (see Fig. 9).

1. The white and orange lead from pin 8 of *V11B*, the video amplifier, being too loose and dressed close to the volume-control terminals. Redress this lead.

2. *C121C*, 80  $\mu$ f, having an undesirable power factor or being leaky. Replace such a capacitor.

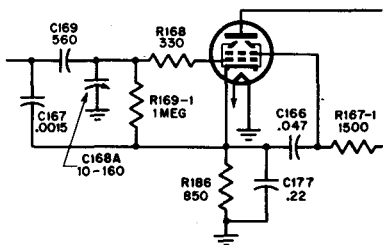
Fig. 11 — Arvin

**Increasing life of V12, 6AV5GT***(see Fig. 11).*

The life of V12 can be increased by making this change:

1. R186 850-ohm, 10-watt resistor added between cathode and ground of 6AV5GT tube.
2. Ground side of C166 capacitor rerouted to cathode of 6AV5GT.

3. *C177*, .22- $\mu$ f, 400-volt capacitor added to cathode circuit of 6AV5GT tube.

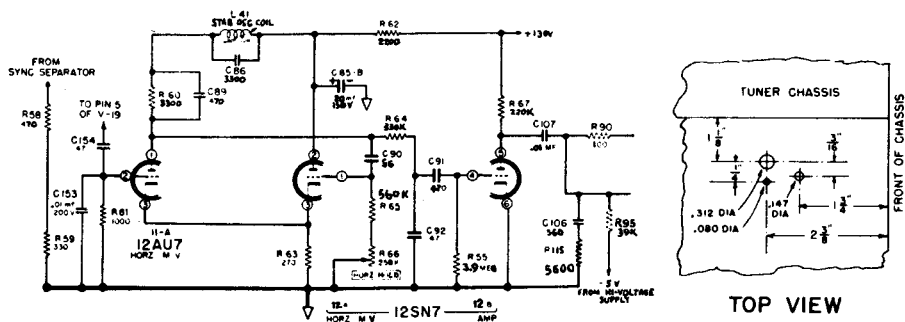
Fig. 13 — Belmont-Raytheon

#### **Stabilized horizontal multivibrator and reduction of picture shift (see Fig. 13).**

The manufacturer supplies modification kit EF to correct the above effects. Since many television broadcasting stations have the practice of locking their sync directly to the 60-cycle line, any phase shift in the transmitter power source may cause side-to-side picture drift. The changes incorporated in this modification reduce the tendency toward picture drift and improve the picture resolution in low-signal areas by providing a flywheel stabilization effect in the horizontal multivibrator.

The wiring changes are primarily located on the sockets of *V11* and *V12* and on the terminal board between the two sockets. They consist mainly of substituting one value of resistor or capacitor for another. For simplicity follow in sequence the wiring instructions below:

1. Change 1,800-ohm resistor on terminal board supplied with modification kit to 3,300 ohms.

2. Remove 470  $\mu\text{f}$  ( $C89$ ) (pin 2 of  $V11$ ) from chassis, and rewire across 3,300-ohm resistor on terminal board supplied with kit.
3. Remove 33,000-ohm resistor ( $R60$ ) connected from pin 1 of  $V11$  to pin 2 of  $V12$ .
4. Change  $R64$  (pin 1 of  $V11$ ) to 330,000 ohms.
5. Change  $C92$  (pin 6 of  $V12$ ) to 47  $\mu\text{f}$ .
6. Connect blue wire to pin 1 of  $V11$ .

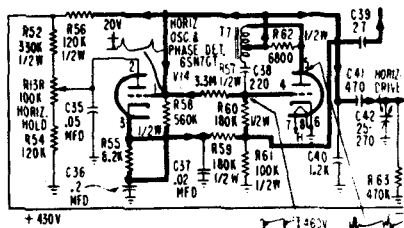
Fig. 14 — Bendix

### Improving centering (see Fig. 14).

In order to improve electrical centering of the raster and to facili-

tate easier mechanical adjustment of the focus coil, a revision of the horizontal oscillator and phase-detector circuit may be made as shown in the figure.

1. Remove lead of capacitor C39 from the junction of capacitors C40 and C41.

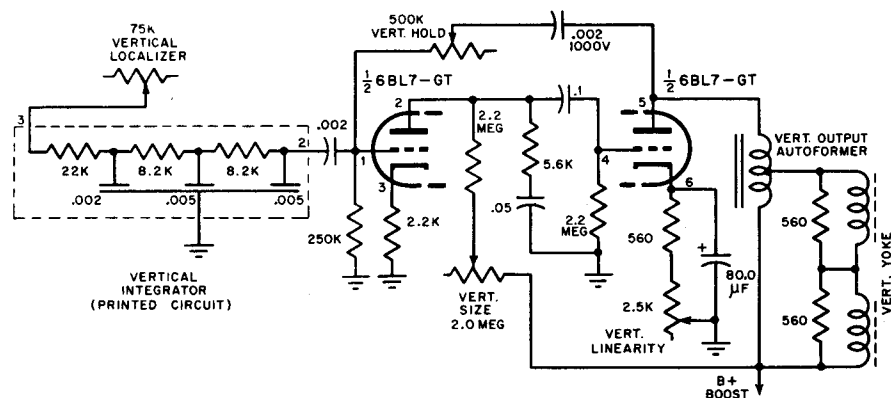
Fig. 15 — Calbest

### *Improved vertical circuit (see Fig. 15).*

In the event foldover at the top of the picture is experienced with the 6BL7-GT, add a resistor whose value is from 22,000 to 47,000 ohms to the 250,000 resistor in the grid circuit.

When making these changes, remove the black heater lead of the picture-tube socket from pin 3 of the 6SN7-GT tube socket, and ground to chassis directly.

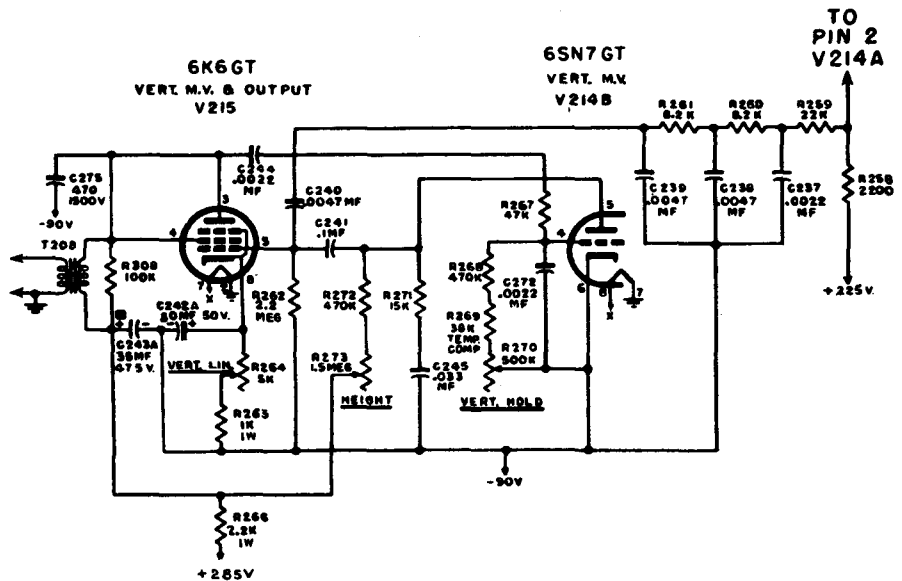
Fig. 18 — Capehart-Farnsworth

#### Improved interlace (see Fig. 18).

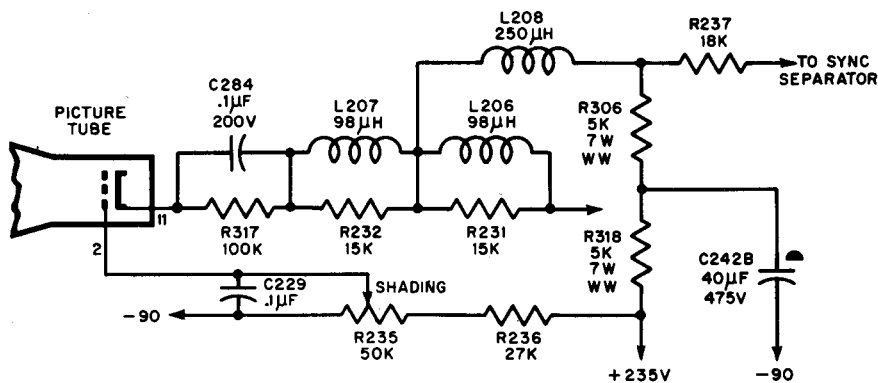
Fig. 22 — Capehart-Farnsworth

#### Preventing blocking on strong signals (see Fig. 22).

#### Reducing picture blooming.

Connect in series with the lead to pin 11 (cathode) of the picture tube a parallel combination of a 100,000-ohm resistor and a .1- $\mu$ f 200-volt capacitor. Care should be taken that undue stray capacitance is not introduced between the cathode lead of the picture tube and ground. This change is also shown in the diagram for the previous cure.

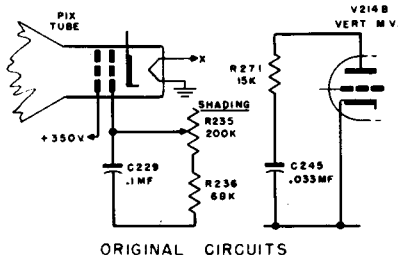
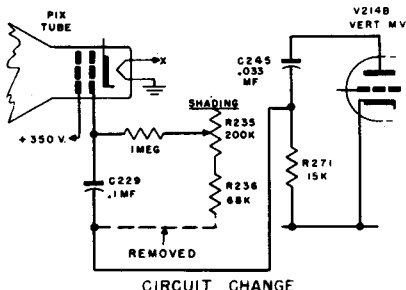
Fig. 25 — Capehart-Farnsworth

### Blanking of vertical-retrace lines (see Fig. 25).

This change will blank out the vertical-retrace lines which may be objectionable. The following changes may be made as shown in the diagrams.

The original circuit has *R271* connected above the capacitor *C245*, and the shading circuit shown with a 200,000-ohm potentiometer, *R235* and *R236* as a 68,000-ohm resistor.

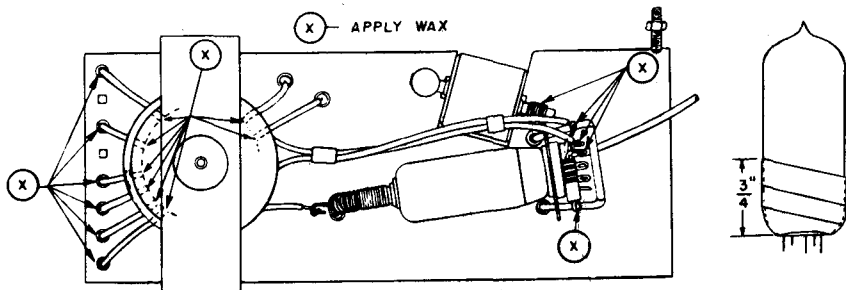
Fig. 33 — Crosley

**Preventing corona and arcing on high-voltage assembly (see Fig. 33).**

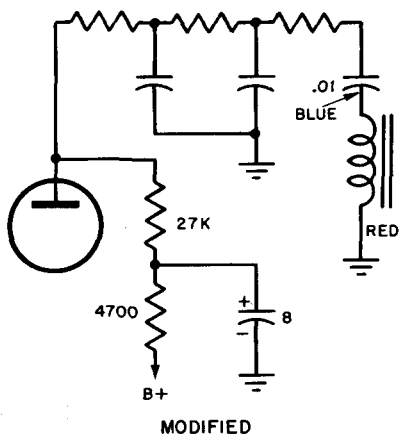
Fig. 36 — DuMont

(see Fig. 36).

6. To the open end of the 27,000-ohm resistor, connect a 4,700-ohm, 1-watt carbon resistor and the positive terminal of an 8- $\mu\text{f}$ , 450v electrolytic capacitor.

7. Ground the negative terminal of the 8- $\mu\text{f}$  capacitor to the chassis.

8. Connect the open end of the 4,700-ohm resistor to the point from which the blue transformer lead was removed in step 1 (above).

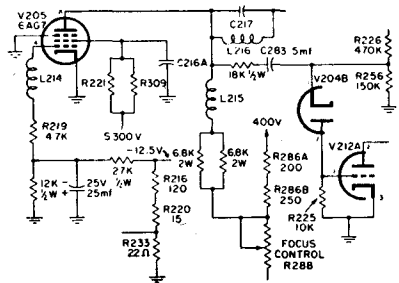
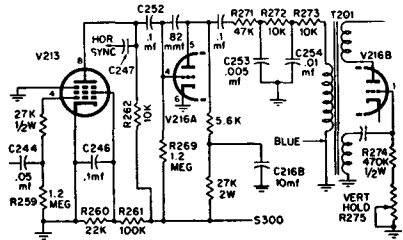
Fig. 37 — DuMont

### Sync noise immunity (see Fig. 37).

8. Remove capacitor *C282*, connected from pin 7 of *V204B* to ground. Remove capacitor *C219*, located between pin 7 of *V204B* and pin 1 of *V212A*, and replace with a short lead, using the pin 7 lug to which *C219* was connected.

9. Remove resistor *R224*, located between pin 1 of *V212A* and ground.

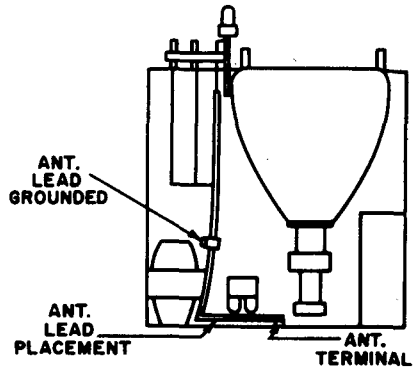
Fig. 38 — DuMont

**Channel 7 beat elimination**  
(see Fig. 38).

Separate from the complaints of channel 5 regeneration and all-channel regeneration, complaints of a beat on channel 7 have been received. This

beat does not exhibit itself in the form of diagonal black lines. Instead, the indications consist of black streaks running horizontally through the picture when the set is tuned "on the nose" to channel 7. This condition is caused by the eighth harmonic (175.2 mc) of the sound i.f. (21.9 mc) beating with the video carrier of channel 7 (175.25 mc).

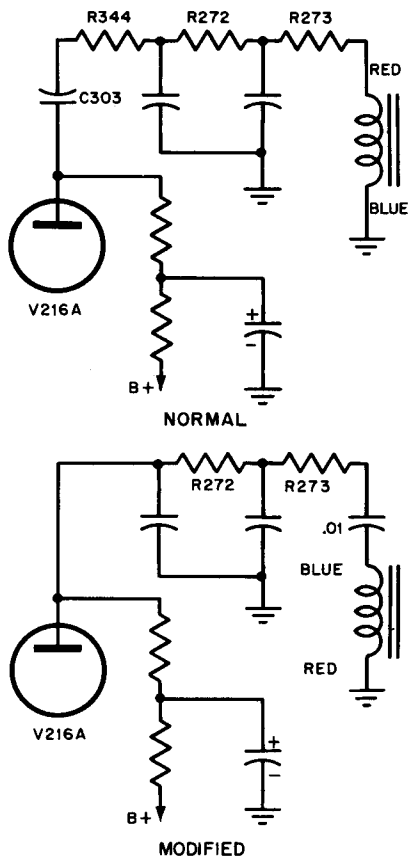
Fig. 39 — DuMont

**Elimination of vertical jitter**  
(see Fig. 39).

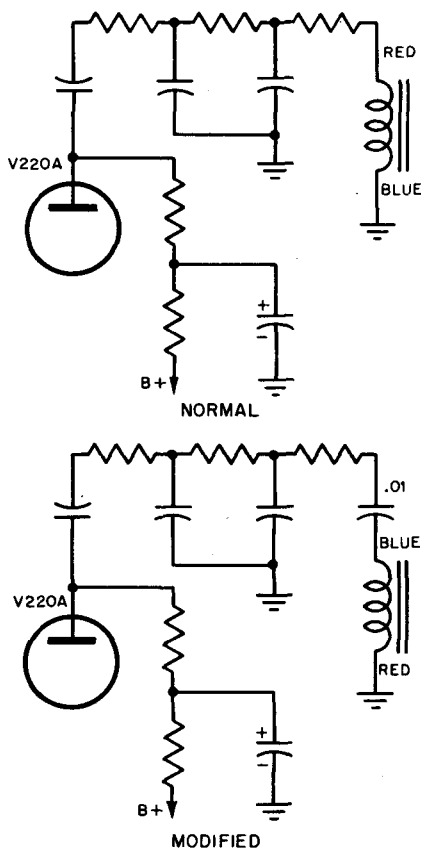
Fig. 42 — DuMont

**Elimination of vertical jitter**  
(see Fig. 42).
