MANUFACTURERS' RECEIVER TROUBLE CURES

VOLUME 2

Copyright 1953 by

JOHN F. RIDER PUBLISHER, INC.

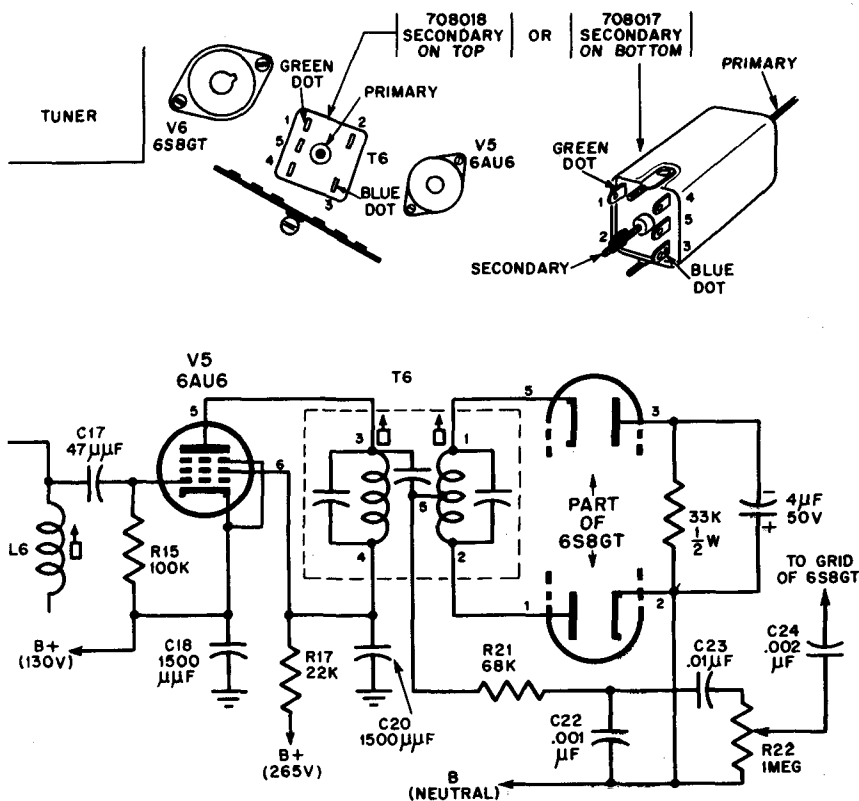
Fig. 2 — Emerson

EMERSON Chassis 120123-B **Intercarrier buzz (see Fig. 2).**

1. *C-21* (110 μmf) connected between pin 5 and pin 2 of *V-6* (6S8).

2. Two 100-k (*R-19*, *R-20*) resistors from lug 5 of discriminator transformer (*T-6*).

3. *R-16*, *C-19* (8,200 ohms and 1,500 μmf) from pin 6 of *V-5* (6AU6).

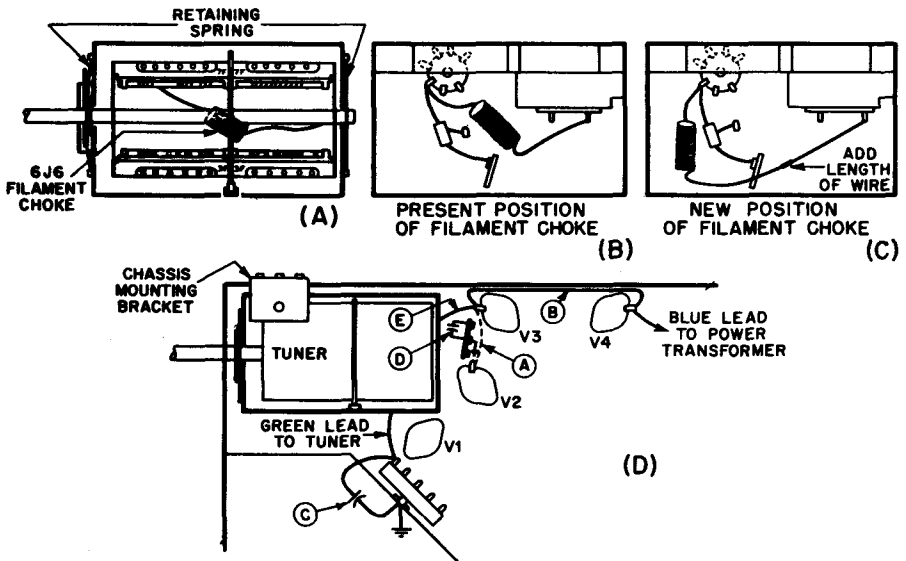
Fig. 3 — Emerson

Reducing effects of Barkhausen oscillation (see Fig. 3).

In certain areas, due to various local conditions, it might be difficult and time consuming to eliminate this interference by normal means; such as adjusting horizontal-drive capacitor or changing 6BG6. In these cases the following simple procedure used in conjunction with the above steps will eliminate or reduce this interference to a negligible amount.

Break the cement which glues the 6J6 filament choke to the underside of the tuner chassis (see part (A) of figure) and dress away from chassis (towards turret). This can be accomplished by removing both sets of coils for channels 4, 5, 6, 11, 12, and 13, and then gently prying the choke loose with a screwdriver. Be careful not to damage or change the shape of the coil.

If the above procedure does not reduce the Barkhausen interference to a negligible amount, then the following more complete procedure will eliminate this condition.

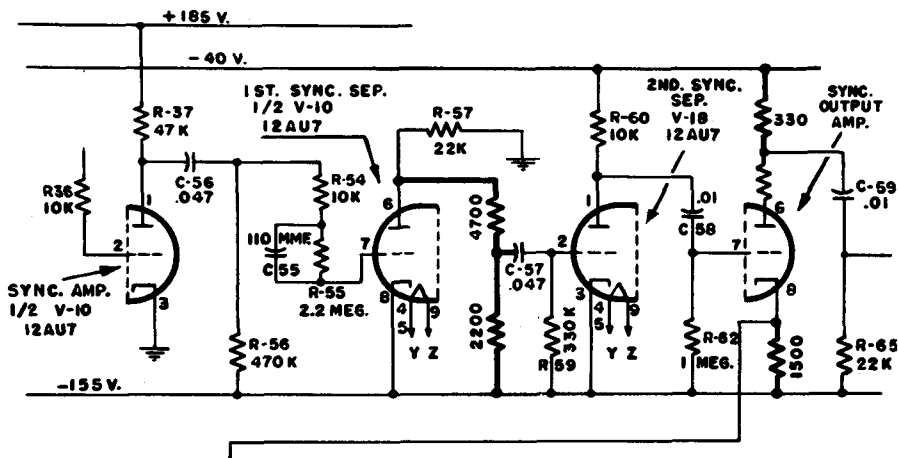
Fig. 4 — Emerson

Improving sync stability in fringe areas (see Fig. 4).

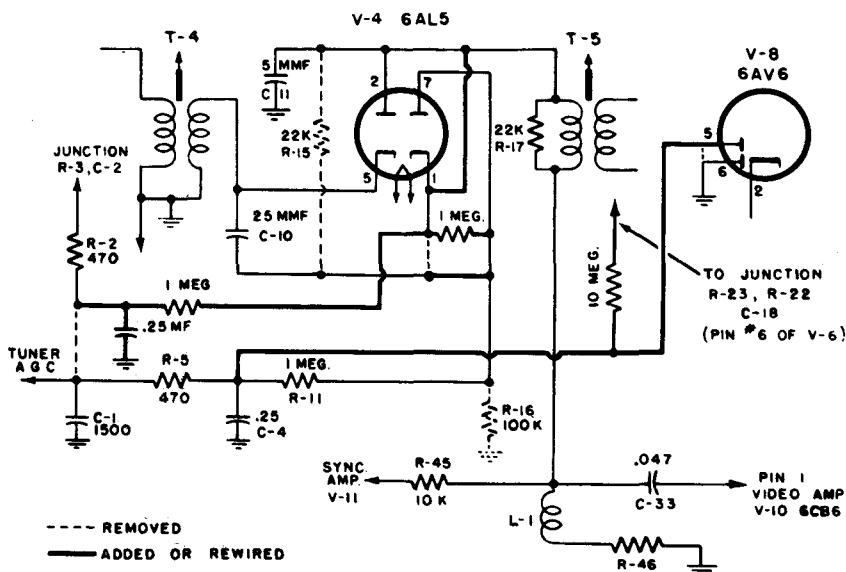
Fig. 10 — Emerson

Modified agc for fringe-area operation (see Fig. 10).

The following changes may be made to improve performance, especially in fringe areas, by modifying the agc system to give a tuner delay. This modification will provide an increase in sensitivity.

1. Remove *R-15* (22k, $1/2$ watt) from pins 1 and 2 of *V-4* (6AL5), replacing it with a jumper wire.
2. Remove *R-16*, 100 k, which is connected from pin 7 of *V-4* to chassis.
3. Remove pigtail of *R-2* (470 ohms) resistor from lug on terminal board and reconnect to empty lug on same terminal strip. This resistor is in the grid circuit of *V-1*.
4. Add a white jumper wire from new position of *R-2* to the empty lug

on the terminal board near sound-output transformer.

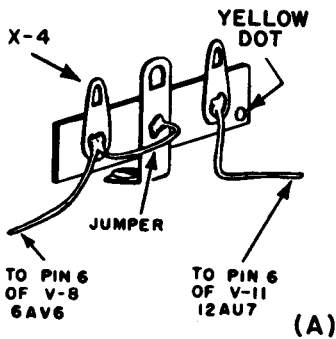
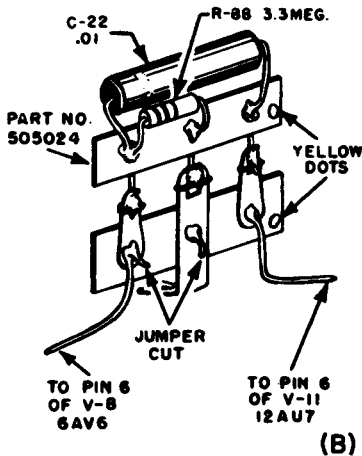
Fig. 12 — Emerson

EMERSON Chassis 120153-B
Preventing jitter in fringe areas
(see Fig. 12).

In fringe areas where there is a great deal of electrical impulse noise, such as ignition, neon signs, electric motors, etc., the picture might tend to jitter or continuously fall out of sync. To reduce this condition to a minimum this chassis has been incorporated with provisions for connect-

ing a "Fringe Compensator," which effectively limits the amplitude of the noise pulses into the sync separator (*V-12A*, 12AU7) to that of the sync pulses, thus minimizing the effects. This fringe compensator should be connected to the set only when it is obvious that it will be beneficial in a certain locality; it should not be installed in strong-signal areas as vertical jitter or audio buzz may result.

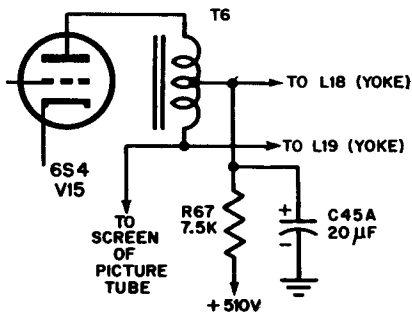
Fig. 15 — Fada

Removing retrace line (see Fig. 15).

To eliminate retrace lines the following circuit changes are necessary:

1. Disconnect screen (pin 10) of picture tube from junction of C-57 and C-58, and reconnect to junction of

L-19 of the yoke and the B+ terminal of *T-6*.

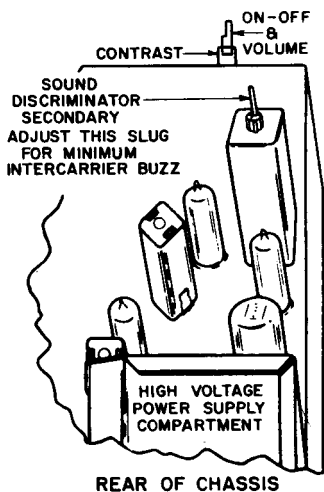
Fig. 17 — Firestone

FIRESTONE Models 13-G-44
through -48, 13-G-51, -52
Reduction of intercarrier buzz
(see Fig. 17).

Slight dynamic unbalance of the discriminator secondary can emphasize intercarrier buzz due to incomplete amplitude modulation rejection. Therefore it is vitally important to obtain an accurate setting of the discriminator secondary slug under actual reception conditions.

Connect an antenna to the receiver to obtain program reception

from a local station. If intercarrier buzz is prominent, a slight readjustment of the discriminator secondary slug should be made to obtain the dip point for the buzzing sound. Note that program sound will be clear and free from distortion at this point. Buzz should now be at an acceptable minimum if station transmission is not at fault.

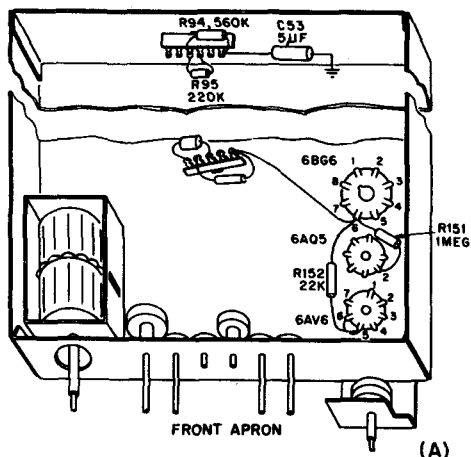
Fig. 18 - Gamble-Skogmo (Coronado)

GAMBLE-SKOGMO (Coronado)Models 05TV2-43-9010B,
15TV2-43-9012A, -9013A**Improving sensitivity in fringe areas (see Fig. 18).**

To improve the signal-to-noise ratio in fringe areas on the models listed above, the changes in the agc circuit shown in the partial schematics are suggested. Part numbers and descriptions of the parts to be removed and added are listed.

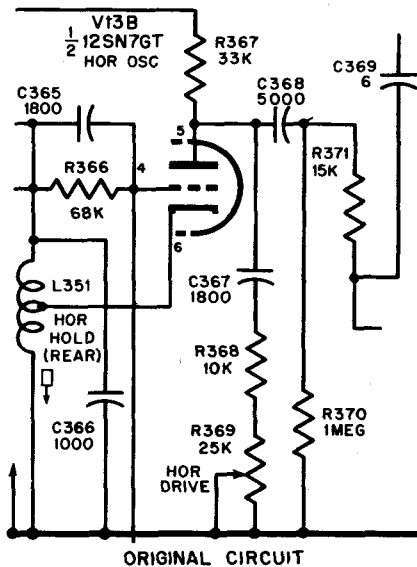
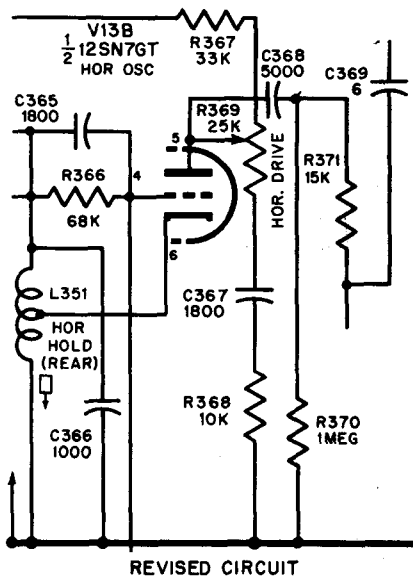
Fig. 23 - General Electric

Drive-control setting affects horizontal pull-in sensitivity (see Fig. 23).

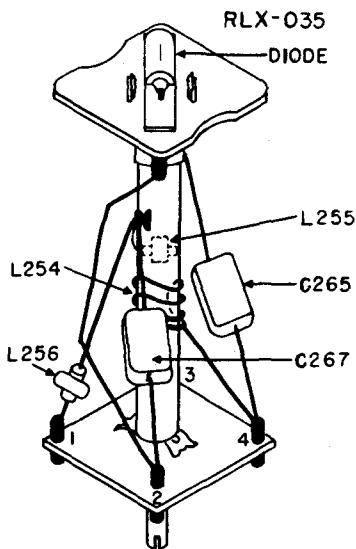
Fig. 28 - General Electric

Replacement of video-detector crystal (see Fig. 28).

To facilitate replacement of the video-detector crystal diode, an improved design of the video-detector assembly (RLX-035, marked with a red dot on top of the assembly) is used to provide top mounting of the diode. It is merely necessary to slip off the cover of the assembly to expose the diode.

In some assemblies a special high efficiency diode is used, marked with a red dot. To maintain the same Q of the circuit and to obtain proper i-f bandwidth a resistor of 12,000

ohms in connected across the diode. In replacing this diode with normal stock do not use this resistor. In case of doubt check for proper bandwidth.

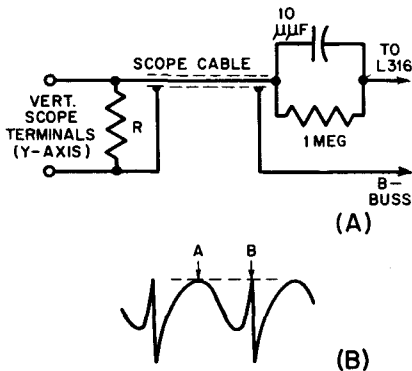
Fig. 29 — General Electric

Horizontal-sync stabilization

On the above production receivers, a tuned circuit is added to the horizontal blocking oscillator circuit to stabilize the sync. The method des-

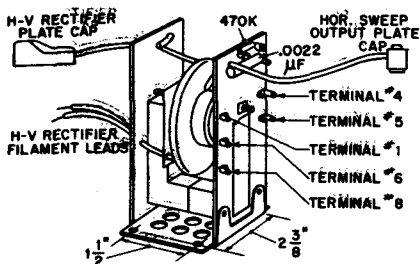
Fig. 30 — General Electric

Improved horizontal-output transformer (see Fig. 30).

A new ceramic-core sweep transformer, stock No. RTO-071, is recommended as a substitute for the original molded horizontal-sweep out-

put transformers for these models. It has several electrical design improvements over the originally specified transformer, among them are higher efficiency and better high-voltage insulation.

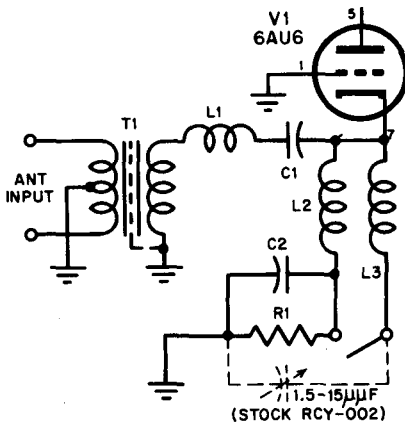
Fig. 31 — General Electric

High-channel interference (see Fig. 31).

The channel selector switch *S-1* is open on low-channel reception connecting the added trimmer in series with *L-3*. This makes a series-resonant circuit of these components which when properly adjusted will effectively reduce the subject interference. On high-channel reception, the trimmer is switched in parallel with *C-2* (1,500 μmf), making the trap circuit inoperative so that it has no effect on the normal high-channel operation.

With the receiver tuned to the low channel and the interfering high channel station operating, two minimum points of interference will be observed when turning the trimmer from the maximum capacitance position. The first minimum indicates that the trap is tuned to attenuate the high-channel fundamental and the second minimum indicates tuning to the second harmonic of the local oscillator. The best point of adjustment for the least interference is the second minimum point or when the trap is tuned to the second harmonic of the local oscillator. Note: The first minimum gives an attenuation of 45 db, while the second minimum gives approximately 83 db attenuation, making it very important to tune for the minimum interference at the lowest capacitance setting of the trimmer.

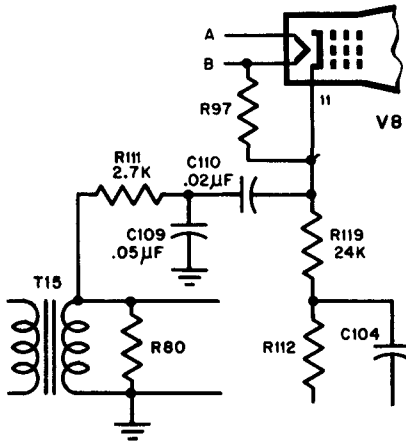
Fig. 33 — General Electric

Removal of vertical-retrace lines (see Fig. 33).

The circuit shown in the figure has been added in late production to remove the vertical-retrace lines which appear when the contrast control is used at a low setting or the brightness control is used at a high

setting. Models not modified may be wired in accordance with the schematic shown with the addition of the following parts: *C-109* (UCC-635) is a .05- μ f, 600-volt capacitor, *C-110* (UCC-631) is a .02- μ f, 600-volt capacitor, *R-118* (URD-059) is a 2,700-ohm, $\frac{1}{2}$ -watt resistor, and *R-119* (URD-1082) is a 24,000-ohm, $\frac{1}{2}$ -watt resistor.

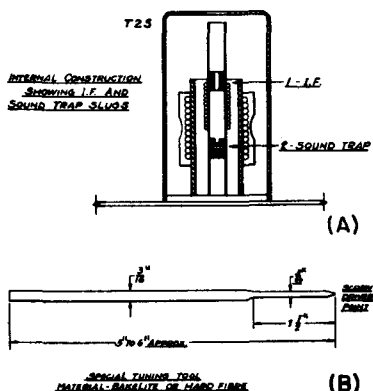
Fig. 34 — Hoffman

Sound bars and/or 4.5-mc beats in the picture (see Fig. 34).

Sound bars appear as alternate light and dark horizontal bars across

the picture which move or vary in synchronization with the received sound. A 4.5-mc beat note appears as a vertical rain-like effect comparable to water running down a window pane. Both phenomena are caused by misalignment of one or more of the absorption wave traps (*T-1*, *T-2*, *T-25*, *T-103*, or *T-105*) in the video i-f circuit. Sound bars indicate the presence of audio frequencies in the video voltage at the picture-tube grid, while the 4.5-mc beat effect in the picture is due to the appearance of a heterodyne signal caused by mixing video i-f carrier and sound i-f carrier. Note: *T-1*, *T-2*, and *T-25* are absorption traps for the sound i-f frequency, while *T-103* and *T-105* affect both the sound i-f interference and the 4.5-mc beat.

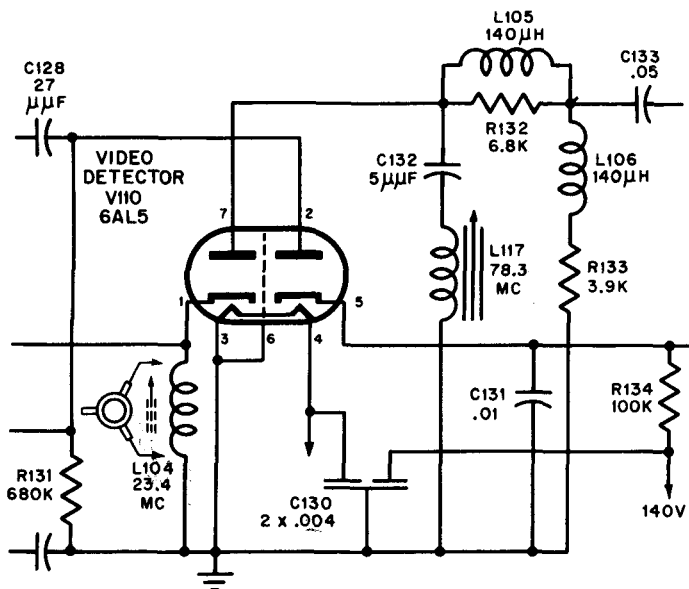
Fig. 35 — Hoffman

Tunable herringbone interference on channel 5 (see Fig. 35).

This internally generated interference appears as a fine herringbone pattern in horizontal bands across the picture. The pattern is tunable with the fine-tuning control. As the fine tuning is varied, the size of the herringbone changes, as well as the number of bands across the picture. The interference is caused by a beat note between the 3rd harmonic of

the picture i-f frequency (26.1 mc) and the channel-5 video-carrier frequency (77.25 mc). When the fine tuning is adjusted for best sound and picture, the interference appears as a herringbone pattern. It is possible to adjust the fine tuning towards a zero beat between the two signals at which time the pattern degenerates to a series of black and white bands across the picture, giving a venetian blind effect.

This i-f 3rd harmonic is present in the picture 2nd detector and video-amplifier stages. It is coupled back to the input and to the antenna lead-in, mixing with the incoming signals. This condition becomes more apparent in weak signal areas where the amplitude of the 3rd harmonic approaches the amplitude of the desired signal. In strong-signal areas, the channel-5 carrier tends to override the interfering harmonic and very little picture disturbance is produced.

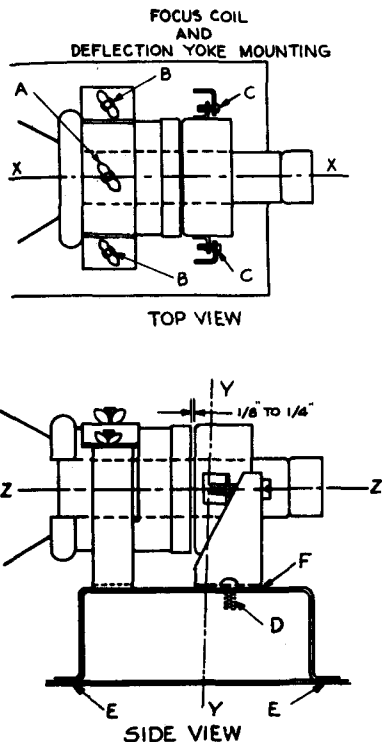
Fig. 36 — Hoffman

**Removing neck shadows (see
Fig. 36).**

A number of remedies are suggested for neck shadows. Any one, or combination of several, may be necessary to clear up the trouble. The primary objective of the remedies is to make certain that the tube is mounted with the neck horizontal, as

compared with the chassis, and exactly centered in the deflection and focus coils. With 15- or 16-inch tubes mounted separately from the chassis, it is generally advantageous and faster to remove the mounting board and tube from the cabinet.

Check the tube mounting. It is imperative that the tube neck axis Z-Z, shown in the side view, be level and concentric with the centers of the deflection and focus coils. The front portion (face) of the tube may be raised by shimming with rubber pads under the front rim where the tube is held in place by the vinyl-resin

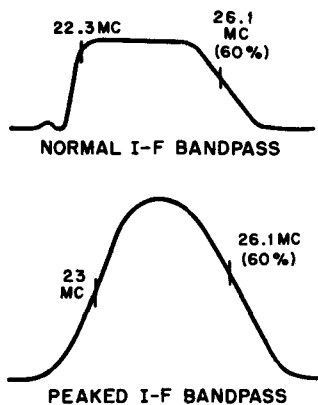
Fig. 39 — Hoffman

HOFFMANChassis 140,
142, 143, 146, 147**Video i-f peaking for fringe-area reception (see Fig. 39).**

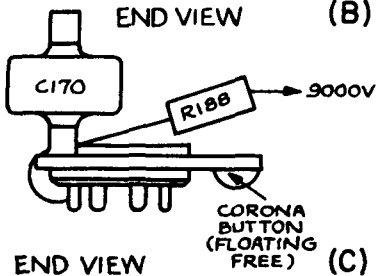
Fig. 40 — Hoffman

Arcing at h-v rectifier socket (see Fig. 40).

1. Remove the 1-meg resistor, *R-188*, (see part (B) of figure) from pin 2 of 1B3GT socket and corona ring.

2. Solder on end of the resistor to the solder lug at the base of the h-v capacitor C-170 (see part (C) of figure).

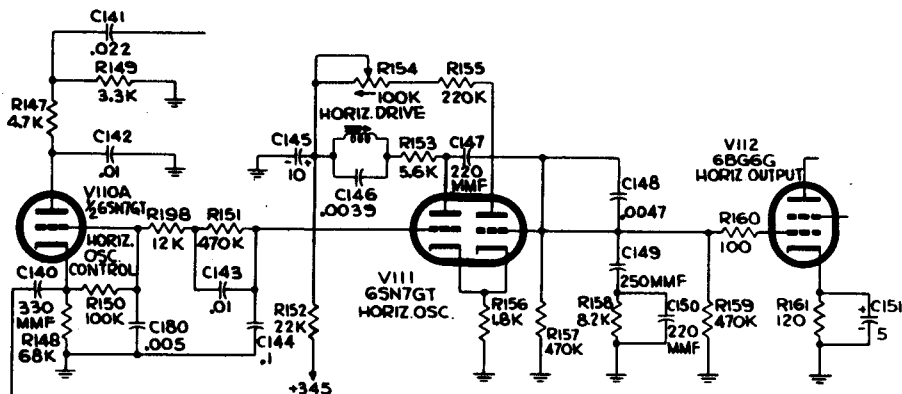
Fig. 47 — Hoffman

Curvature in vertical lines (see Fig. 47).

Curvature in vertical lines in the top portion of the picture is commonly called "hook." This curvature is particularly apparent on a test pattern, or a picture with distinct vertical lines, such as the sides of a door or folds in drapery. The curvature is normally in the form of a bow or a bend to the right in top portion of the picture.

The hook can be materially decreased by addition of a 12k-ohm, 20%, 1/2-watt, composition resistor (*R-198*) and a .005- μf ceramic capacitor (*C-180*) in the grid circuit of the horizontal oscillator control tube, *V-110A*. Refer to the schematic diagram shown here for location of these components. A further change which will improve the hook is the change of *C-142* from a .0047- μf to a .01- μf , 400-v paper type capacitor. However, this change reduces the horizontal sync hold-in range, and it is imperative that *C-146* and *C-149* be changed

to zero temperature coefficient types as described under "Horizontal drift" for chassis 159 and 160 if the change of *C-142* is made.

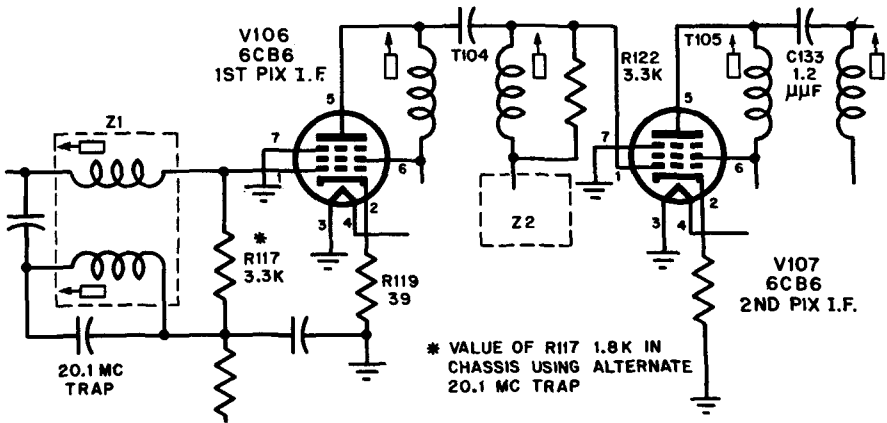
Fig. 52 — Hoffman

Improved video i-f bandpass characteristic (see Fig. 52).

These changes have been made on all sets produced after serial No. G067626.

Note: R-117 should be reduced to 1.8 k in those chassis which employ the alternate adjacent channel sound trap. This alternate trap may be easily identified by ceramic trimmer capacitor mounted on the lip of the i-f subchassis near the 1st video i-f stage.

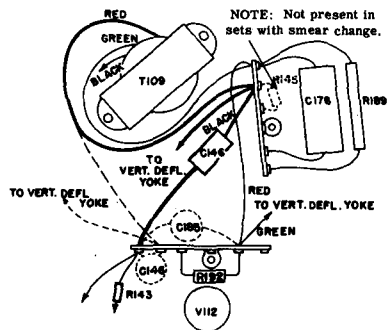
Fig. 53 — Hoffman

HOFFMAN Chassis 170 through 176
Dark shading at top of picture (see Fig. 53).

smear" for chassis 170, 171, 173, 175), remove C-185 and reduce the resistance value of R-143 to 100k ohms. Change C-146 to a higher voltage rating (.0047 μf at 1,000 volts) and rewire as indicated in figure. Dotted lines indicate wiring and components before this change was made. Heavy black lines indicate wiring and components changed.

For sets not containing the smear change, move C-146 leads to other

side of *R-145*, eliminating *R-145* from the circuit. Also, reduce resistance value of *R-143* to 100k ohms.

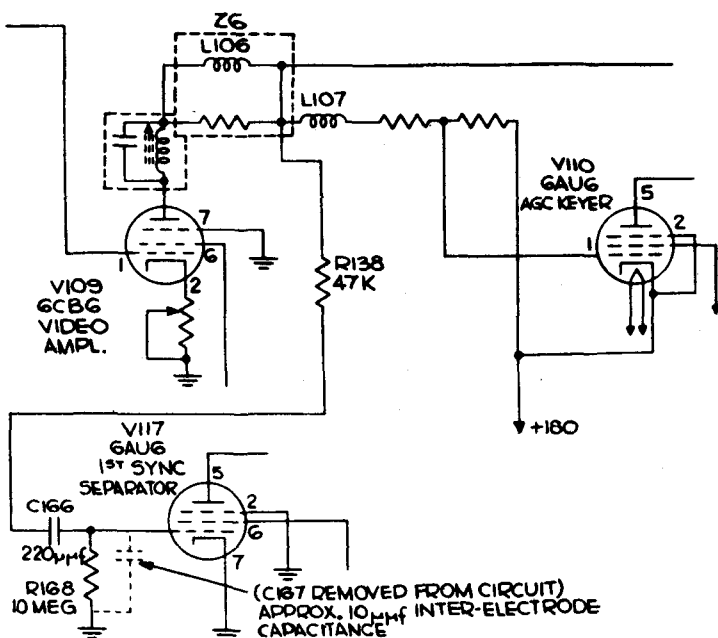
Fig. 54 — Hoffman

Improved picture definition (see Fig. 54).

1. Remove *R-139* (47,000-ohm resistor connected to the grid of the agc keyer tube) and replace it with a short piece of hook-up wire. It is suggested that the leads of *R-139* be kept as long as possible during its removal so that it may be used to replace *R-138*.

2. Remove *R-138* (10,000-ohm resistor between the video amplifier and the sync separator) and connect a 47-k resistor between the junction of *L-106*, *L-107* (plate circuit of video amplifier) and the tie lug

previously used for connecting *R-138* to *C-166*.

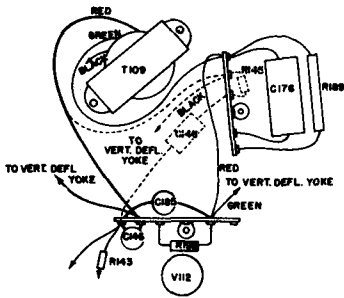
Fig. 55 — Hoffman

Reduction of picture smear (see Fig. 55).

A change concerning the retrace line elimination circuit is made in order to reduce picture smear present when the picture tube draws grid current. A study of the schematic diagram will reveal that retrace-line elimination circuit can act as a grid-leak biasing circuit for the picture-tube grid. When the grid draws grid current, as it will when the cathode is driven by relatively high negative peaks (high contrast levels), a nega-

tive bias is produced which tends to bring the picture grid to its cut-off potential. This negative bias remains on the grid until it has had time to leak off via the RC path of the circuits involved. By reducing the RC time constant of the effective grid leak, the grid is not held near cut-off for so long a time, relatively speaking, and the faster recovery makes it possible for the grid to better follow the transmitted video information.

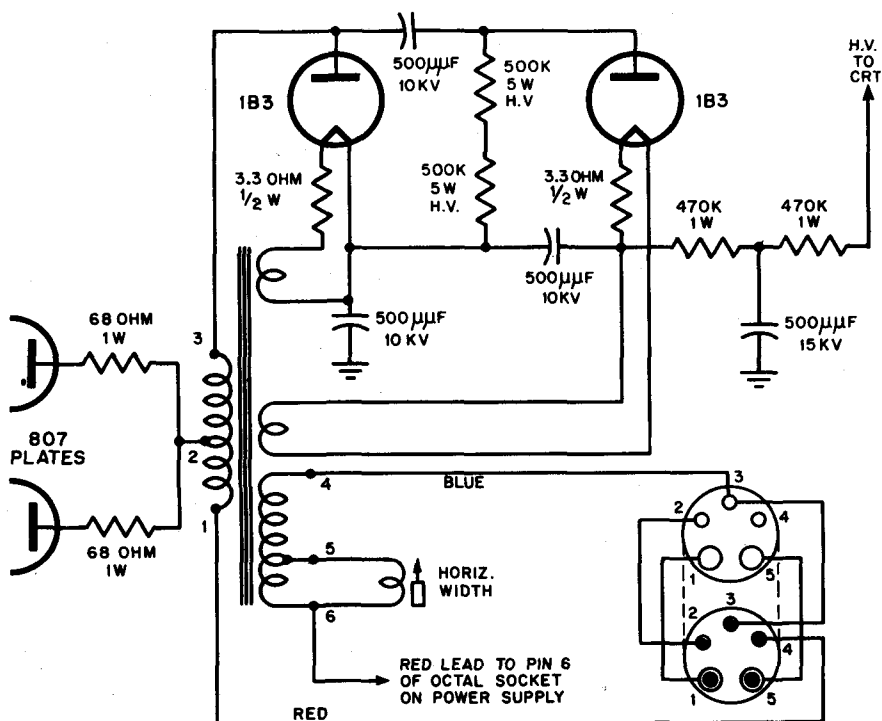
Fig. 60 — Industrial

INDUSTRIAL Chassis IT-1R
Replacement of high-voltage transformer (see Fig. 60).

Due to recurrent failures and breakdown in the 60-cycle high-voltage supply used in the IT-1R (with the 20B-27 h-v transformer), a means has been devised to change over to a fly-back doubler-type supply, such as is used in the IT-3R, 11R, and 13R. This type has proven to be much more dependable, and will greatly reduce, if not eliminate, high-voltage supply failures.

An adapter plate, supporting the necessary components, is supplied. The installation instructions follow:

1. Disconnect all leads from *T-102* (black horizontal-output transformer).

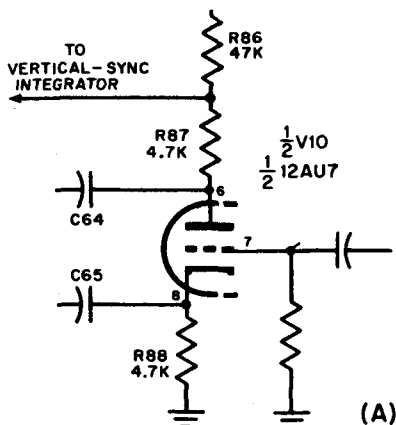
Fig. 62 — Industrial

INDUSTRIAL Chassis IT-21R
Improving sync stability (see Fig. 62).

Alter vertical sync integrator circuit as shown in part (B) of figure.

1. *R-85* is omitted.
2. *C-114*, .01-μf, 300-v mica capacitor is added in parallel with *C-67*.

4. *C-61* is changed to $.01\text{-}\mu\text{f}$, 600-v tubular.

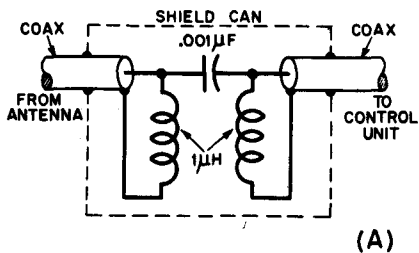
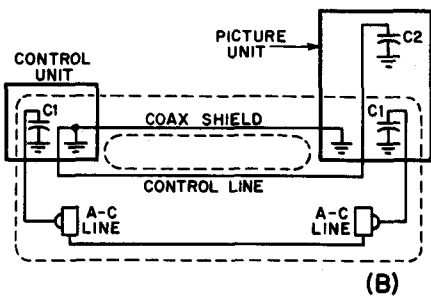
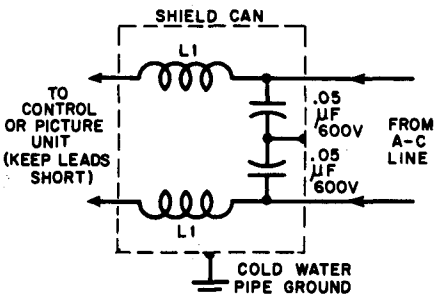
cables, the cure may be more involved and difficult. The cause of this interference may be from direct pick-up of the interfering a-m signal by the shield of the coax cable, or it may be introduced by a pick-up loop type of circuit, as shown in part (B). In the figure, *C-1* is the primary-to-ground capacitance of the power transformer, and *C-2* is the coil-to-ground capacitance of control relay. Loops are indicated by dotted lines. The alleviation of the interference may require trying several different techniques. Here are a few which should be tried:

1. If the installation is close to an a-m station, keep the control and picture units as close together as possible and the interconnecting cables as short as possible.
2. The simplest method, which can only be used where a relatively strong

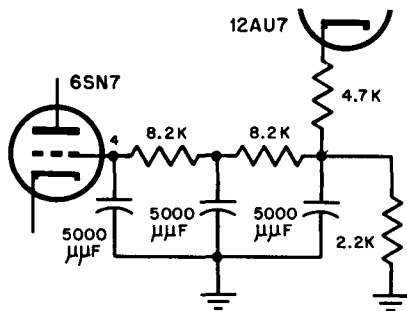
Fig. 65 — Jackson

JACKSON Chassis 114G, 116G, 117G, 120G
Improving vertical sync stability in fringe areas (see Fig. 65).

To improve the vertical-sync stability in weak-signal areas, proceed as follows:

1. Remove vertical-integrator plate.
2. Make up vertical integrating circuit as shown in the the figure.
