TV

MANUFACTURERS' RECEIVER TROUBLE CURES

VOLUME 3

A RIDER Publication

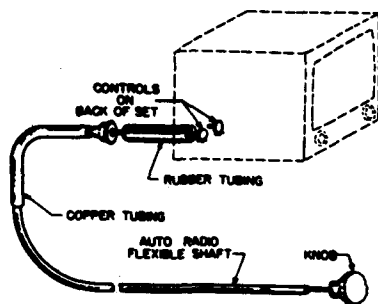
Fig. 23 — Motorola

MOTOROLA All chassis
Extension for rear-panel controls (see Fig. 23).

If your arms are not long enough to reach around a 20-inch tv set to adjust the rear controls while watching the picture from the front, you might like to make a gadget resembling the enclosed sketch.

The copper tubing is helpful in controlling the degree of bend to

prevent binding. The short length of rubber tubing is cut from windshield-wiper hose.

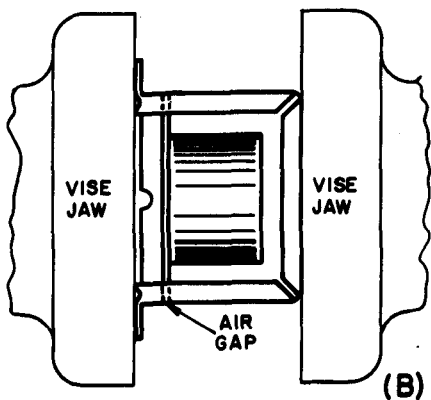
Fig. 25 — Muntz

Pear-shaped picture
(see Fig. 25).

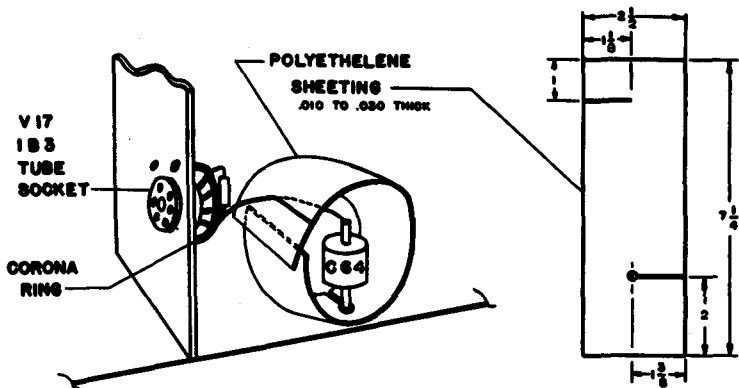
Fig. 33—Pacific Mercury

Models 150-series Arcing around h-v filter capacitor (see Fig. 33).

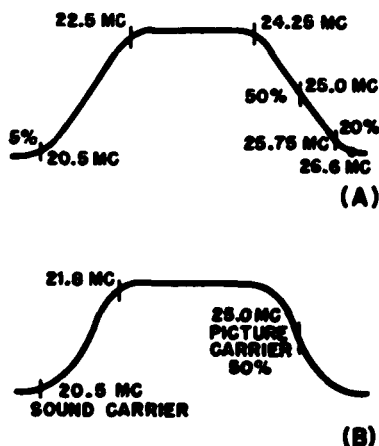
Fig. 35 — Packard Bell

Alignment in fringe areas
 (see Fig. 35).

In order to gain the added sensitivity necessary in some fringe areas, it is recommended that the picture i.f. be aligned as shown in part (A) of the figure. Normal response is shown in part (B).

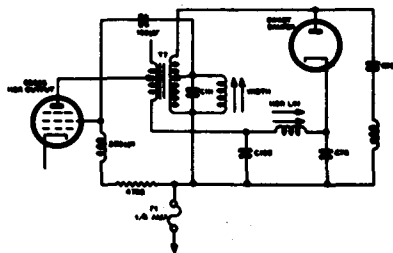
Fig. 47 — Philco

Reducing a-c current through fuse (see Fig. 47).

To reduce the a-c current through the h-v fuse, this fuse (*F1*) is rewired as shown in the figure. In addition, the value is changed from $\frac{3}{8}$ ampere to $\frac{1}{4}$ ampere (part No. 45-2656-8). Increased production is also afforded by this change, already made in production run 4.

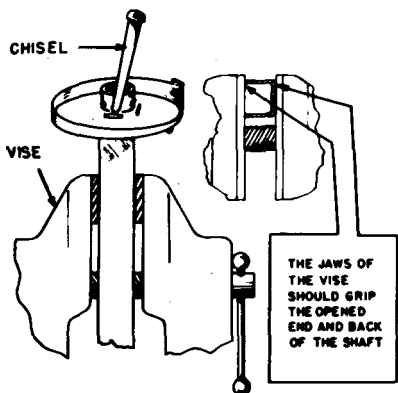
Fig. 48 — Philco

PHILCO Model 51-PT1200
Replacement of fine-tuning cam (see Fig. 48).

The tuner shaft arrangement in the above model is different in that the channel selector knob is secured to the channel-selector shaft by means of an Allen screw. Often a serviceman may inadvertently pull on the knob without removing the set screw. This will sometimes result in a cracked bakelite fine-tuning cam. The shaft and bakelite cam assembly, part No. 76-5846, is no longer available as a replacement item.

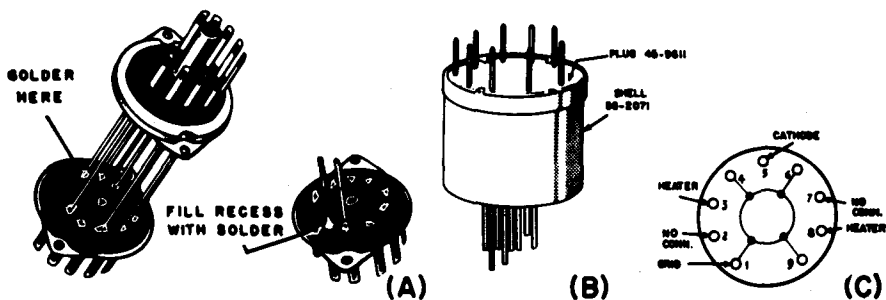
Fig. 49 — Philco

PHILCO Model 51-PT1207 series
Picture tube cable adaptor (see Fig. 49).

The procedure for making up this adaptor is given below. See part (A) of the figure.

1. Strip the No. 18 wire of all insulation and cut nine lengths of this wire to approximately $1\frac{1}{4}$ inch.
2. Insert the nine lengths of cut wire into the holes of both sockets. This is done to hold the nine wires in the proper position for soldering.
3. Solder the nine lengths to the bottom socket with non-corrode solder. Make sure the solder runs down the pins and makes good electrical bond with the socket pins and also fills the recesses of the socket so that the pins are rigid.
4. When all nine pins have been soldered to the bottom socket, remove the top socket and trim the nine pins to approximately $\frac{1}{4}$ inch above the face of the socket.

5. Slip the plug and socket shields over the cable and solder the cable wires to pins 5, 1, 3, and 8 of the plug and socket.

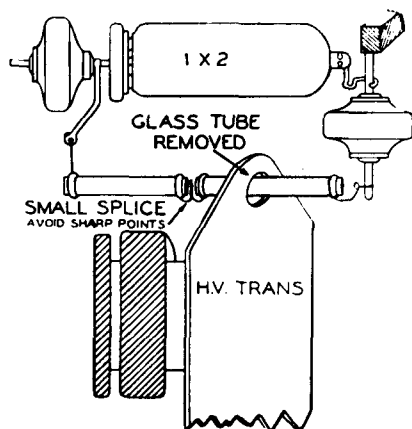
Fig. 50 — Philco

Replacement of high-voltage resistor (see Fig. 50).

High-voltage resistor, part No. 33-1352, is used and has been used for some time in production instead of the older type, part No. 33-1346. The newer resistor has the advantage over the older type, in that it will stand the rough handling which is sometimes encountered in servicing and production of television receivers which resulted in some premature failures of the carbon-filament type.

All field replacements of 2-meg resistors should be made with the newer special carbon mix type. In all of the above series receivers two of these resistors are to be used in series as the d-c return path for the

second stage of the voltage doubler. This statement is true regardless of whether the original wiring of the set used one 2-meg resistor, one 4-meg resistor, or two 2-meg resistors. The newer resistor is color coded red-green-green indicating 2.5 meg nominal value. The resistors under operating conditions are approximately 1.8 meg.

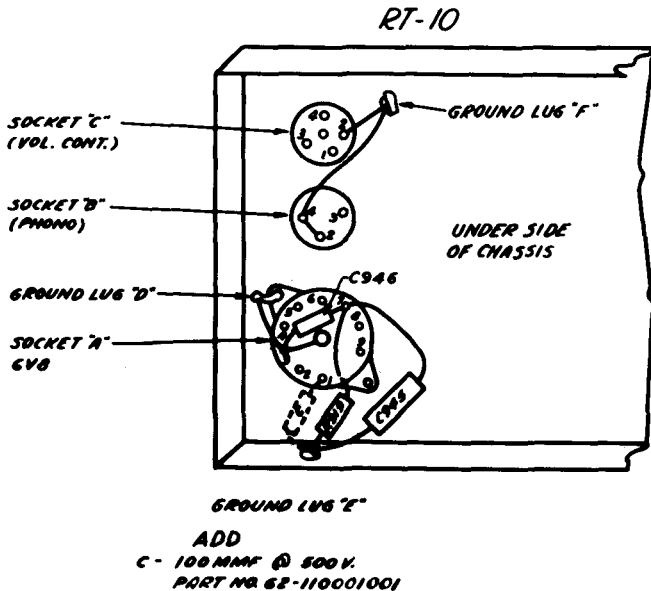
Fig. 51 — Philco

PHILCO Model RT-10
Instability on f.m.
(see Fig. 51).

The following changes will correct the instability of the f-m section of the above model. The changes should be made following a definite procedure which is outlined below:

1. Study the pictorial diagram carefully.
2. Remove bare wire connecting pin 2 of socket B and ground lug D.
3. Remove ground end of C946 from pin 2 of socket B and connect to pin 3 of socket A as shown.

4. Remove ground end of *R919* from pin 2 of socket C and connect to ground lug E as shown.

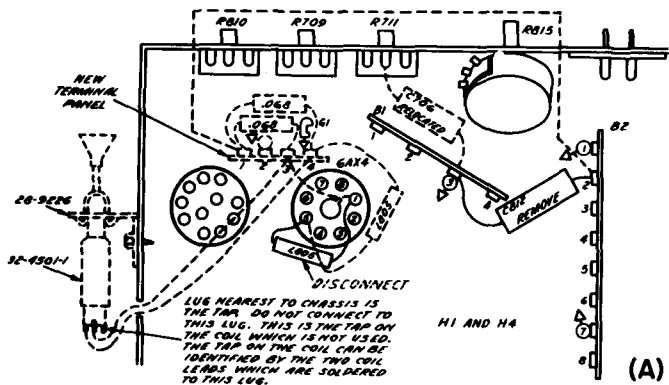
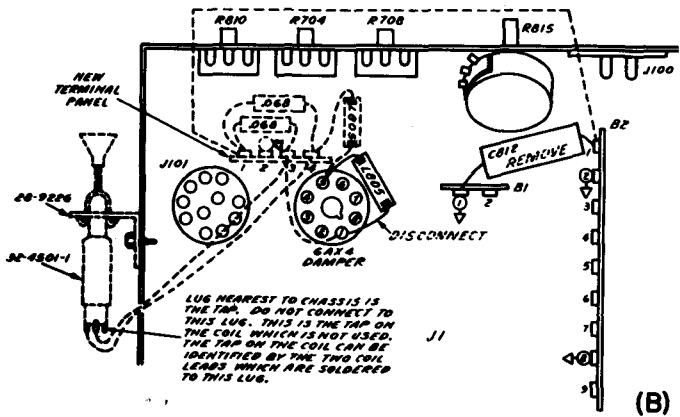
Fig. 52 — Philco

**PHILCO Models TV-80 series,
TV-90 series
Addition of horizontal-linearity
control (see Fig. 52).**

6. Disconnect the r-f choke *L805* from the damper-tube socket pin 1

and connect this end to lug 4 of the new panel, as shown on the wiring layouts.

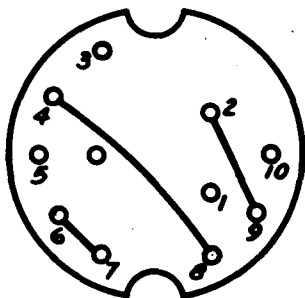
Fig. 54 — Philco

PHILCO Models TV-84, TV-94 Operation of tv without radio section (see Fig. 54).

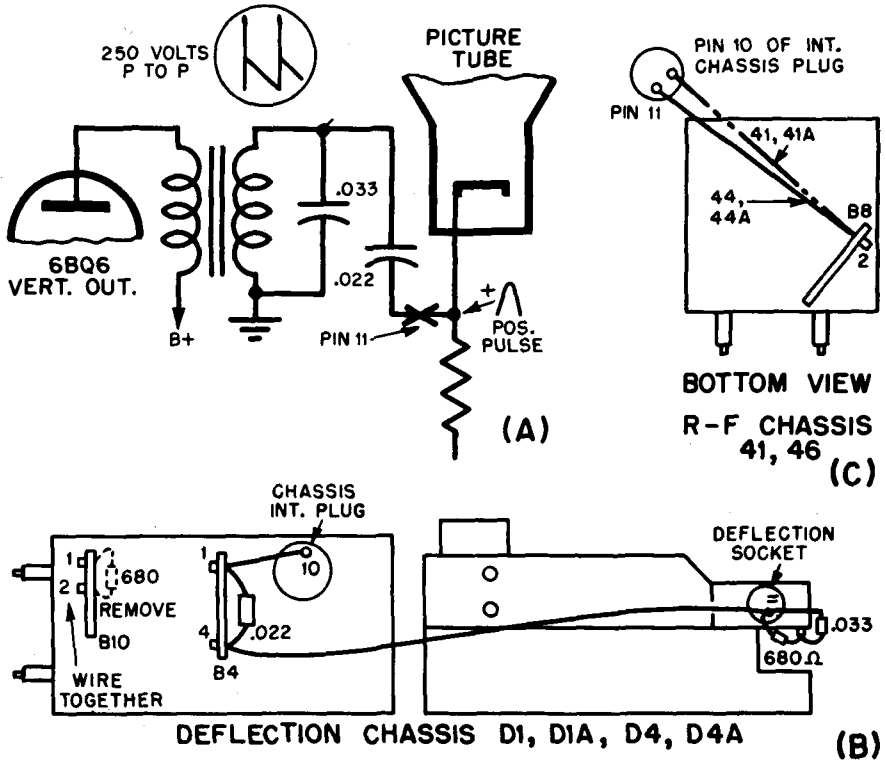
Fig. 57 — Philco

Vertical-retrace suppression
(see Fig. 57).

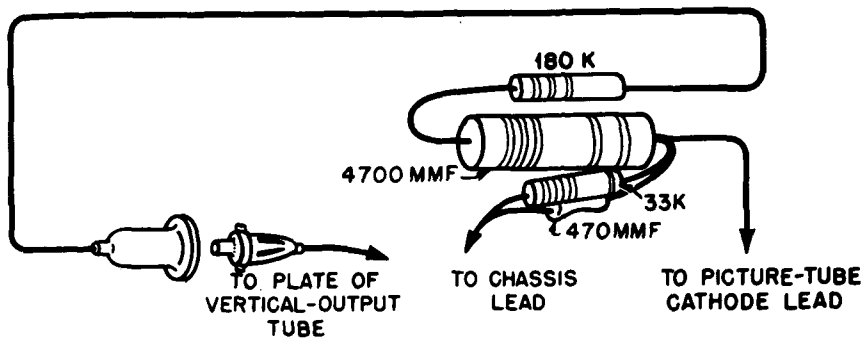
Fig. 58 — Philco

Vertical-retrace suppression (see Fig. 58).

In lieu of the wiring changes described under "Vertical-retrace suppression" for the above chassis, an alternate form of vertical-suppression circuit can be incorporated as follows. An external wiring assembly as shown in the figure is used. The connector provides flexibility in chassis removal.

1. Cut cathode lead in picture-tube cable near socket.

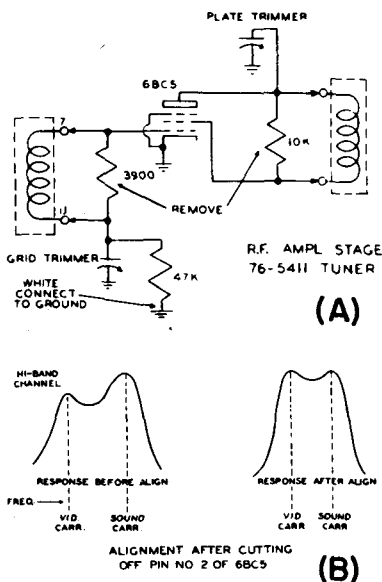
Fig. 60 — Philco

PHILCO Models with 76-5411 tuner
Improving sensitivity of tuner in fringe areas (see Fig. 60).

Changes can be made in the r-f amplifier section of the above tuner by increasing the Q of the grid and plate tuned circuits. This can be accomplished by removing the 3,900-ohm resistor in the grid circuit of the r-f amplifier and the 10,000-ohm resistor in the plate circuit of the r-f amplifier. See part (A) of the figure.

Recently it was found that by introducing a slight amount of regeneration in the r-f amplifier stage, additional gain of another 20 percent may be realized on the high-band channels and especially near the upper end of the high band. This regeneration can be very easily introduced by simply clipping off pin 2 of the r-f amplifier tube. Doing this introduces an impedance common to the suppressor and cathode. This common impedance is the internal cathode tie and the cathode lead. The relatively high capacitance between the plate and suppressor provides a feed-back path which causes some amount of regeneration in the r-f amplifier tube. The circuit actually takes the form of a modified Colpitts oscillator. After pin 2 is clipped off and the tube is reinserted, the tuner should be realigned to complete the modification of the r-f stage for good fringe performance. It is necessary to realign the r-f stage because introducing regeneration tends to produce a definite peak on the sound side (high-frequency side) of the response curve, therefore the r-f stage must be realigned so that the sound and video peaks are equal. It will be found that it is necessary to retune the grid and plate trimmers to give correct response. See part (B) of the figure.

As was stated before, introducing this type of regeneration only makes a difference on the high-band channels. On the low channels no apparent difference is noted. It will also be noticed that regeneration tends to make alignment more critical so, in general, improved gain is realized only on the channel used for alignment and the adjacent channels.

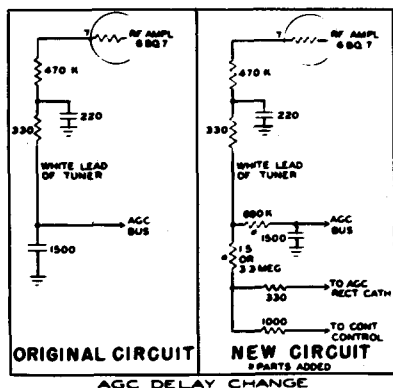
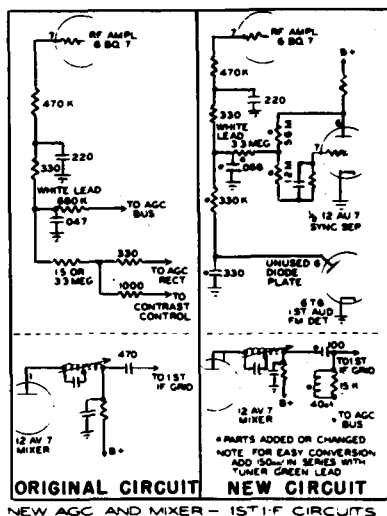
Fig. 61 — Philco

Reduced snow and better signal-handling ability (see Fig. 61).

In the chassis employing the Colorado tuner there have been several changes in the agc system. The original agc system applied agc voltage to the 6BQ7 r-f amplifier from the same bus which supplied the i-f amplifier stages. The second system modified the agc circuit to provide an extra delay for the agc supplied to the tuner. This was accomplished by connecting a small positive voltage from the contrast control through a 1.5-megohm resistor to the agc feed point for the tuner. At this

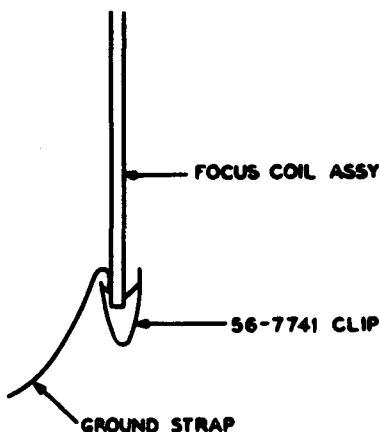
Fig. 63 — Philco

PHILCO 1950 models
with built-in antenna
Reducing harmonic beat
(see Fig. 63).

To reduce harmonic beat in models having a built-in antenna, it is important that the picture-tube mounting-frame assembly be grounded to the chassis. This grounding is accomplished by means of a flat metal strap.

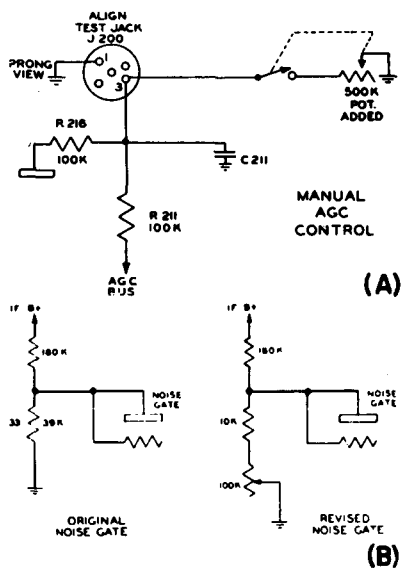
Fig. 64 — Philco

PHILCO 1951 models
Variable agc and noise-gate
voltages for fringe areas
(see Fig. 64).

The practical limits for reducing the agc voltage in the i-f strip is at the point where sync clipping starts to occur. Part (A) of the figure shows a simplified circuit of the manual agc control.

Under conditions of heavy noise, as would be experienced in some fringe areas, it is advantageous to be able to manually control the bias on the noise-gate diode, thus controlling the clipping level of the tube. A circuit to accomplish this is shown in part (B) of the figure. The 39,000-ohm resistor is replaced by a 10,000-ohm resistor in series with a 100,000-ohm potentiometer.
