MANUFACTURERS' RECEIVER TROUBLE CURES

VOLUME 4

(CAT. NO 143-4)

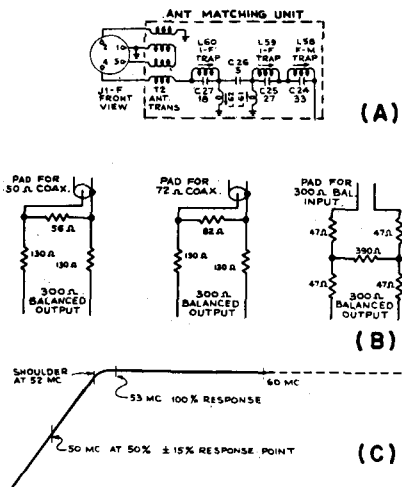
Fig. 12 — RCA Victor

Alignment of antenna-matching unit with low-output signal generator (see Fig. 12).

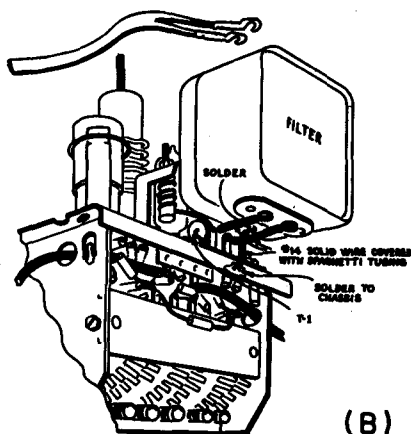
Fig. 18 — RCA Victor

RCA VICTOR Models with
KRK2, -5, -7, -8 tuners
Installation of high-pass filter
(see Fig. 18).

If interference is experienced due to the presence of strong signals below 50 mc, it can usually be eliminated by the use of a high-pass filter. To be effective, the filter must be installed at the r-f tuner units with leads as short as possible and the case of the filter connected to the r-f unit chassis.

Part (A) of the figure shows the method of attaching the antenna input connectors to the filter so that

it can be plugged directly into the antenna matching units employed with KRK5, KRK7, and KRK8 r-f tuners.

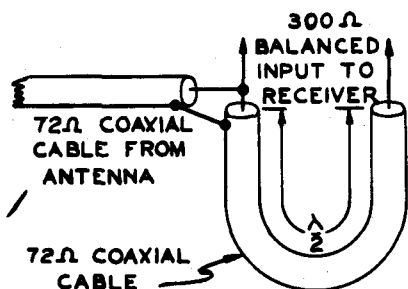
Fig. 20 — RCA Victor

**Coax to balanced line
matching network**
(see Fig. 20).

In some locations it may be necessary to use 72-ohm coax transmission line between antenna and receiver because of reflection or interference pick-up. Later receivers are provided with a 72-ohm coax input in addition to the usual 300-ohm input. Early receivers employing the above series r-f tuner units are provided only with 300-ohm balanced input. To connect the coax to these early receivers, construct a network as shown in the figure. The matching section should be one electrical half wavelength long for the picture carrier of the weakest signal received.

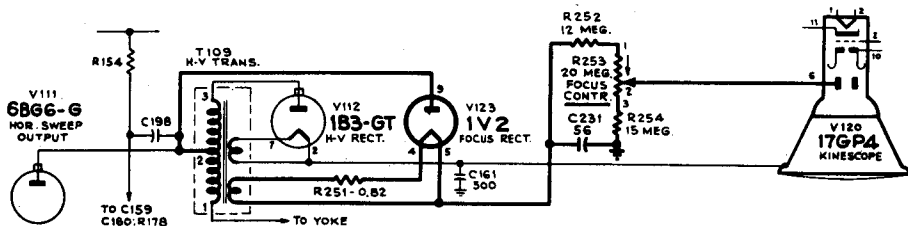
Fig. 24 — RCA Victor

Substitution of electrostatic focus picture tube (see Fig. 24).

As shown in heavy lines in the partial schematic, a new high-voltage transformer is required and a 1V2 rectifier is provided to supply the focus potential to the picture tube. A focus-control potentiometer is also supplied and is conveniently located on the back of the chassis.

Since the focus magnet is dispensed with on the 17GP4, a new centering magnet is provided to center the picture on the screen. This magnet assembly is in the form of two wire rings mounted on a non-magnetic form which is placed around the neck of the picture tube, and at a distance of about three-eighths of an inch in back of the deflection yoke. When the magnets are rotated on the tube so that the gaps in the rings are together, then maximum picture shifting effect is produced. When the rings are rotated so that their gaps are 180 degrees apart, then little or no shifting of the picture is obtained. To shift the picture, rotate one of the magnets with respect to the other. To move the picture in a desired direction, rotate the entire centering mag-

net assembly around the neck of the picture tube. Repeat these two adjustments until the picture is properly centered and no corner shadows are obtained.

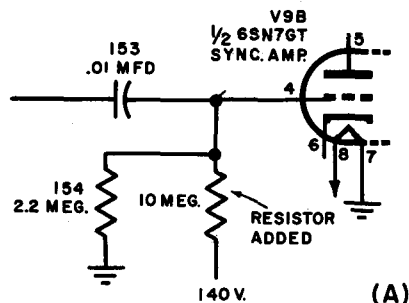
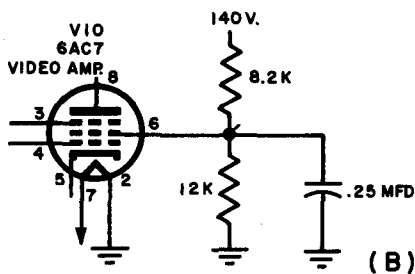
Fig. 29 — Sears Roebuck

SEARS ROEBUCK Chassis 100.208
Increased fringe-area sync stability (see Fig. 29).

3. Add a 12,000-ohm, 1-watt resistor from pin 6 of the 6AC7 video amplifier to chassis ground.

4. Add a .25- μ f, 200-volt capacitor from pin 6 of the 6AC7 video-amplifier tube to ground.

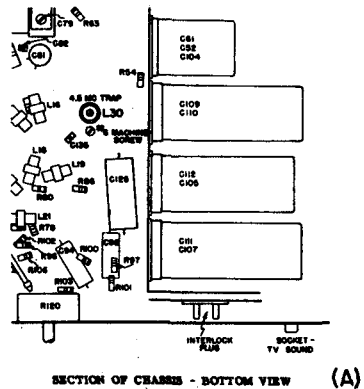
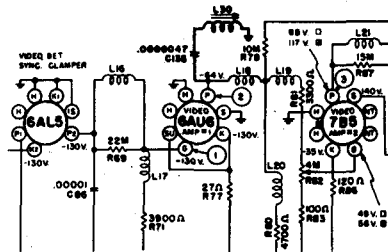
Fig. 30 - Sears Roebuck

SEARS ROEBUCK Chassis 101.846 Installation of 4.5-mc trap (see Fig. 30).

Later production of the above chassis incorporates a 4.5-mc trap off the plate of the first video-amplifier tube 6AU6. This is necessary to

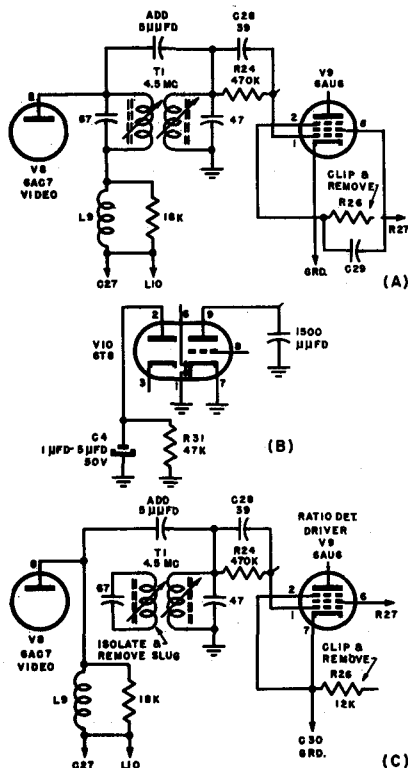
Fig. 31 — Sears Roebuck

SEARS ROEBUCK Chassis 110.499
Reducing Intercarrier Buzz
 (see Fig. 31).

2. Attach a $5\text{-}\mu\text{mf}$ capacitor from pin 8 to the top side of the secondary of $T1$.

3. In addition, completely remove all wires from the primary of $T1$ and remove its slug.

4. Remove *R26* and change *C4* as described previously.

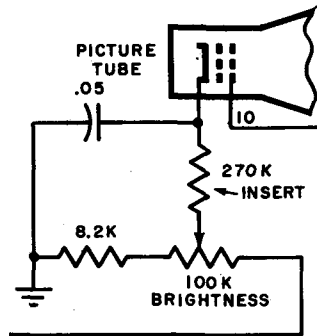
Fig. 32 — Sears Roebuck

The initial production of this chassis may have considerable interaction between picture controls. This is evidenced by a great change in linearity with an adjustment of the focus control, a change of the contrast control beyond the normal range, or under-normal adjustment of the brightness control.

To correct this condition, remove the yellow wire from pin 11, cathode, of the picture tube and remove the .05- μ f capacitor, *C28*, from the center arm of the brightness control. Attach a 270,000-ohm, 1-watt resistor to the center arm of the brightness control. Attach the other end of the resistor to the yellow wire from pin 11 and the .05- μ f capacitor. It will be noted that to obtain good

linearity it may be necessary to adjust the linearity control from one end of the range to the other.

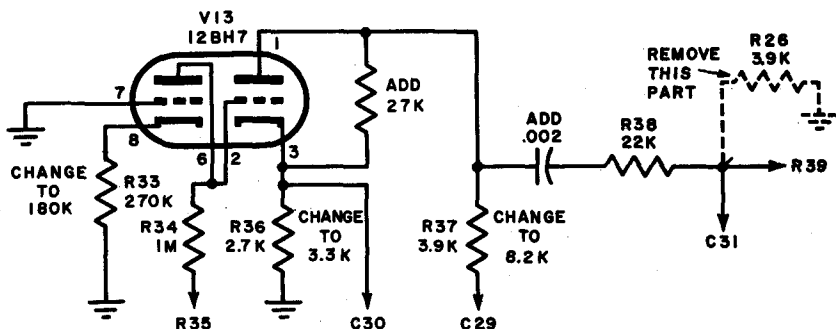
Fig. 33 — Sears Roebuck

Improved vertical stability in fringe areas (see Fig. 33).

In fringe areas where the above chassis is more critical vertically and more susceptible to noise pulses, it is possible by making a few minor component changes to improve the noise immunity and vertical stability. The changes should be made as follows (see the figure):

1. Add a 27-k resistor from plate (pin 1) of *V13*, 12BH7, to the cathode (pin 3).

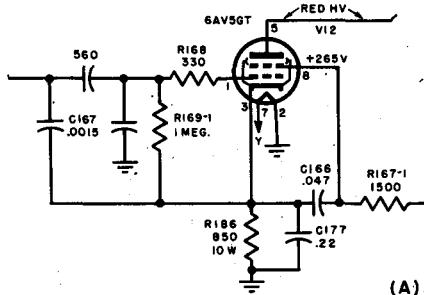
Fig. 34 — Sears Roebuck

SEARS ROEBUCK Chassis 132.889 Increasing life of horizontal-output tube (see Fig. 34).

Later production of the above chassis incorporate the accompanying circuit change to decrease the dissipation in the 6AV5GT horizontal-output tube and increase the life of this tube. In every case where a model 106 or 107 with the above chassis is returned for service, this change should be made. The following parts, available as a kit (part

No. N24033-1) from the manufacturer, are needed:

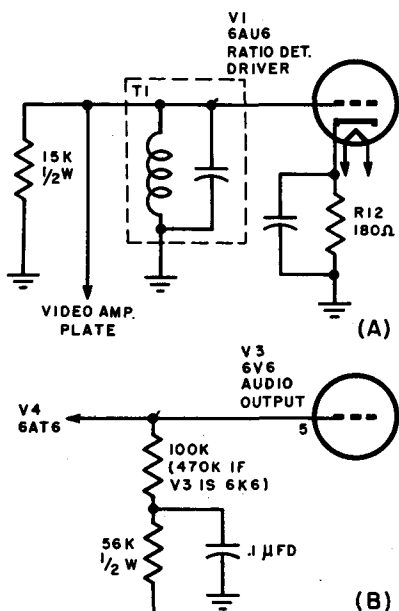
Fig. 36 — Sears Roebuck

Chassis 478 series
Reduction of buzz (see Fig. 36).

A study of buzz conditions in the above models has revealed the

two dominant causes to be inter-carrier buzz and audio pick-up of vertical-sweep or sync pulses.

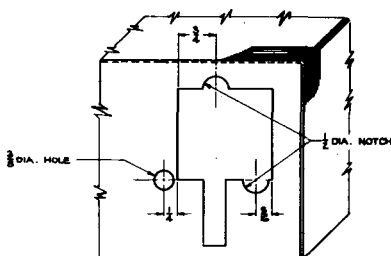
Fig. 38 — Sears Roebuck

SEARS ROEBUCK Chassis 528.631 Removal of tuner cover (see Fig. 38).

The radio-frequency tuner used with this receiver has a bottom cover plate. The cover plate is attached to the tuner at the rear by two tabs which fit into slots in the back apron of the tuner. At the front, it is held in place by two screws which fasten to threaded holes in the front apron of the tuner.

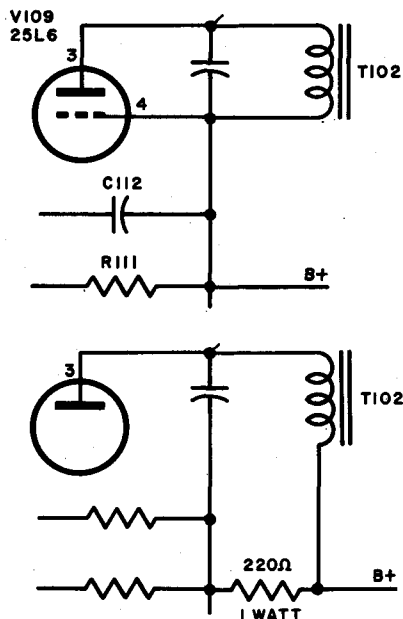
Fig. 39 — Sears Roebuck

SEARS ROEBUCK Chassis 549.102
Audio-hum reduction
 (see Fig. 39).

In the above chassis, audio hum can be slightly reduced by adding a 220-ohm, 1-watt resistor as shown in the figure.

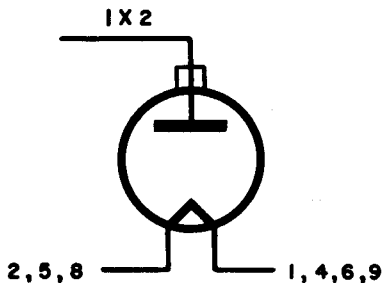
Fig. 40 — Sears Roebuck

Substitute 1X2 socket connections (see Fig. 40).

The socket connections of the 1X2 are very fragile and can break easily. However, it is not necessary to replace the tube socket when this happens. Pins 1, 4, 6, and 9 are connected together to one side of the filament while pins 2, 5, and 8 are connected to the other side of filament. If one of the socket connections breaks, resolder the leads to one of the other pins in the series.

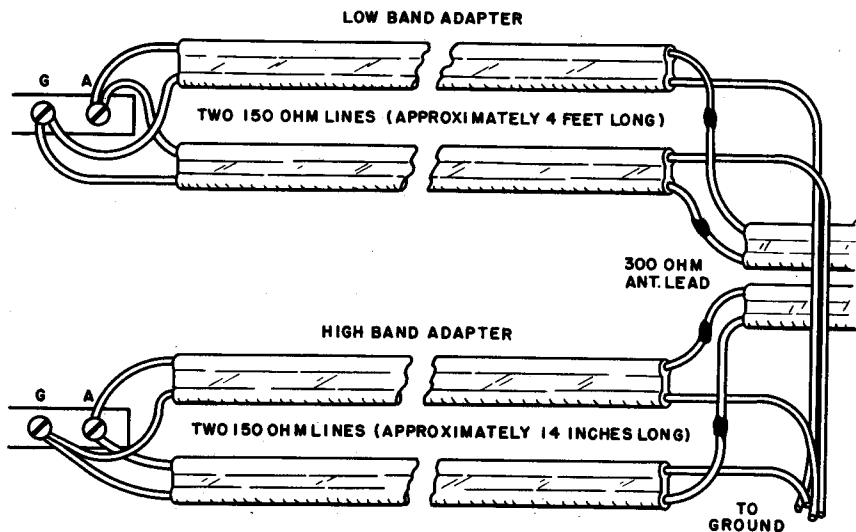
Fig. 41 — Sears Roebuck

Antenna-matching section (see Fig. 41).

The purpose of this arrangement (shown in the figure) is to connect a 300-ohm lead-in to those sets employing a 75-ohm antenna input. It consists of two adapters, one 14

inches, and one 4 feet long, each consisting of two 150-ohm leads, connected in parallel at one end and in series at the other end so that d-c continuity exists across the paralleled connection.

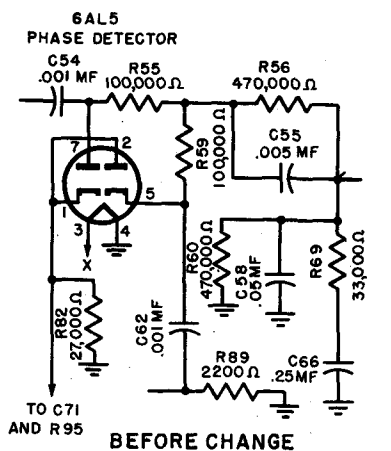
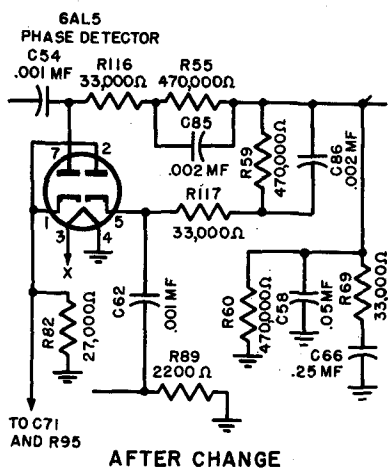
Fig. 44 — Sentinel

Improving horizontal hold
(see Fig. 44).

b. Two .002- μ f, 200-volt capacitors *C85* and *C86* are added in parallel with *R55* and *R59*. Part number of the capacitors is 23E205.

c. Two 33,000-ohm, 10%, 1/2-watt resistors *R116* and *R117* are added in series with *R59* and pin 5 and in series with *R55* and pin 7 on the 6AL5 phase-detector tube socket. Part number of these resistors are 27E333-2.

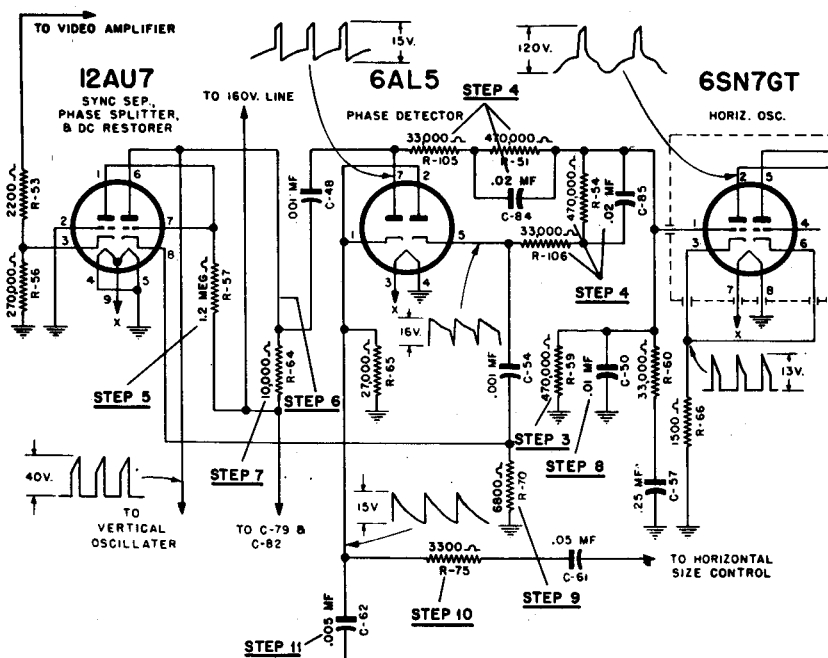
Fig. 46 — Sentinel

SENTINEL Model 416
Improving horizontal stability
 (see Fig. 46).

2. The .005- μ f capacitor *C49*, part of the parallel filter in the output circuit of the phase detector, is removed from the circuit.

3. The 470,000-ohm resistor *R52*, part of the parallel filter, is rewired

to ground to take the place of R59 removed in step 1 above.

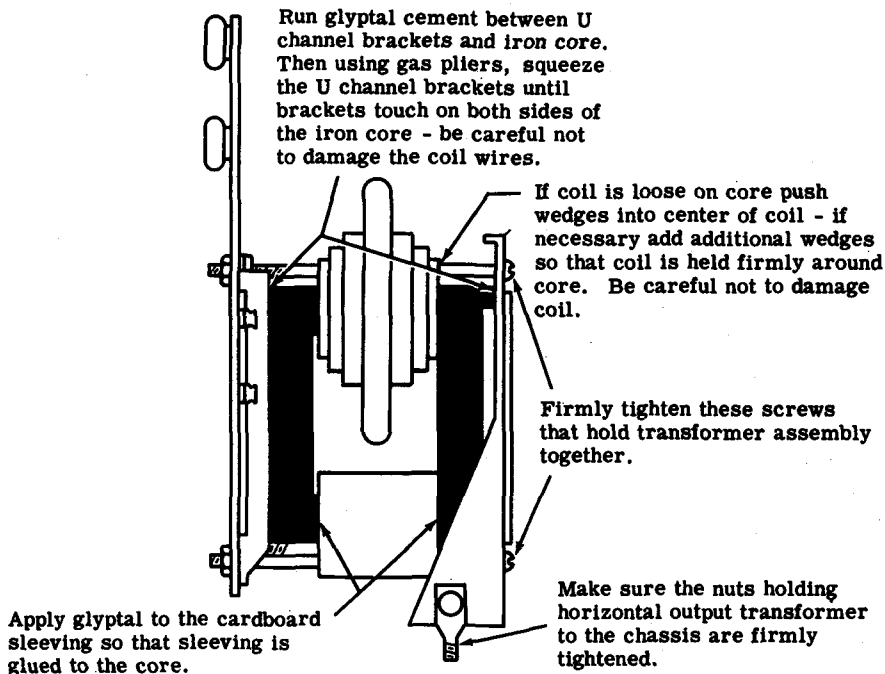
Reduction of buzz.

If station buzz is excessive and is not due to contrast control being

Make sure all horizontal output transformer leads are dressed away from this transformer, particularly the lead going to the fuse.

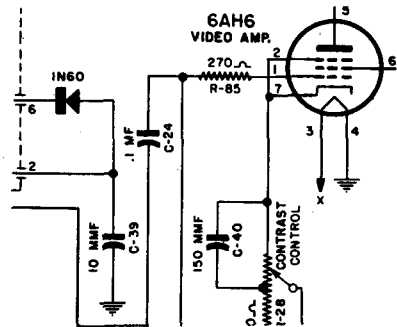
Fig. 49 — Sentinel

Premature crystal-detector failure (see Fig. 49).

An early sign of crystal failure is excessive sound bars in the picture that are not due to fine-tuner mis-

adjustment. Ultimately, complete failure will result in weak picture and loss of sync. This may be due to momentary surge current in the control-grid circuit of the 6AH6 video-amplifier tube due to internal shorting of the screen grid to the control grid. This will result in damaging the 1N60 crystal detector.

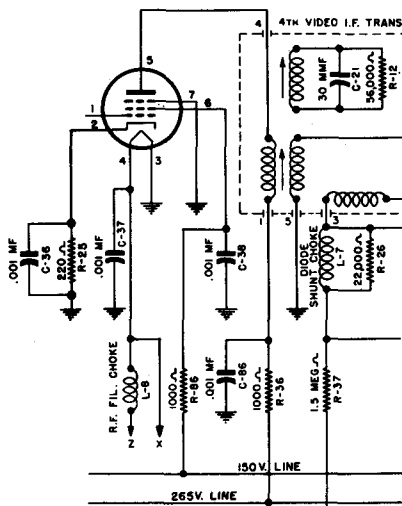
Fig. 51 — Sentinel

Picture rolling and tearing on strong signals (see Fig. 51).

In initial production the screen and plate were tied together to the 150-volt line. If you encounter a set in which the plate is tied to the 150-volt line and the picture tears or rolls on strong signals, the following changes should be made to tie the plate of the 3rd video i-f tube to the 265-volt line:

1. Change the 6CB6 3rd-video i-f amplifier 82-ohm cathode resistor (*R25*) to 220 ohms, $\frac{1}{2}$ watt.

2. Remove the jumper wire that runs from the screen (pin 6) of the 3rd-video i-f tube to terminal 1 of the 4th video i-f transformer. This will leave the screen (pin 6) of the 3rd video i-f tube connected to the 150-volt line through a 1,000-ohm resistor.

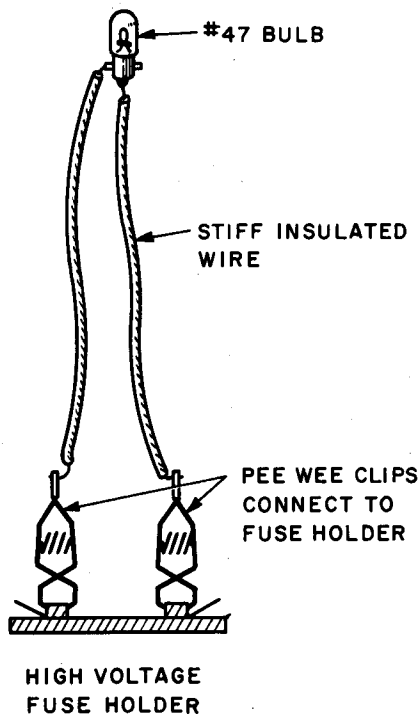
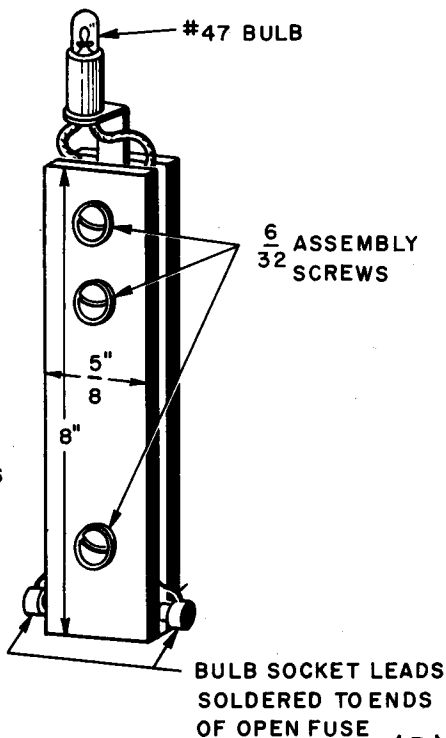
Fig. 52 — Sentinel

SENTINEL All models
Linearity-coil adjustment
 (see Fig. 52).

2. Clip a lead from the pilot light to each terminal of the fuse holder.

3. Adjust the horizontal-linearity control for minimum pilot-light brightness.

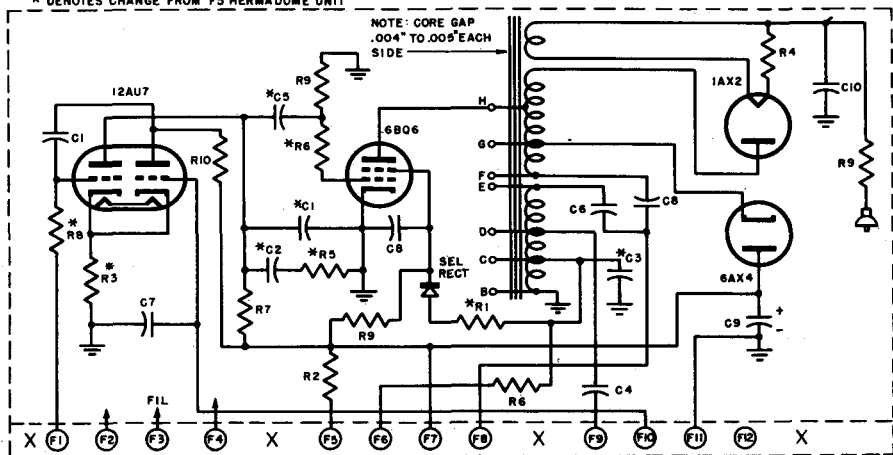
Fig. 54 - Setchell Carlson

Preventing overdrive of horizontal-output tube (see Fig. 54).

An automatic-drive arrangement may be incorporated into Series 5 of the F Hermadome unit. This arrangement, included in Series 6 of the unit, offers a great advantage in that

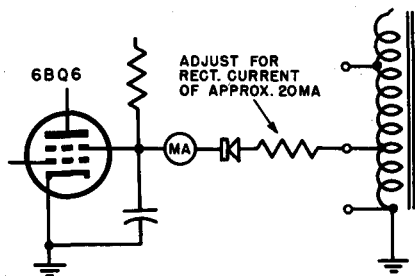
Fig. 55 — Satchell Carlson

Checking selenium-rectifier current when making a replacement (see Fig. 55).

When replacing a selenium rectifier in any of the models of F unit, be sure to check the rectifier current as a safety measure. The current must be held within the limits of 15 and 25 milliamperes, with 20 ma being considered optimum.

Connect a milliammeter between the screen terminal of the horizontal-output tube socket and the selenium rectifier (see sketch). If the meter is inserted at any other point, the capacitance of the leads may cause faulty readings.

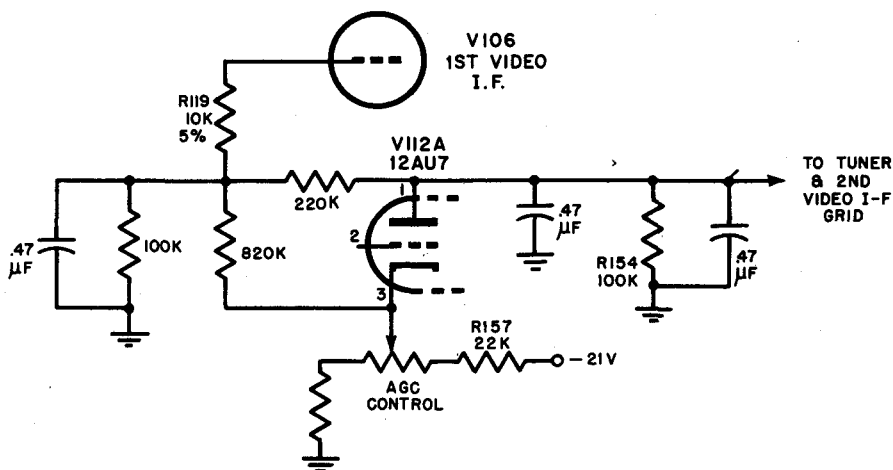
Fig. 58 — Shaw TV

Buzz on either side of correct tuning position (see Fig. 58).

Buzz may occur on either side of the correct adjustment of the fine-tuning control. This effect can be eliminated by the following modification, already made in production runs 301-304.

1. Mount a single-lug terminal strip under the nut of the discriminator can (closest end to *V112* age tube).

2. Wire a 820-k, $\frac{1}{2}$ -watt resistor from pin 3 of *V112* to the terminal-strip lug.
