## MANUFACTURERS' RECEIVER TROUBLE CURES

### **VOLUME 5**

**MANUFACTURERS'  
RECEIVER  
TROUBLE CURES**

*Edited by*  
Milton S. Snitzer

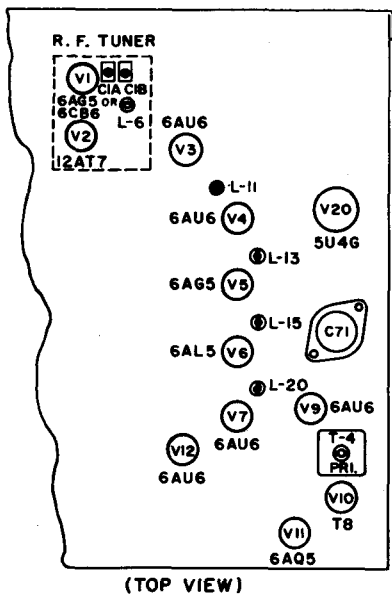
Fig. 2 — Sparton

### Picture i-f instability (see Fig. 2).

If the picture i-f strip is badly out of alignment, it may become unstable and fall into oscillation. When this condition occurs, a comparatively large voltage is developed across the picture detector load resistor. This voltage is independent of i-f signal input at the converter grid.

8. Replace  $R48$  (1 meg) from pin 6 to +135 volt line with new  $R48$  (4.7 k).

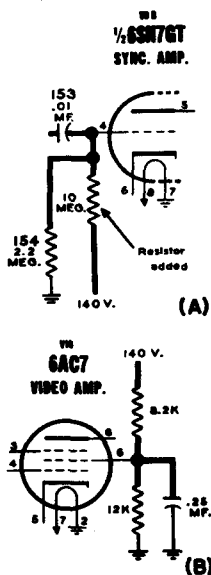
Fig. 5 — Stewart-Warner

1951, 1952 19-tube Models  
**Increased fringe area sync  
stability (see Fig. 5).**

The following circuit changes should be incorporated in all 19-tube models that are being operated in extreme fringe areas. These changes will result in greatly improved sync stability under conditions of weak signal. *Do not* make those modifications on chassis located in *strong* or *moderate* signal areas.

RESISTOR NO.	VALUE	PART NO.	REPLACE WITH
R223	2 meg, 5%, $\frac{1}{2}$ w	510765	510769
R225	100,000 ohms, 10%, $\frac{1}{2}$ w	510172	510766
R226	4.7 meg, 10%, $\frac{1}{2}$ w	510759	510768
R227	1.5 meg, 5%, $\frac{1}{2}$ w	510752	510767

RESISTOR NO.	VALUE	PART NO.	REPLACE WITH
R320	1.5 meg, 5%, $\frac{1}{2}$ w	510721	510767
R322	100,000 ohms, 10%, $\frac{1}{2}$ w	510172	510766
R323	6.8 meg, 20%, $\frac{1}{2}$ w	510196	510771
R324	1.2 meg, 10%, $\frac{1}{2}$ w	510738	510770

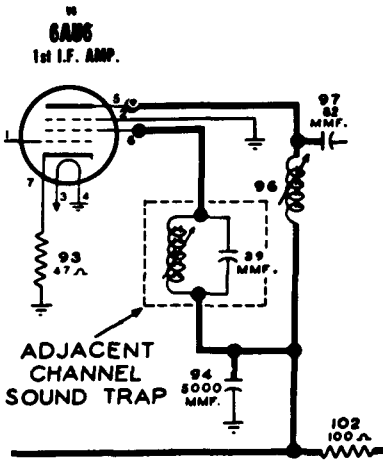
Fig. 6 — Stewart-Warner

### 1951 19-tube Models Installation of adjacent-channel sound trap (see Fig. 6).

Adjacent-channel sound trap, part No. 520131, comprising a slug tuned coil and fixed ceramic capacitor, was designed to minimize interference caused by the sound carrier of the lower frequency adjacent channel.

2. Properly tune receiver for a normal picture by using fine tuning control on front panel of receiver. Do not touch this control during the rest of the adjustment procedure.

3. Connect a standard signal generator through a 330- $\mu\mu\text{f}$  capacitor to

point *Q* on the r-f tuner and a vtvm to the green lead coming from the crystal detector shield can.

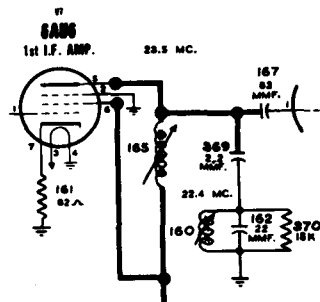
Fig. 7 — Stewart-Warner

1951 26-tube Models  
**Improved sensitivity and sync stability (see Fig. 7).**

6. The new trap coil should be aligned to the old trap frequency of 22.4 mc.

7. After completing this conversion, the 4th i-f stage should be changed in frequency from 24.75 mc to 24.9 mc.

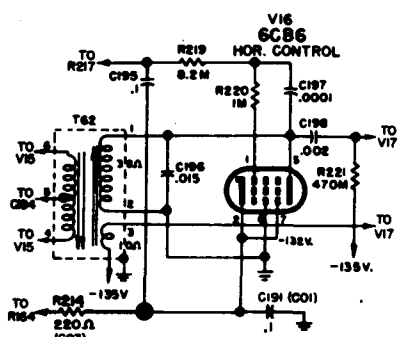
Fig. 21 — Sylvania

**Greater horizontal stability (see Fig. 21).**

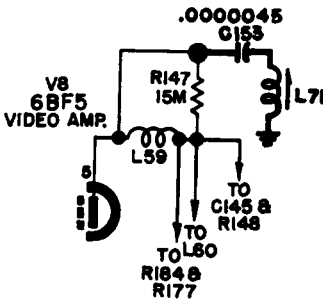
Fig. 22 — Sylvania

**SYLVANIA** Chassis 1-437-3  
**Reducing 4.5-mc sound interference in picture (see Fig. 22).**

To reduce 4.5-mc sound interference in picture, add *C153*, 4.7- $\mu$ f capacitor, and *L71*, 4.5-mc trap coil, in series between the plate of *V8*, 68F5 video amplifier, and ground. The alignment procedure for *L71* is as follows:

1. Ground the grid (pin 1) of *V6*, the 6CB6 4th video i-f amplifier to chassis.

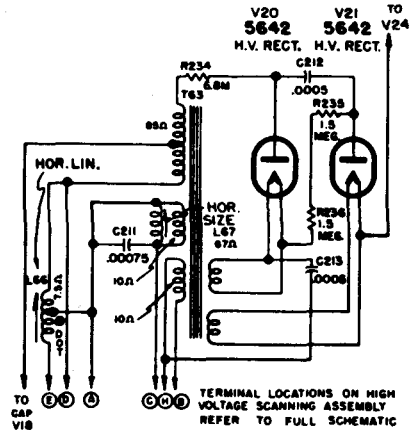
Fig. 23 — Sylvania

**SYLVANIA** Chassis 1-502  
**Increasing stability of h-v output (see Fig. 23).**

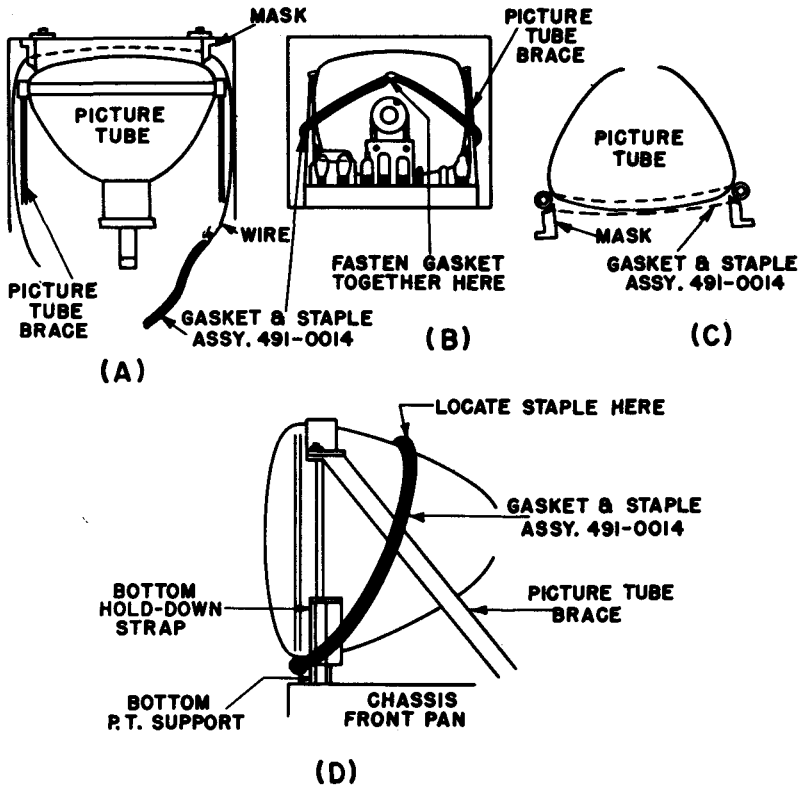
Fig. 25 — Sylvania

**SYLVANIA** All 17-inch chassis **Installation of dust seals for picture tube (see Fig. 25).**

Mask and gasket assembly, part No. 491-0014, may be installed on 17-inch tv models with the chassis either in or out of the cabinet. The methods for each type of installation are given as follows:

Installation with tv chassis in cabinet:

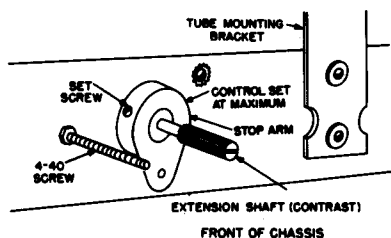
Fig. 30 — Western Auto

#### **Preventing contrast control shaft connector from breaking (see Fig. 30).**

Since the contrast control is located on the video i-f strip assembly, an extension shaft and shaft connector are used to operate the contrast control. The extension shaft can be rotated a full 360 degrees while the contrast control will reach its stop after approximately 280 degrees. If the extension shaft is rotated clockwise after the contrast reaches its stop, the fibre shaft connector will be broken. To prevent the shaft connector from breaking, simply follow the instructions below:

1. Remove the chassis from the cabinet.
2. Remove the lower screw and lockwasher holding the contrast shaft bracket to the front of the chassis.

3. Insert the small 4-40 screw through the hole in the contrast shaft bracket so the screw head is inside the chassis. Tighten to the chassis with the lock-washer and nut provided.
4. Place the stop-arm assembly over the contrast control extension shaft so the stop-arm is away from the chassis.
5. Set the contrast control to maximum (clockwise).
6. Rotate the stop-arm clockwise until it reaches its stop (the 4-40 screw).
7. Tighten the two stop-arm assembly set screws.
8. Replace the chassis in the cabinet.

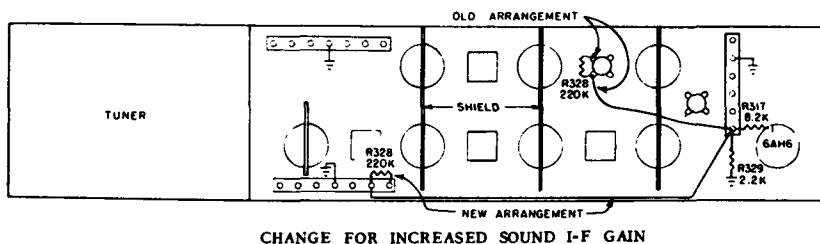
Fig. 38 — Westinghouse

**WESTINGHOUSE** Models  
H-640T17, -641K17,  
-642K20  
**Increasing contrast range and sound output (see Fig. 38).**

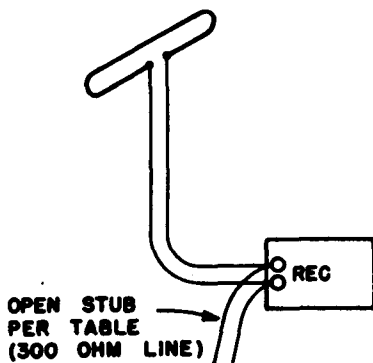
Fig. 44 — Zenith

### Improving overall fringe performance (see Fig. 44).

#### 1. Grounding Turret AGC.

This procedure consists of removing the turret agc lead from the agc string and returning it to ground through a resistor of 500-k to 1-meg
