# TV

## MANUFACTURERS' RECEIVER TROUBLE CURES

**VOLUME 6**

This is the sixth in a series of volumes which deal with specific tv receiver troubles and their cures. These trouble cures are the tv manufacturers' own answers to some of the problems that may arise in their particular receivers.

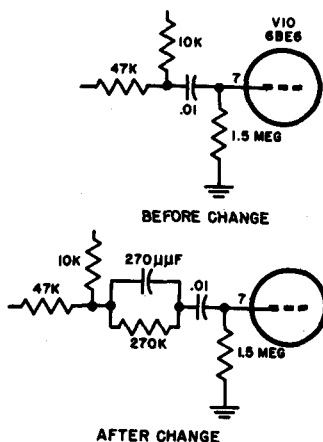
Fig. 12 — Arvin

**Horizontal wavering at top of picture (see Fig. 12).**

when the r-f signals are received from faulty distribution systems. This wavering is due to intermittent partial loss of horizontal sync pulses in the receiver sync separator. Those distribution systems that "pipe-in" r-f signals are usually community antenna systems or multiple dwelling antenna systems. The condition outlined above will not appear on a normal air signal.

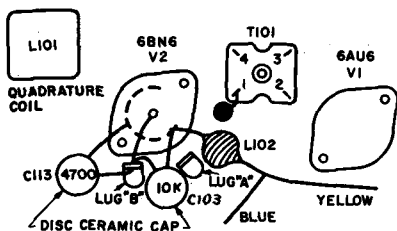
Fig. 14 - Arvin

**Preventing interference due to 6BN6 radiation (see Fig. 14).**

Under certain signal conditions, interference in the picture caused by radiation from the 6BN6 circuit may be present. To check for this type of interference, remove 6BN6 tube from set. If the interference disappears, make the following changes:

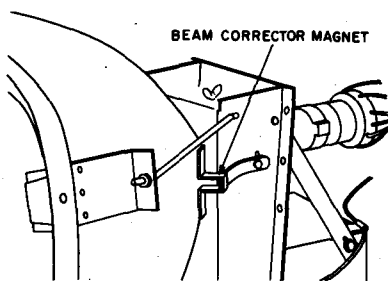
Fig. 17 - Capehart

**CAPEHART** Chassis CX-37  
**Installation of beam-corrector magnets (see Fig. 17).**

Misadjustment of the magnet may cause an irregular bend to appear at the edge of the raster.

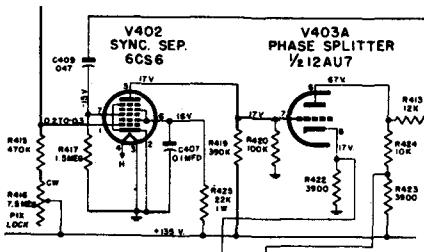
Fig. 18 — Capehart

**CAPEHART** Chassis CX-37  
**Improving sync separation and hook at top of picture (see Fig. 18).**

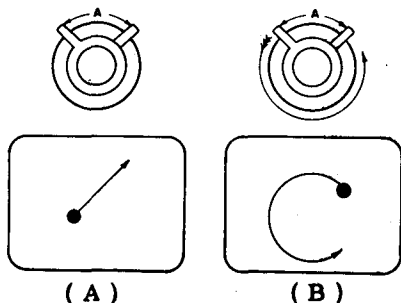
Fig. 21 — CBS-Columbia

**Adjustment of magnetic centering rings (see Fig. 21).**

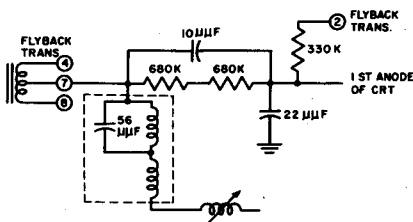
Fig. 22 — CBS-Columbia

**Eliminating ringing and vertical shading (see Fig. 22).**

3. Change **C318, 220- $\mu$ mf, 1000-volt capacitor** connected to **R318** to **680k-ohm, 1-watt resistor**.

4. Add a **10- $\mu$ mf, 1500-volt capacitor** to parallel **680k-ohm resistor**.

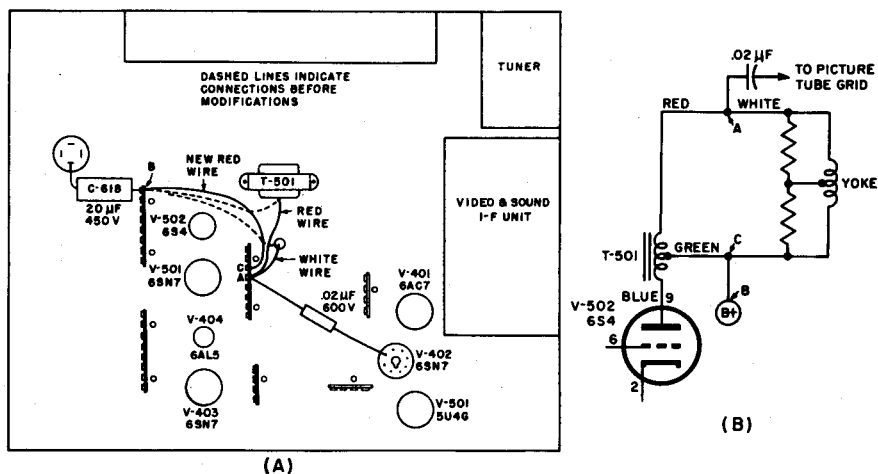
Fig. 25 — Conrac

**CONRAC** Models 36, 39  
**Removal of retrace lines**  
(see Fig. 25).

1. Connect a .02- $\mu$ f, 600-volt capacitor between pin 3 of *V402* (this is also the crt grid tie point) and tie point *A*.

2. Remove red wire leading from *T501* (vertical output transformer)

from tie point *B* (*B+* boost) and reconnect to tie point *A*.

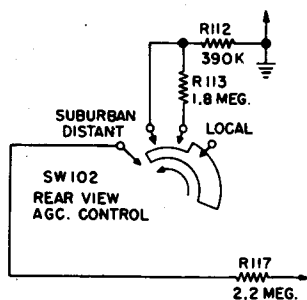
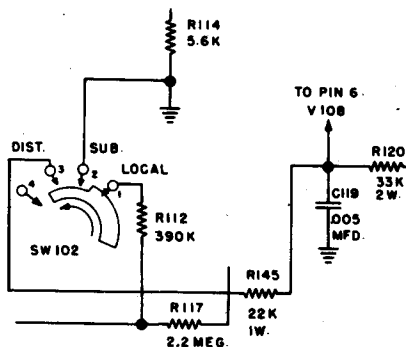
Fig. 26 — Crosley

**CROSLEY** Chassis 385, 386, 387, 393, 394, 396  
**Improving vertical sync stability (see Fig. 26).**

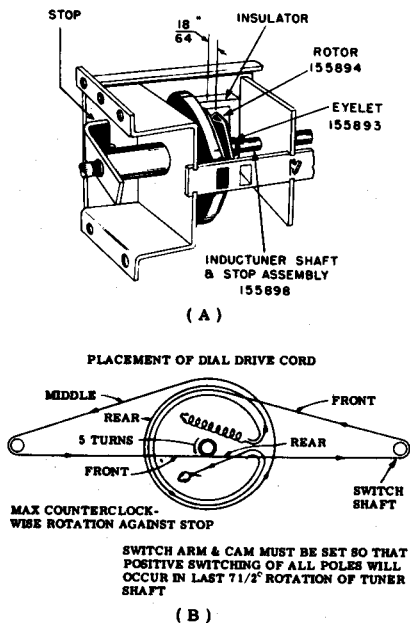
Fig. 27 - Crosley

### Repairing damaged tuning mechanism (see Fig. 27).

1. Remove the Inductuner cover by removing the three retaining nuts.

2. Scratch a mark on the rear of the pulley, on the fiber hub at rear

of pulley, and on the stop, so that the position of the scratch marks coincide. These marks will be used as a reference for correct positioning of the parts when they are re-assembled.

5. Check position of rotors on Inductuner shaft with respect to the position of the stop on the knurled portion of the shaft as shown in part (A) of the figure, and as explained in the note below. Do not remove the stop from the Inductuner shaft unless it has been definitely determined that the stop was previously off (removed from) the shaft and is now improperly positioned. If the stop is loose (can be wobbled) on the knurled portion of the shaft, it can be tightened by carefully soldering it to the shaft. A low melting point solder (part No. 154830) is recommended. (This solder is also recommended for soldering of components and connections in all uhf converters.) Trim off all surplus solder so that the fiber hub fits properly over the end of the shaft.

Note: Before soldering the stop to the shaft, make sure that the stop is positioned correctly on the knurled portion of the shaft with relation to the position of the rotors. To do this, turn the Shaft to its extreme counterclockwise position. The correct rotor position is shown in the figure, the 18/64-inch measurement is taken from the inner surface of the insulator to the corner of the metal plate that holds the contacts on the rotor. If the rotors are not positioned as shown in the sketch, remove the stop from the knurled portion of the shaft and then replace the stop on the shaft in a position that will result in the

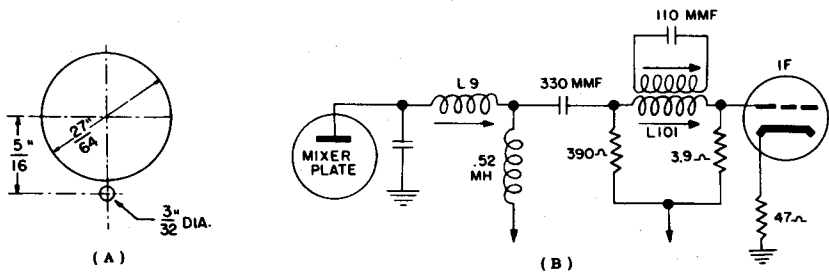
Fig. 28 — Crosley

#### **Minimizing adjacent sound interference by adding trap (see Fig. 28).**

6. Insert the new coil (part No. 155304) into the 27/64-inch hole. The two connecting lugs on the coil form should be nearest the chassis. Connect the parts removed from the original coil in step (1) to their respective lugs on the new coil.

7. Connect a 390-ohm resistor (part No. 39374-20) on the lug of the coil that has the 330- $\mu\text{f}$  capaci-

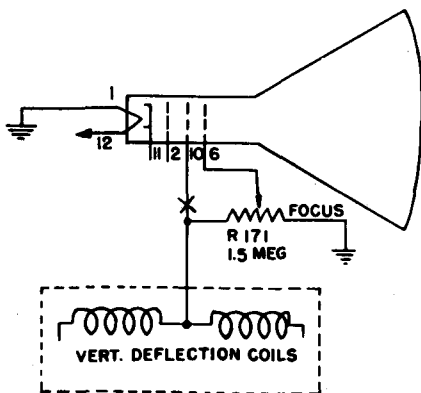
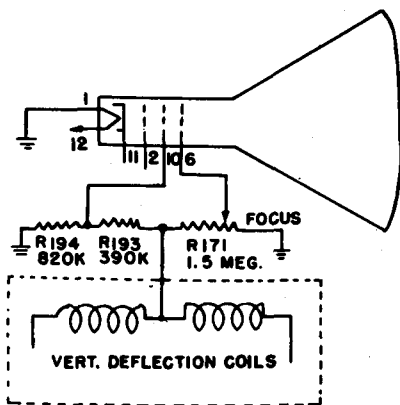
Fig. 29 — Crosley

**Improving picture contrast and shading (see Fig. 29).**

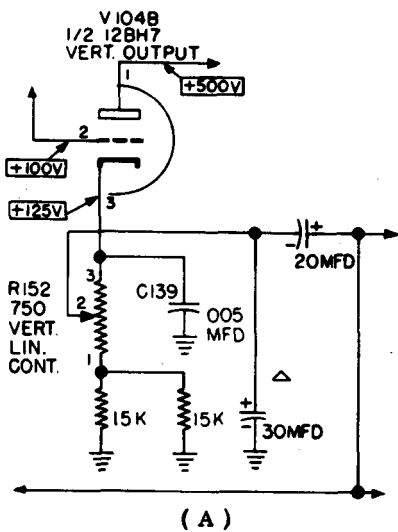
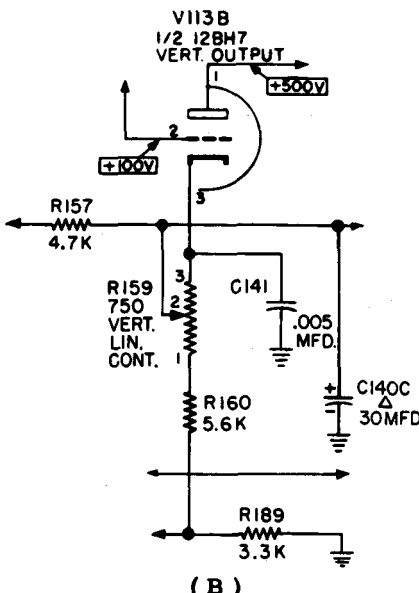
Fig. 30 - Crosley

**Increasing heat dissipation ability of cathode circuit of vertical output tube (see Fig. 30).**

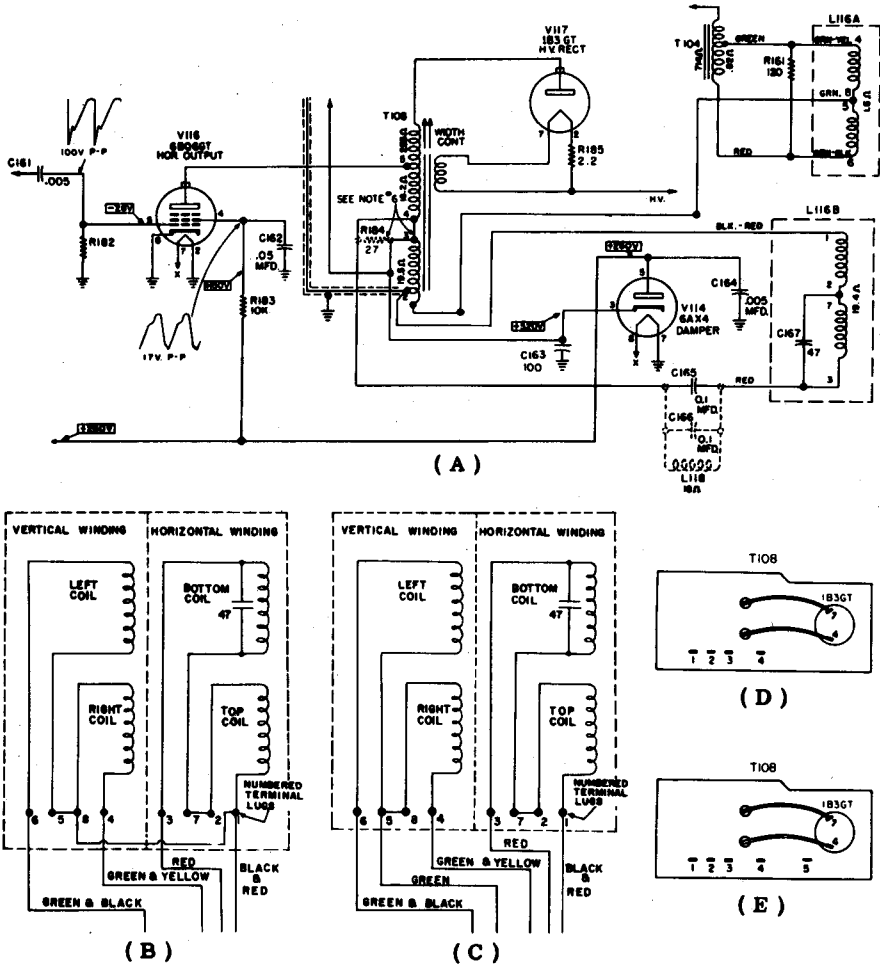
Fig. 31 - Crosley

**Improvement of horizontal linearity (see Fig. 31).**

The following changes, made in later production, are incorporated to

improve the horizontal linearity. Part (A) of the figure shows the changes that are made to the schematic diagram of the custom chassis. The same parts are used in both the Deluxe and the Custom chassis. Although the

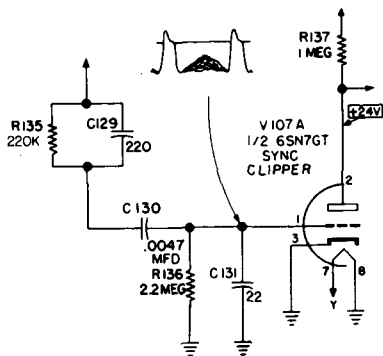
Fig. 32 — Crosley

#### Improving vertical sync stability (see Fig. 32).

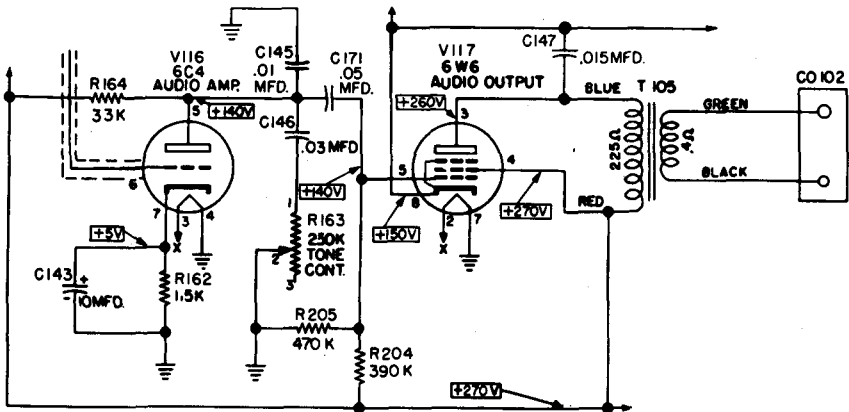
Fig. 34 - Crosley

**CROSLEY** Chassis 411, 412, 414, 416  
**Preventing oscillation in audio section (see Fig. 34).**

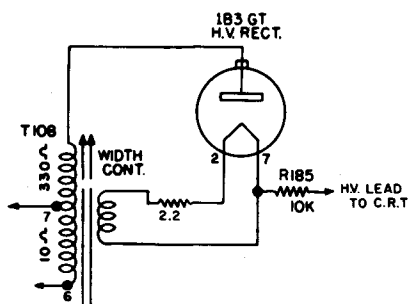
Fig. 35 — Crosley

**Improving operation and prolonging life of h-v rectifier (see Fig. 35).**

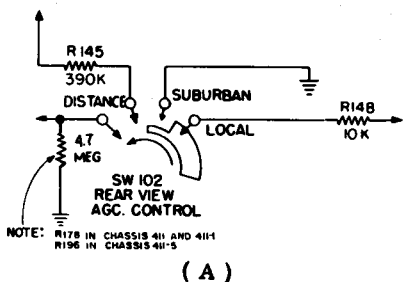
Fig. 36 — Crosley

**Improvement in sync stability (see Fig. 36).**

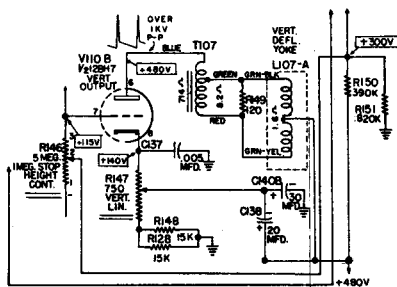
Fig. 37 — Crosley

**CROSLLEY** Chassis 426  
**Avoiding excessive height (see Fig. 37).**

On later production of the above chassis (code letter *D* or later) a wiring change was made in the vertical circuit to avoid excessive height by reducing the plate voltage on *V110A* (vertical oscillator tube). However, no parts were added or deleted. The change on the schematic is shown in the figure. The figure shows also the correct color coding of the two leads of *L107A*, vertical

deflection coils. The colors for these two leads as shown in the schematic in the receiver service notes are incorrect.

switch. The circuit for the Deluxe chassis is given in (A) along with the correct code letters; the circuit for the Custom chassis is shown in part (B) of the figure. This change is already made in later production.

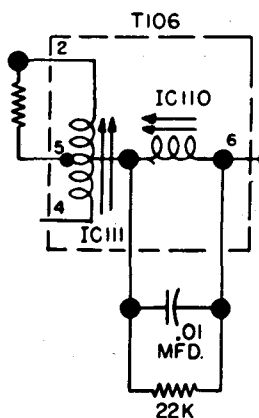
Fig. 38 — Crosley

**CROSLLEY** 1950, 1951, 1952,  
1953 custom chassis  
**Horizontal drift due to high  
humidity (see Fig. 38).**

If horizontal drift is experienced due to humidity, replace the .01- $\mu$ f

capacitor that is connected in parallel with a 22,000-ohm resistor from lug 5 to lug 6 of the transformer *T106*. The replacement capacitor is treated with a special glazed coating and is stocked under part No. 148813-2. Replacement capacitors (part No. 148813-1 or 148813-2) that do not have the special glazed coating may be used in less critical circuits.

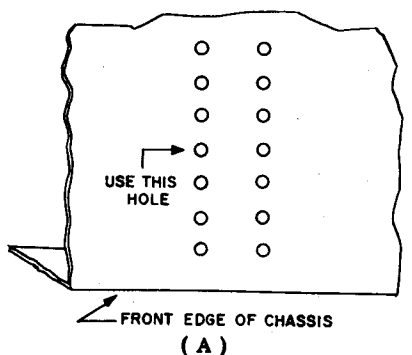
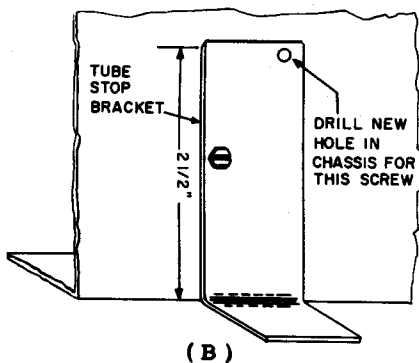
Fig. 39 — Crosley

**CROSLEY** 1953 chassis with  
21MP4 picture tube  
**Replacing metal picture tube  
with glass picture tube (see  
Fig. 39).**

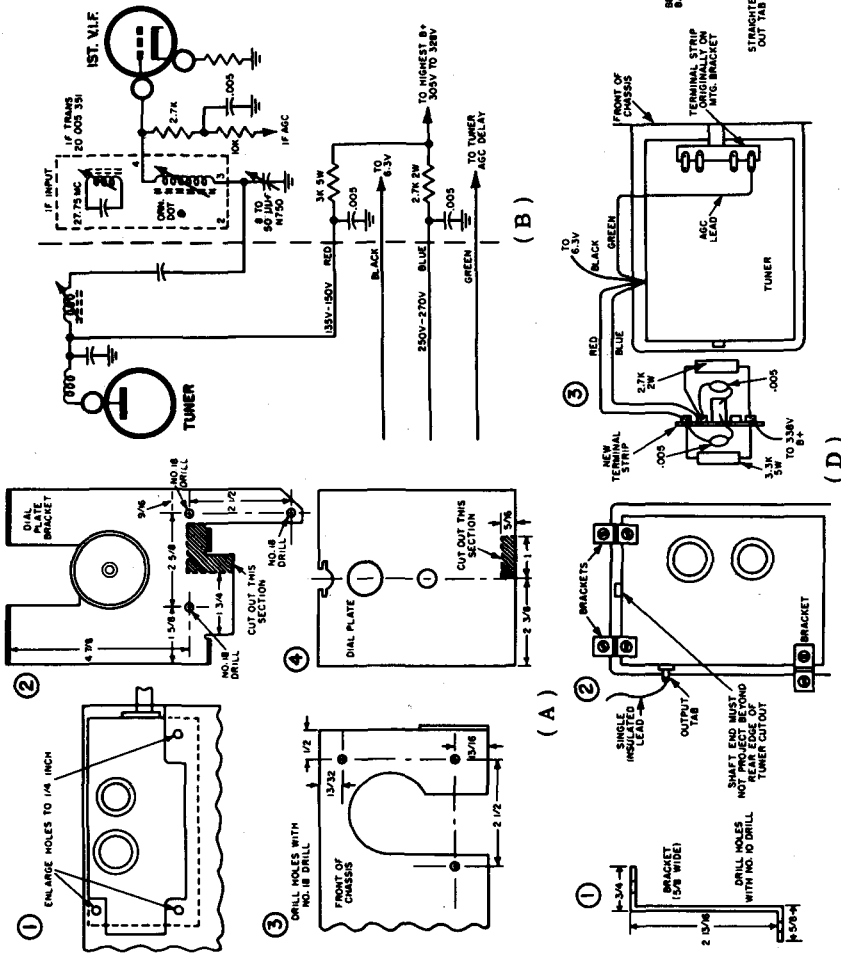
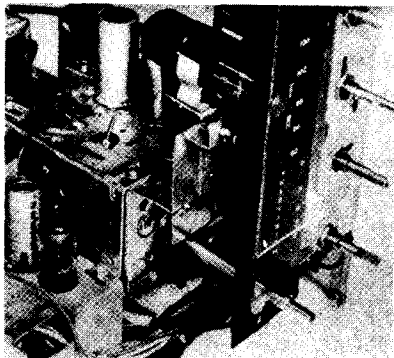
Fig. 41 (Part A-E) — Dumont

**Installing cascode turret tuners for weak signal areas (see Fig. 41).**

4. Mount the tuner in the chassis cutout.

5. Fasten the terminal strip mentioned in step (1) to the front of the chassis, under the tuner, using one of the holes already available. Lengthen the leads where necessary.

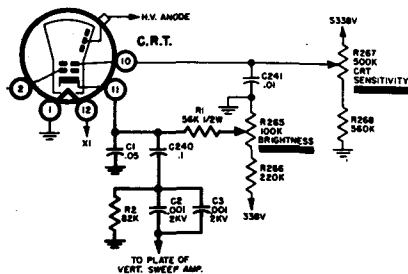
Fig. 42 — Dumont

### DUMONT Models RA-109, RA-116, RA-130, RA-133 Adding retrace blanking (see Fig. 42).

The circuit changes necessary to add vertical retrace blanking to the above chassis are shown in the figure. shown in the schematic, was originally connected between the crt cathode and ground. It should be removed and connected as shown. Additional parts required are listed below.

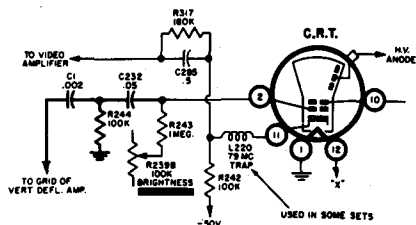
Fig. 43 — Dumont

**Adding retrace blanking (see Fig. 43).**

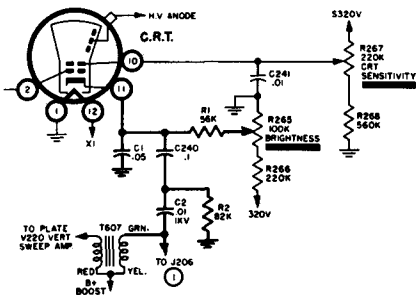
Fig. 44 — Dumont

**DUMONT** Model RA-119  
**Adding retrace blanking (see Fig. 44).**

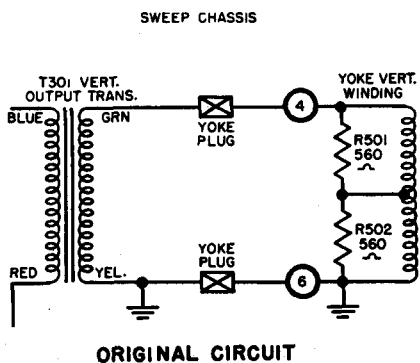
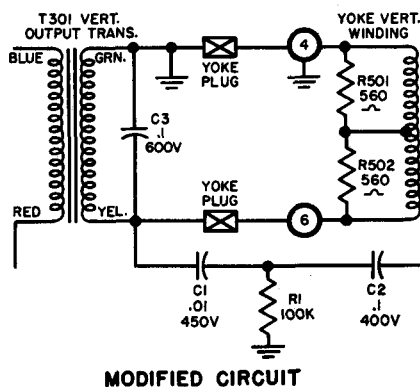
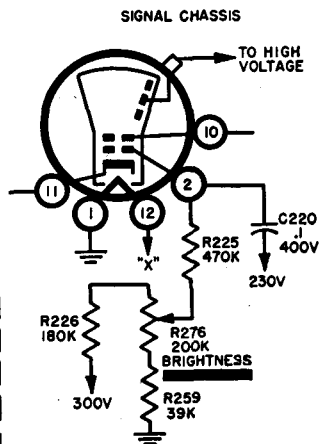
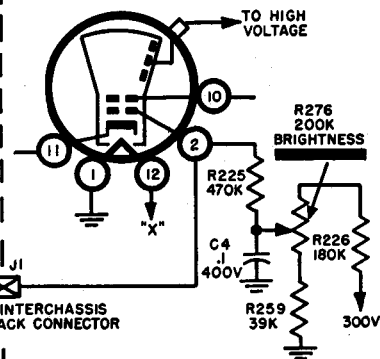
Fig. 45 — Dumont

**Adding retrace blanking (see Fig. 45).**

1. Mount a pin jack, part No. 09 019 870, in the hole next to *C330* (40- $\mu$ f B+ boost electrolytic capacitor near afc test jack).

2. Disconnect the black ground lead from the yellow vertical output transformer (*T301*) secondary lead, and connect it to the green secondary lead.

9. Connect *C4*, an 0.1- $\mu$ f, 400-volt capacitor, between the arm of the brightness control and ground.

10. Connect an insulated stranded lead to the green crt cable lead. A 24-inch lead is required for the RA-160 and a 30-inch length for the RA-162. A base pin removed from a discarded octal tube should be soldered to the other end of the lead. Plug this connector pin into the pin jack on the sweep chassis (see step 1).

11. Remove the ground lead from terminal 6 of the yoke and connect it to terminal 4.

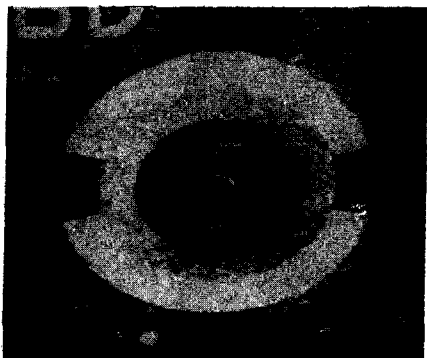
Fig. 46 — Dumont

#### Horizontal jitter at top of picture (see Fig. 46).

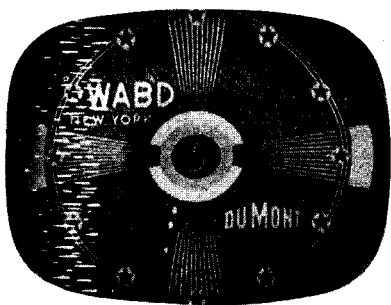
Fig. 47 — Dumont

**Eliminating parasitic oscillations in the filament supply (see Fig. 47).**

To eliminate the possibility of parasitic oscillation in the filament supply wiring, the following change is made. This condition causes a series of white streaks to appear on the left-hand side of the picture when the set is tuned to channels 9, 10, or 11. It also results in a loss of horizontal sync stability.

1. Disconnect the filament lead running from pin 4 of *V213*, the sec-

ond vertical sync clipper, to pin 8 of *V214*, the horizontal sync clipper, at pin 4 of *V213*.

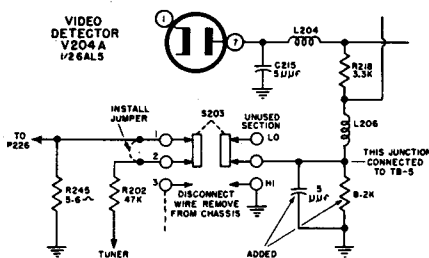
Fig. 48 — Dumont

### Improving performance in fringe areas (see Fig. 48).

1. If there are two leads connected to the end terminal of *TB-5* next to the terminal to which *L206* is connected, remove the leads, connect them together and insulate the joint with tape or spaghetti.

2. Disconnect the grounded end of *L206* and connect it to the end

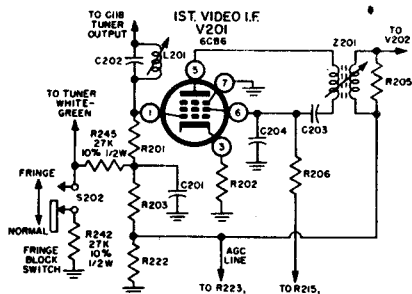
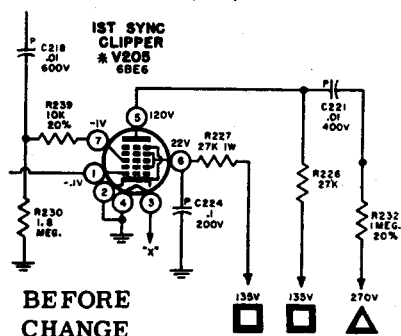
Fig. 50 — Dumont

**Improving picture quality and sync stability in weak signal areas (see Fig. 50).**

To improve picture quality in weak signal areas by reducing picture noise and increasing sync stability, proceed as follows:

1. Remove the jumper between terminals 2 and 3 of TB2 (-7.5 volt terminals on terminal board adjacent to 1st video i-f amplifier), and connect R245, a 27k-ohm, 10%, 1/2-w resistor between these terminals.

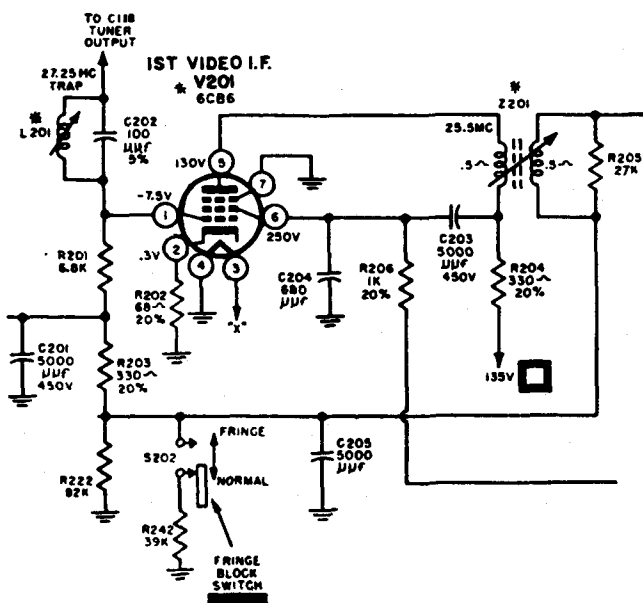
Fig. 53 — Dumont

**Improving picture quality by  
reducing mixer noise and  
improving sync stability (see  
Fig. 53).**

1. Replace R203 (located in the agc circuit) with a 330 ohm, 20%,  $\frac{1}{2}$ -w resistor (part No. 02032390).

2. Replace R222 with an 82k-ohm 10%,  $\frac{1}{2}$ -w resistor (part No. 02032000).

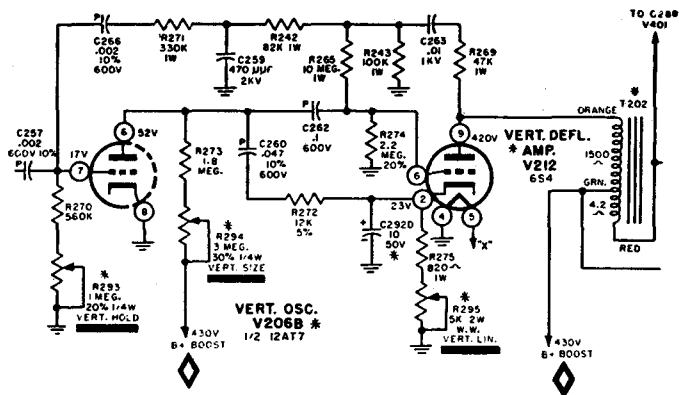
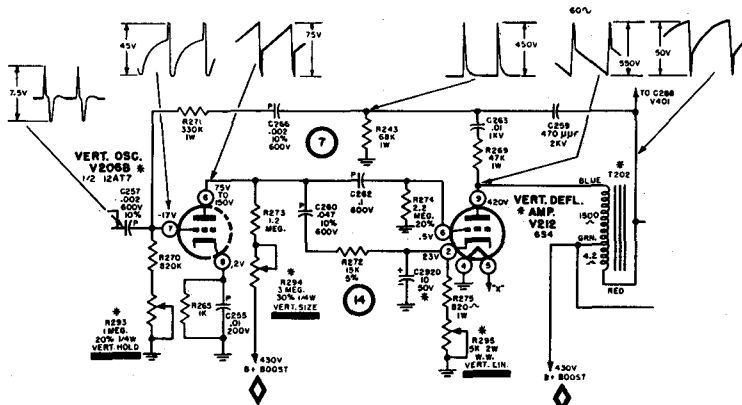
Fig. 54 — Dumont

### **Increasing vertical interlace stability (see Fig. 54).**

4. Replace *R243* (100k ohms) with a 68k-ohm, 10%, 1-w resistor (part No. 02034990).

5. Replace *R270* (560k-ohm grid resistor of vertical oscillator) with an 820k-ohm, 10%, ½-w resistor (part No. 02032120).

6. Replace *R272* (12k-ohm peaking resistor) with an 18k-ohm, 5%, ½-w resistor.

7. Replace *R273* (1.8-meg plate resistor of vertical oscillator) with a 1.2-meg, 10%, ½-w resistor.

8. Disconnect pin 8 of *V206*, the vertical sweep oscillator, from ground.

9. Connect *C255*, a .01- $\mu$ f, 20%, 200-v capacitor (part No. 03119780) between pin 8 of *V206* and ground.

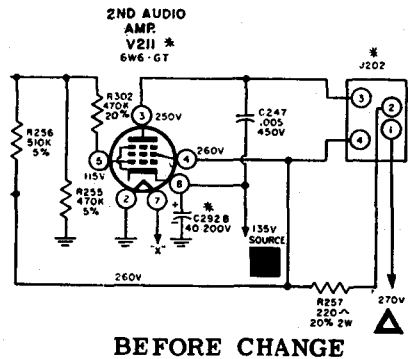
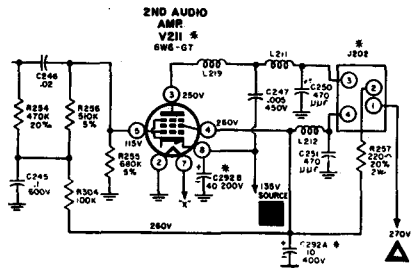
**Fig. 55 — Dumont**

**Preventing audio in picture  
and beats on channels 5, 7  
and 11 (see Fig. 55).**

The procedure is to connect *L220*, covered with an adequate insulation sleeve, between the tuner (21010783) output tab and *L201*, *C202*, the adjacent channel trap.

Note: Tuner 21010783 must be used with *L220* or mixer plate coil *L110* will not align properly. Tuners 21010781, 21010782 and 89012601

may be used as direct replacements if *L220* is removed from the circuit.

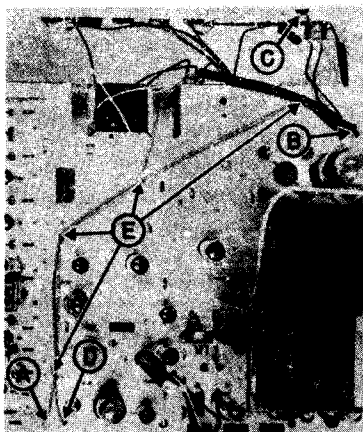
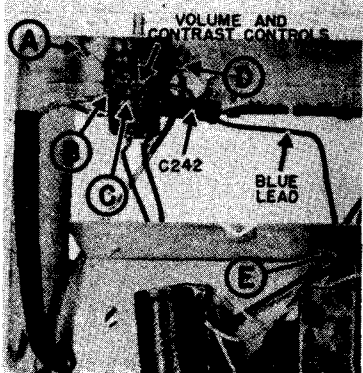
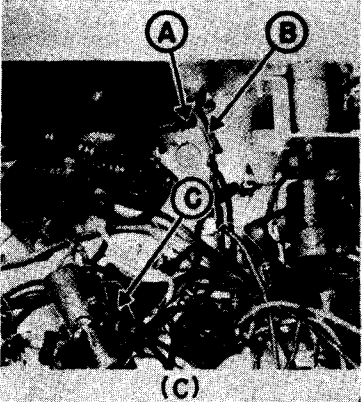
Fig. 56 — Dumont

**Eliminating audio buzz,  
minimizing residual hum and  
improving sound quality (see  
Fig. 56).**

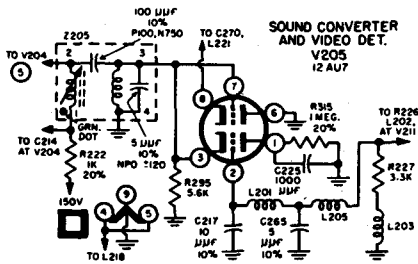
Fig. 57 — Dumont

**Preventing i-f harmonic interference in picture (see Fig. 57).**

To reduce radiation of harmonics of the sound and video i-f signals, generated in the video detector and sound converter, V205, proceed as follows. Under some conditions these harmonic signals enter the tuner causing interference in the picture.

1. Remove the 6AL5 and its socket. Replace the socket with a 9-pin miniature socket. Rewire the circuit as shown in the figure.

2. Remove R265, a 1k-ohm resistor connected between the junction of C219 (6.8-µµf coupling capacitor to sound i-f amplifier), L221 (coil originally tied to the cathode of the sound converter) and ground. Connect R265, 2.7k-ohm, 10%,  $\frac{1}{2}$ -w resistor, from the junction of L221, C270 (10-µµf capacitor to ground) and pin 8 of V205, to ground.

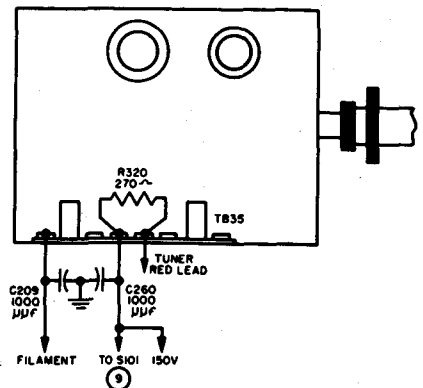
Fig. 58 — Dumont

**Preventing regeneration on uhf models (see Fig. 58).**

1. Mount S204, a single-pole three-position rotary switch (part No. 05008731), on rear of chassis above L210 (horizontal stabilizing coil).

2. Remove R210 (240k-ohm resistor in r-f agc bus). Connect a 180k-ohm, 1/2-watt, 5% resistor between terminal 1 of S204 and terminal 3 of TB18. This is the -3 volt

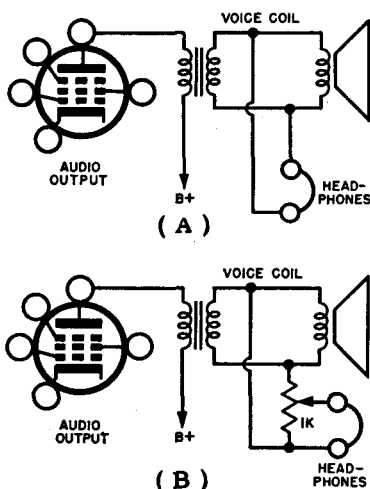
Fig. 61 — Dumont

**Connecting headphones to  
receiver (see Fig. 61).**

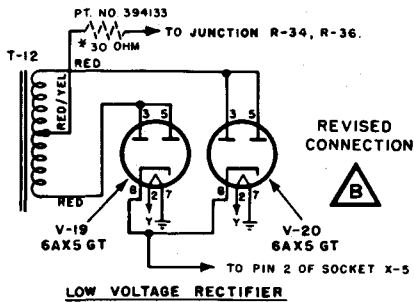
Fig. 63 — Emerson

**EMERSON** Chassis 120162-A  
**Reducing excessive horizontal size at high line voltages (see Fig. 63).**

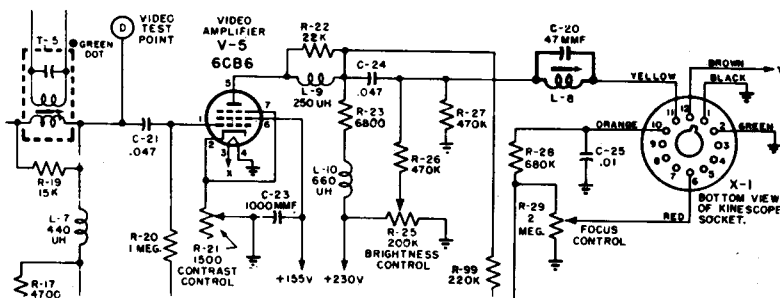
Fig. 65 — Emerson

**EMERSON** Chassis 120166-D,  
120168-D, 120171-B  
**Increasing 4.5-mc rejection and  
increasing audio sensitivity**  
(see Fig. 65).

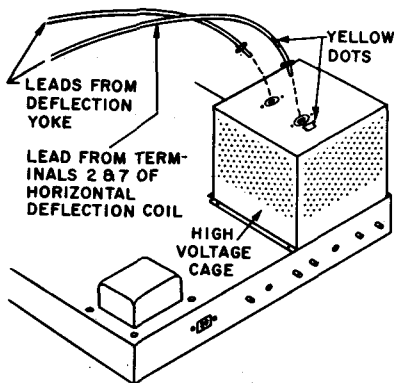
Fig. 68 — Emerson

**Proper polarity of plugs in h-v cage (see Fig. 68).**

With the fine tuning set for the maximum 4.5 mc in the picture, adjust the 4.5-mc video trap *L8* for the minimum 4.5-mc beat note in the picture.

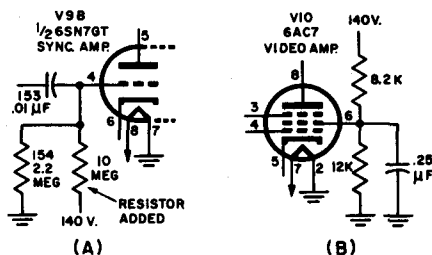
Fig. 73 — Firestone

**FIRESTONE** Models 13-G-51,-52  
**Improved sync stability in fringe areas (see Fig. 73).**

Tube manufacturers have taken steps to improve the heating characteristics of the 6AX4 tube and in most cases it is felt that replacement of the old 6AX4 tube with one of recent manufacture will completely cure the trouble. However, in stubborn cases where replacing the 6AX4 tube does not correct the trouble, the following circuit change is suggested.

Replace the 40X331 drive control R89 (150k ohms, linear,  $\frac{1}{4}$  watt) with a 40X378 (150k ohms, linear,  $\frac{1}{2}$  watt). Wire as before and add an additional wire from the outside vacant lug to pin 6 of the damper tube (B+ 300 v). The drive control will now be wired as a potentiometer, with the boost voltage connected to one side and the B+ 300-v power supply voltage to the other. In ad-

dition the 430- $\mu$ f coupling capacitor, C67 (connected between pins 1 and 5 of the horizontal oscillator), should be replaced with a 360- $\mu$ f unit, part No. 47X568, for additional stability. Check to see that the B+ 250-volt line is connected to the start of the horizontal frequency coil winding L14. Reversed connections to this coil would aggravate the unstable condition.

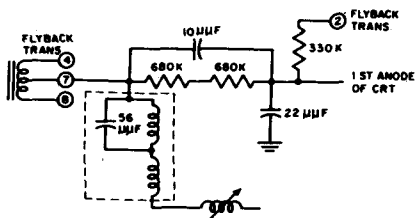
Fig. 74 — Emerson

**Vertical shading and horizontal  
ringing (see Fig. 74).**

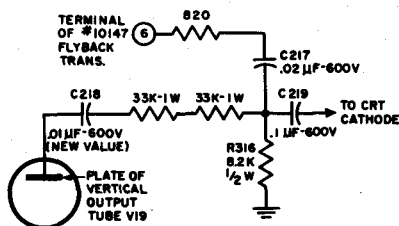
Fig. 75 — Emerson

**FIRESTONE** Models 13-G-151,  
 -152,-152A  
**Eliminating horizontal ringing  
 and vertical shading (see  
 Fig. 75).**

In addition to the above, the following modifications are made. A 27k-ohm, 1/2-watt resistor is added to

attenuate the shaping pulse. By doing this, a certain amount of phase shift is noted. In order to compensate for this, a 22- $\mu\text{mf}$ , 500-volt capacitor parallels the resistor to allow a certain amount of blanking to bypass the resistor in order to prevent this phase shift.
