MANUFACTURERS' RECEIVER TROUBLE CURES

VOLUME 7

(CAT. NO. 143-7)

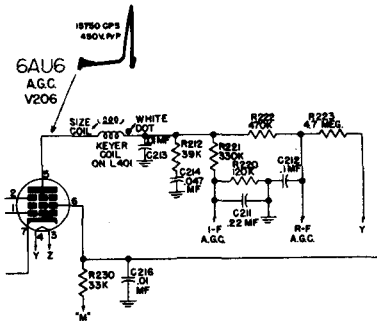
Fig. 11 — Magnavox

MAGNAVOX Chassis 105-, 106-, 107-series
Troubleshooting "sync lockout"
(see Fig. 11).

5. If sync lockout takes place with normal signal input from the antenna, loosely couple antenna twinlead to input terminals and watch the bias. If there is a normal fall-off toward the values indicated under condition of zero signal (see above), it can be assumed that the biasing network is functioning properly.

6. If bias is not being developed at all, the amplitude of the keying spike on the plate of the agc keyer is the first check. This should be about 440 volts, with no leading or trailing spikes of a sufficient amplitude to cause the keyer to fire prematurely or for a period past that of the main spike. If the keyer pulse is not good, check the pulse on pin 5 of the horizontal output transformer.

14. Sync lockout can also occur in the event of troubles existing in the sync separator, sync amplifier, sync clipper, horizontal afc, horizontal oscillator or output stage. If all the foregoing steps have been checked and found normal, and if the picture tends to roll vertically as well as being in horizontal lockout, a leaky coupling capacitor between the agc keyer and sync separator (*C309* particularly), between the separator sync amplifier (*C310*); between the amplifier and clipper (*C311*); between the clipper and horizontal afc (*C304*) can be suspected. Using a scope and low capacitance probe, check the waveforms before the stages mentioned. The resultant waveform on the grid of the afc tube should be a clean, stable spike of about 20 volts p-p. The reasoning behind experiencing lockout here is that in the event of discontinuity in the sync chain feeding the afc, the horizontal oscillator will run at random frequency. This results in delivering this voltage to the keyer tube through the keyer coil at an incorrect time with respect to the transmitted sync signal which is delivered to the grid of the keyer (the grid and plate pulse should be applied to the tube simultaneously). This is required in order that the agc charging capacitor *C213* be permitted to charge and then discharge exponentially to furnish bias during the time no sync is transmitted (the picture time).
